**MARINE ACCIDENT
INVESTIGATION REPORT**

Vessel type and name: Cargo ship ERNA OLDENDORFF

Accident type: Collision (Bridge)

Location: Oshima Bridge which spans Obatake Seto, Yamaguchi Prefecture

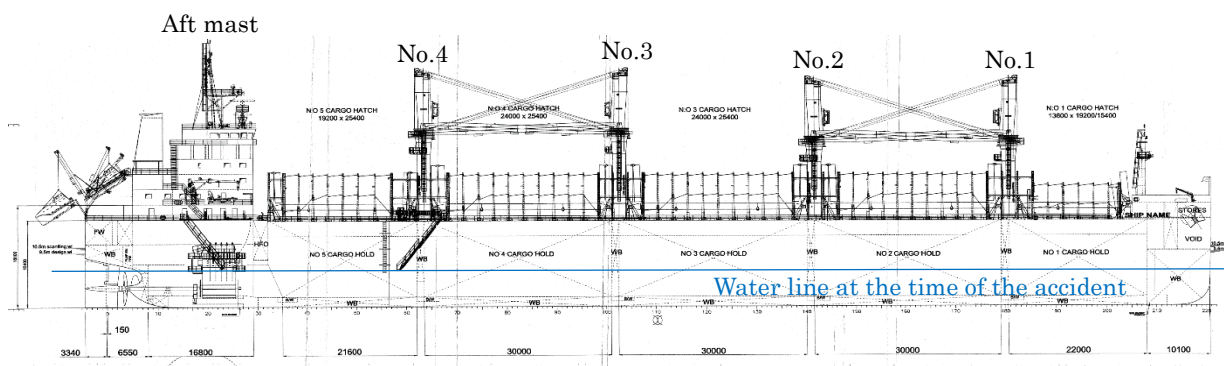
Figure 4 General Arrangement of the Vessel

According to on-site investigation and the Vessel’s general arrangement plan, the Vessel is a cargo ship with five cargo holds and a docking bridge; ‘the heights above the water line at the time of the accident to the top of each cargo crane installed on the deck and to the top of the aft mast installed above the bridge’ (hereinafter referred to as “the height of crane and mast”) were as follows. (See Figure 4)

Height above the water line
No. 1 and No. 2 cranes	Approx. 34 m
No. 3 and No. 4 cranes	Approx. 35 m
Aft mast (including antenna)	Approx. 42 m (the Vessel’s air-draft*5)

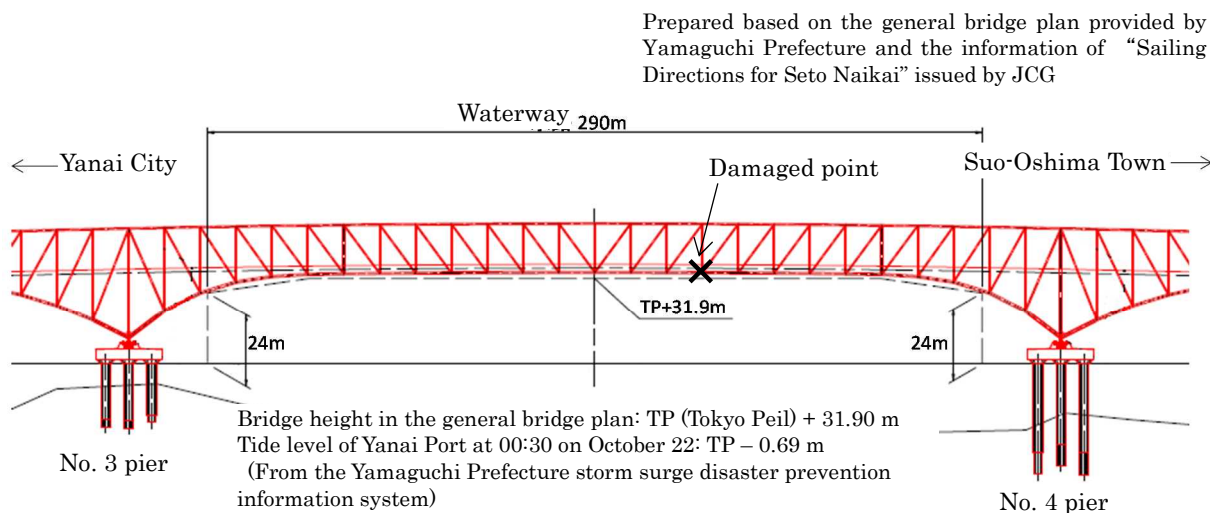
Figure 6 Oshima Bridge

According to information of Oshima Bridge’s general bridge plan and the Yamaguchi Prefecture storm surge disaster prevention information system, the height from the ocean’s surface at the time of the accident to Oshima Bridge (lower edge of the inspection passage installed under the girders) was approximately 33 meters at the highest point. (See Figure 7)

In addition, according to the statement and replies to the questionnaire by the person in charge of the Yamaguchi Prefecture, the situation before the accident which the inspection passage, etc. had been installed under the girder around the damaged point was as shown in Figure 8.
