**MARINE ACCIDENT
INVESTIGATION REPORT**

Vessel type and name: Cargo ship CAPE VERDE

Vessel type and name: Fishing vessel MUNEYOSHI MARU

Accident type: Collision (Fishing gear)

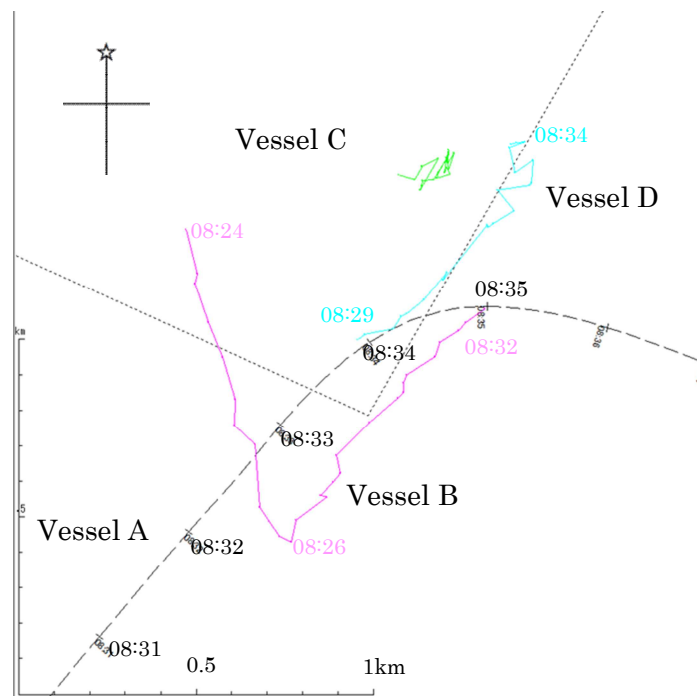
Figure 2.1-1 Navigation Tracks of Vessels B, C and D

According to Table 2.1-2, the navigation track of Vessel B from around 08:23:57 to around 08:34:12 was as shown in Figure 2.1-1, Attached Figure 1 “Navigation tracks” and Attached Figure 2-1 “Navigation tracks (Close-up).”

According to Table 2.1-3, the navigation track of Vessel C from around 08:28:42 to around 08:34:42 was shown in Figure 2.1-1.

According to Table 2.1-4, the navigation track of Vessel D from around 08:29:12 to around 08:34:27 was as shown in Figure 2.1-1.

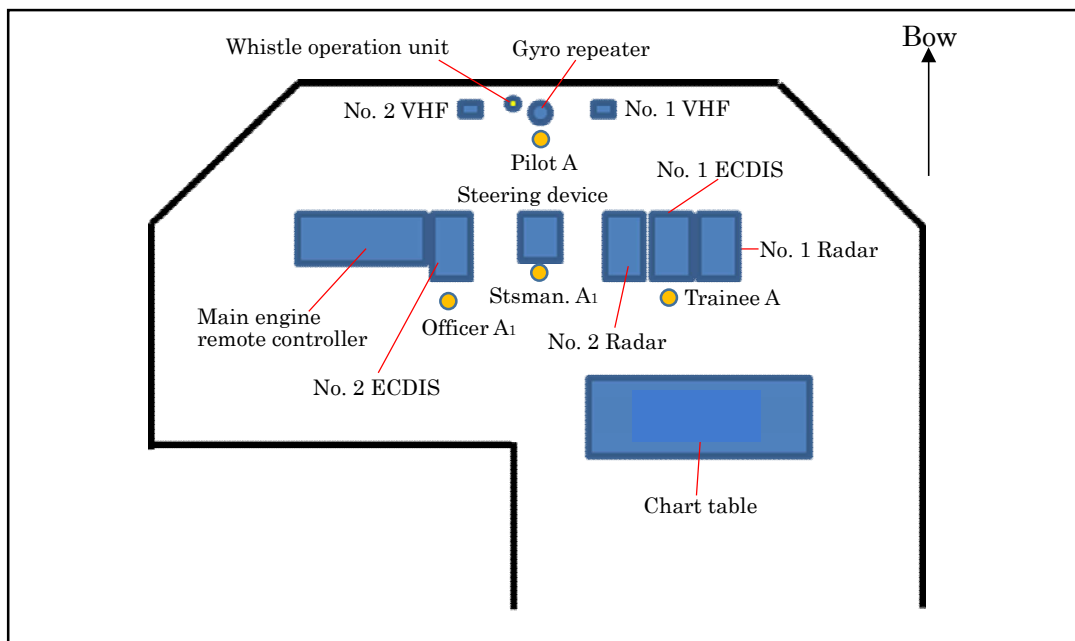
Figure 2.5-1 Bridge of Vessel A (Main Positions of Officer A₁, Steersman A₁, Pilot A and Trainee A at the time of the accident according to their oral statements)

According to oral statements from Pilot A, Pilot A and Trainee A monitored radar Nos. 1 and 2 by alternately changing the range between 6 and 3 M at the time of the accident.

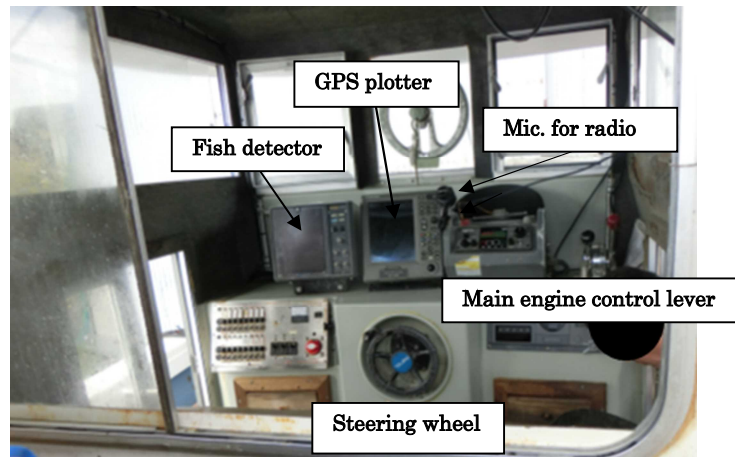
Photo 2.5-3 Wheelhouse of Vessel B

Vessel B was equipped with a fish detector, GPS plotter, microphone for fishery radio equipment, throttle and clutch levers of the main engine in order from the port side on the bow side of the wheelhouse and a steering wheel below the GPS plotter.

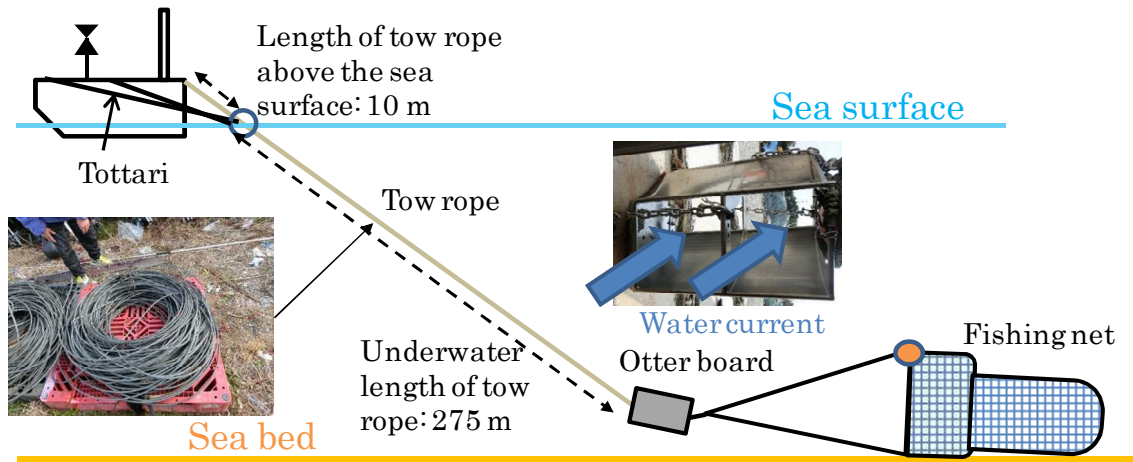
Figure 2.5-2 State of Vessel B in Operation (Image)

- (1) A metal wire called the tow rope was paid out from the left and right drums installed in the center of the hull through the rail on each side of the stern end.
- (2) The tow ropes were released about 10 m from the stern end to the sea surface and about 275 m under the sea surface, with the otter board and fishing net attached to the end of these ropes.
- (3) At the time of operation, the underwater length of the fishing gear comprising tow ropes and fishing net was about 355 m.
- (4) To prevent tow ropes from being entangled in the propeller and disperse the force applied to these ropes, a fiber rope called "Tottari" was extended from each side of the bow and the stern, and hooked to each of the tow ropes.
- (5) During operation, Vessel B exhibited a black shape on the mast indicating that it was a ship engaged in fishery operations.

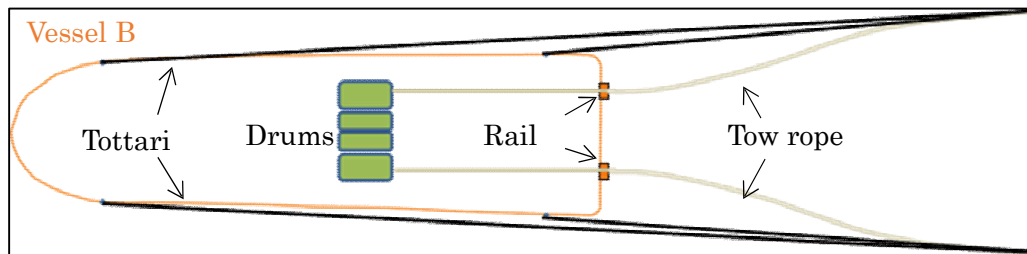
Figure 2.5-3 Tow Ropes and Tottari (Image)

While Vessel B was proceeding northeast with the main engine's control lever set to full ahead while pulling the net at a speed of 2 to 3 kn, when Skipper B looked at the stern of Vessel B 10 minutes after starting the fourth operation, he found that Vessel A was approaching close to the stern of Vessel B. He felt quite close and steered to port to avoid Vessel A, but Vessel B did not turn to port so easily, so the crewmember of Vessel B (hereinafter referred to as “Crewmember B”) let out the “fiber rope fastened from the port bow to the port tow rope” (hereinafter referred to as “Tottari ”) to turn Vessel B to port.

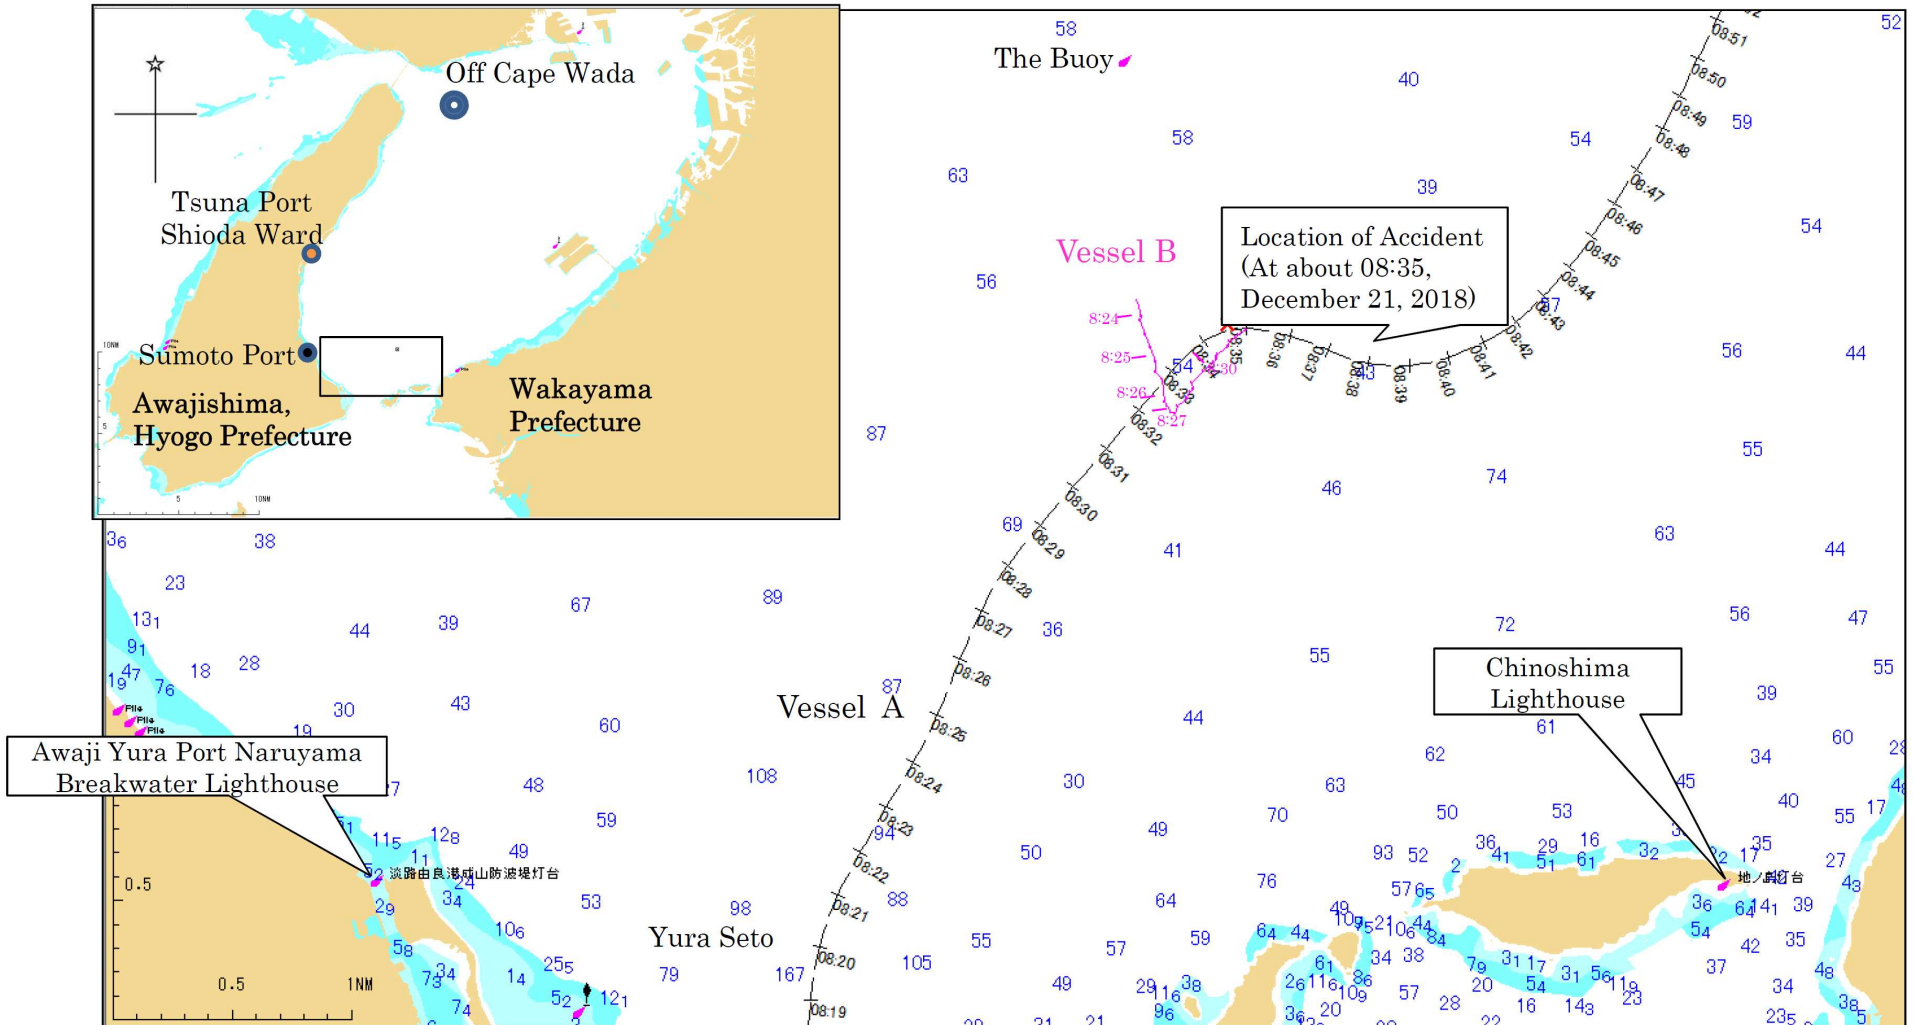
Attached Figure 1 Navigation tracks

According to Table 2.1-1, the navigation track of Vessel A was as shown in Figure 2.1-1, Attached Figure 1 “Navigation tracks” and Attached Figure 2-1 “Navigation tracks (Close-up).”

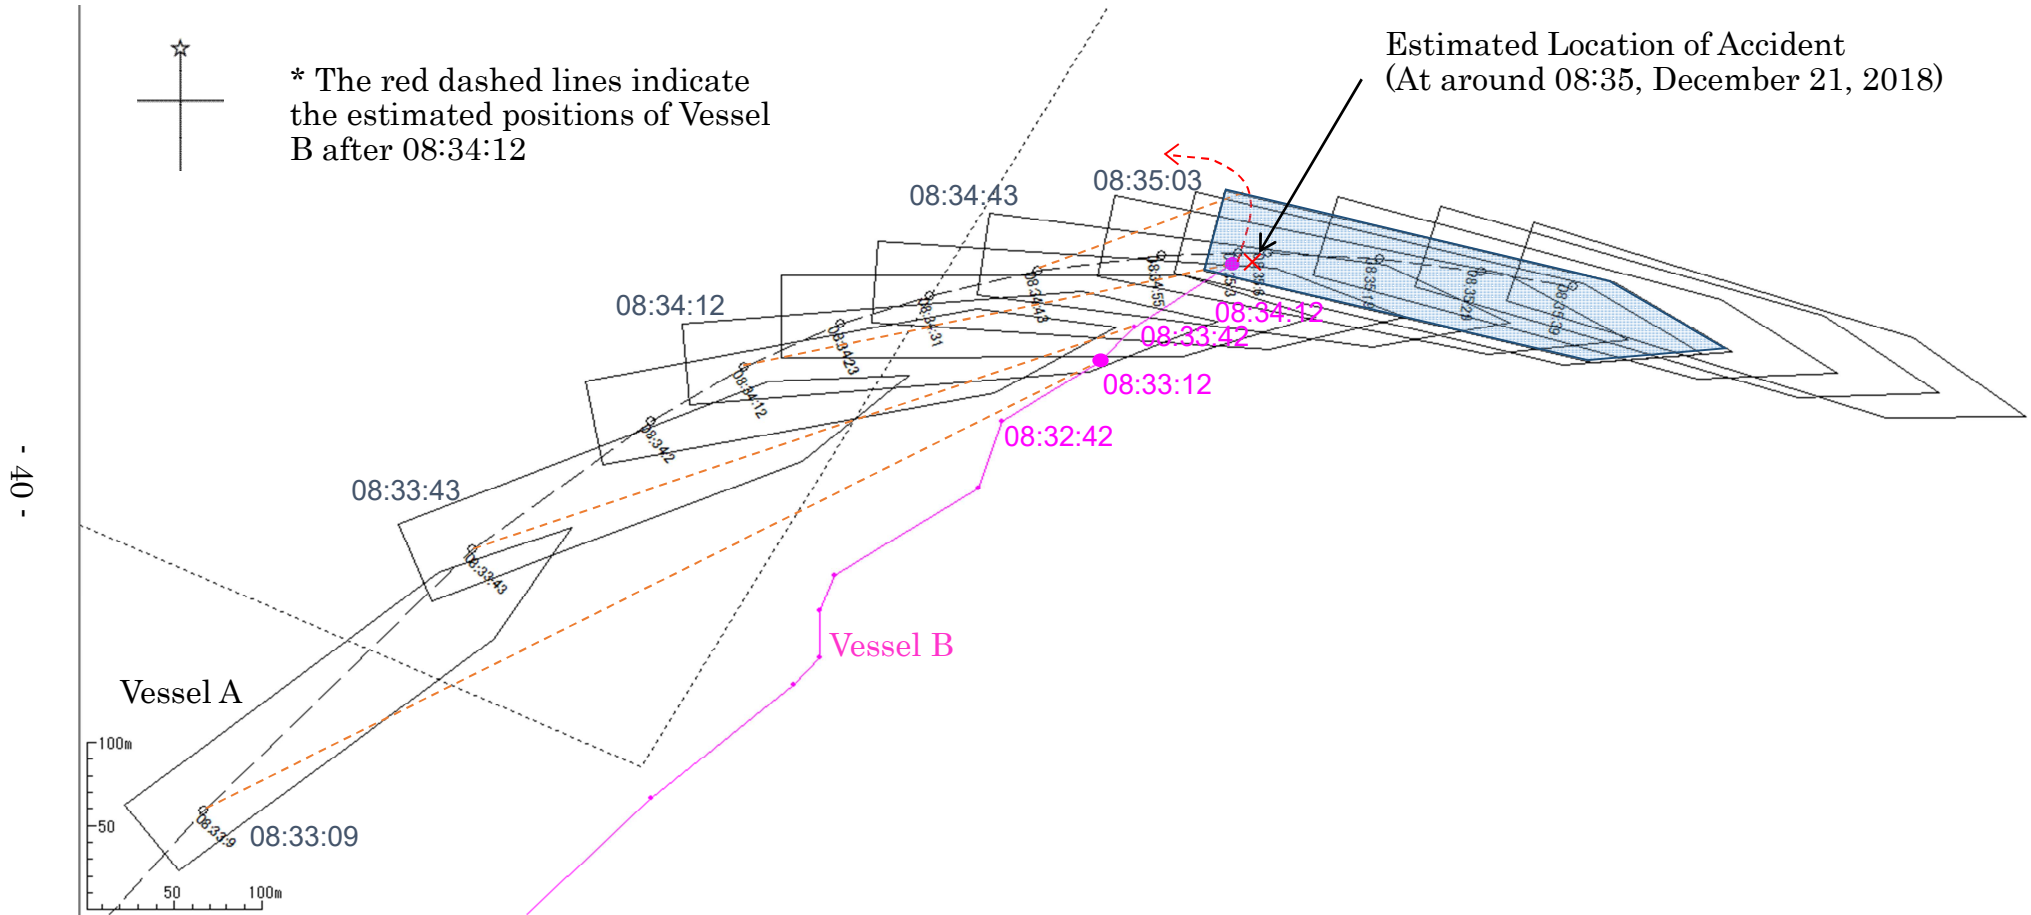
[1] According to the AIS data of Vessel A and the oral statements from Pilot A, Trainee A, Skipper B and Skipper E, it is somewhat likely that Vessel B adopted the positions shown in Attached Figure 2-1 Navigation tracks (Close-up) from 08:34:12 up to around 08:35.

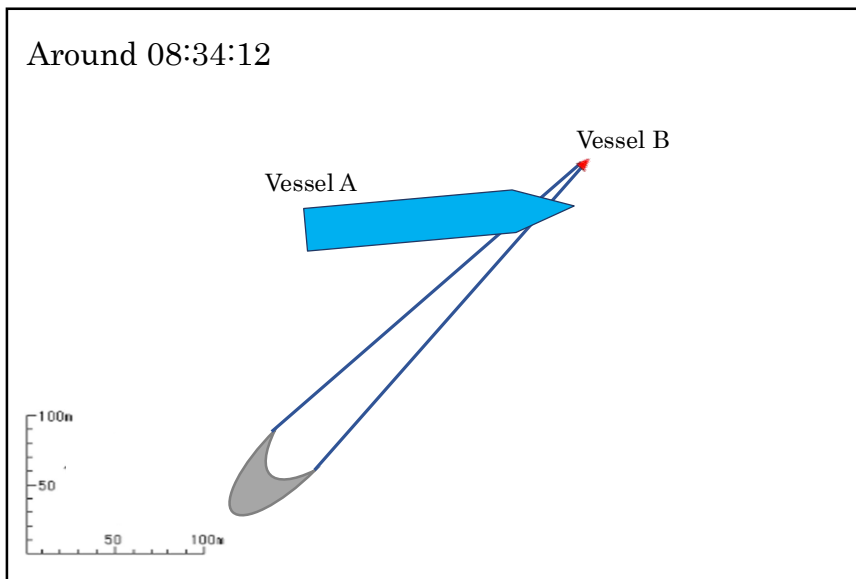
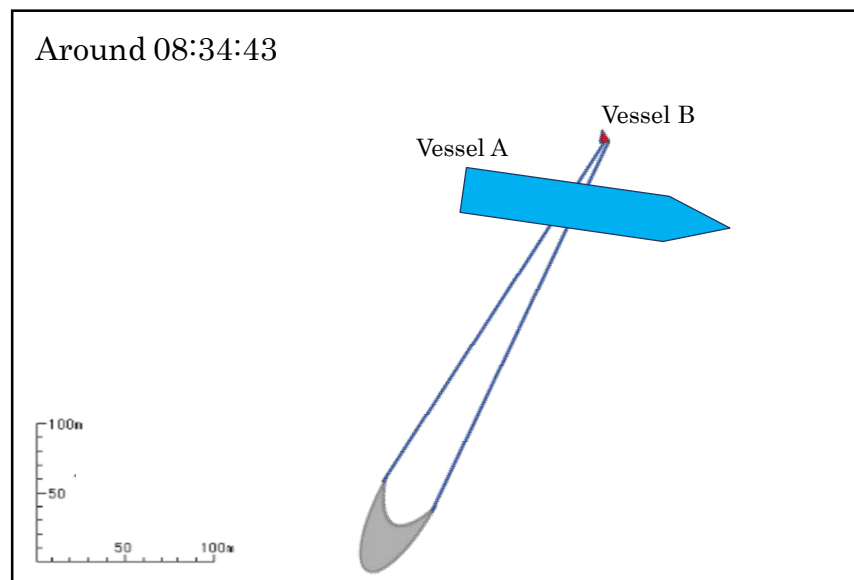
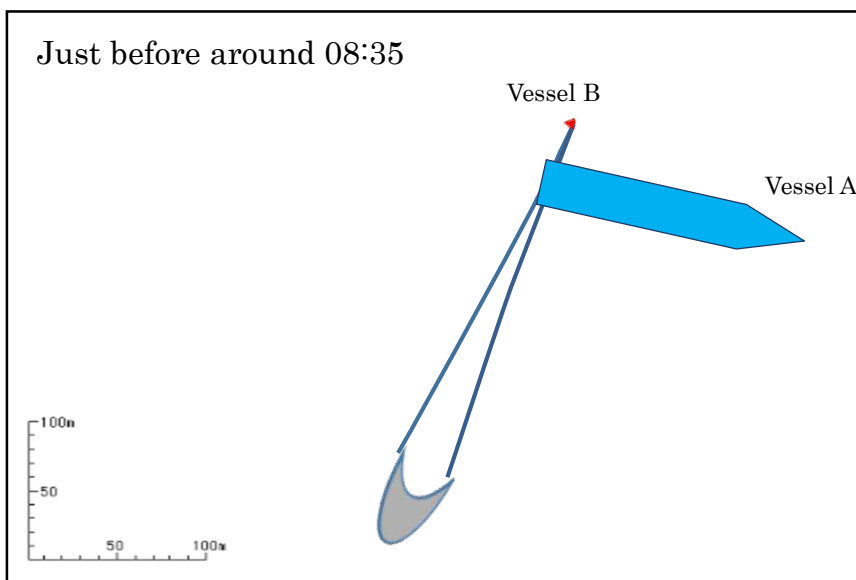
Attached Figure 2-2 Diagram of the Positional Relationship between Vessel A and Vessel B's Fishing Equipment
(Conceptual Diagram)

(See Attached Figure 2-2 "Diagram of the Positional Relationship between Vessel A and Vessel B's Fishing Equipment [Conceptual Diagram]")

* This figure is a conceptual diagram of the positional relationship between Vessel A and Vessel B that is based on the positions of Vessel A and Vessel B at each time indicated. However, it is possible that Vessel B's position, heading, and condition of fishing equipment differ from reality.

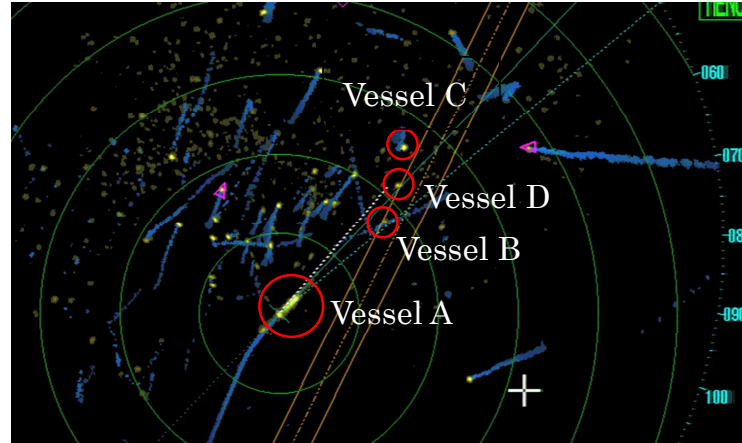
(2) At around 08:29:12

- (1) According to the Sailing Directions for the Seto Naikai published by the Japan Coast Guard, Yura Seto on the Tomogashima Suido channel is a sea area where fishing vessels and recreational fishing vessels gather as a good fishing ground for steamship trawl fishery operations.
- (2) According to the oral statements from Pilot A and Skipper E, there were always many fishing vessels, including recreational fishing vessels, in the vicinity of the accident water area as well as many ships on the day of the accident.
- (3) According to the radar image of Vessel A, ships displayed on the starboard side of Vessel A were fewer than those observed on the port side at about 08:29 on the day of the accident. (See Attached Figure 3 “(2) At around 08:29:12.”).
