MA2021-4

**MARINE ACCIDENT
INVESTIGATION REPORT**

Vessel type and name: Cargo Ship AZUL CHALLENGE

Accident type: Grounding

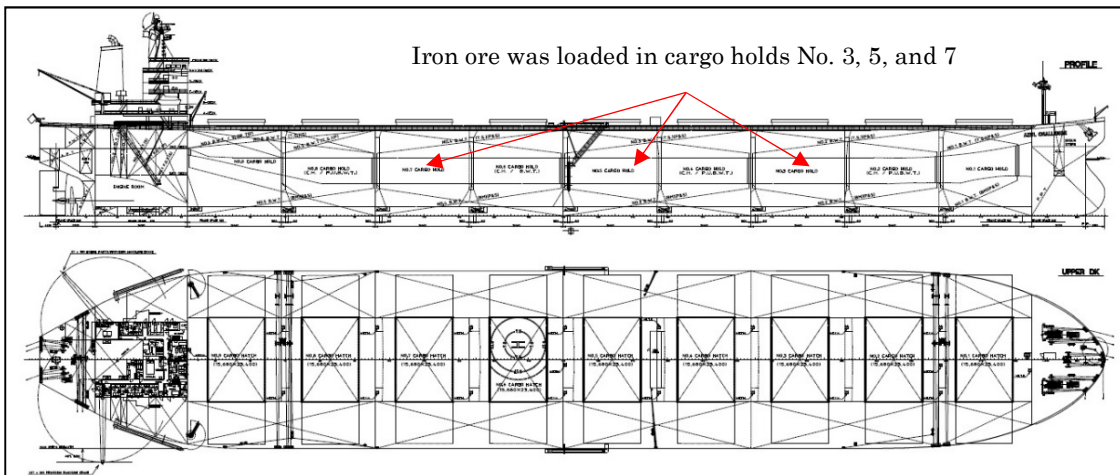
Figure 4 General Arrangement Plan (Excerpt)

According to the general arrangement plan, the Vessel was a cargo ship with a docking bridge. She had nine cargo holds that were numbered in order from the bow. (See Figure 4)

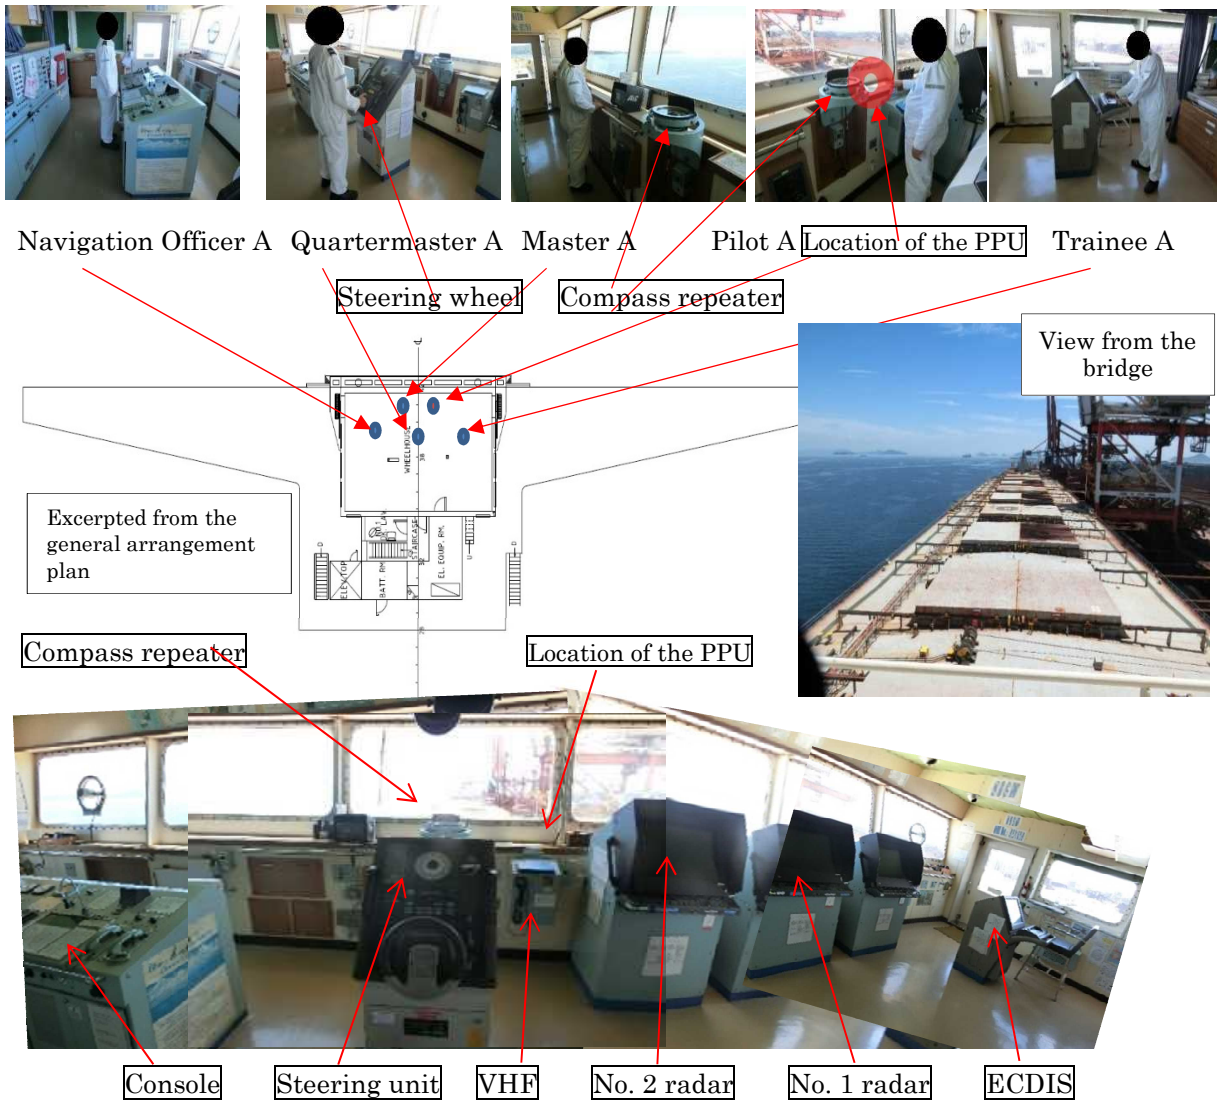
Figure 5 The Vessel's Bridge (for Illustrative Purposes)

There was no malfunction or failure in the hull, engine, or machineries at the time of the accident.

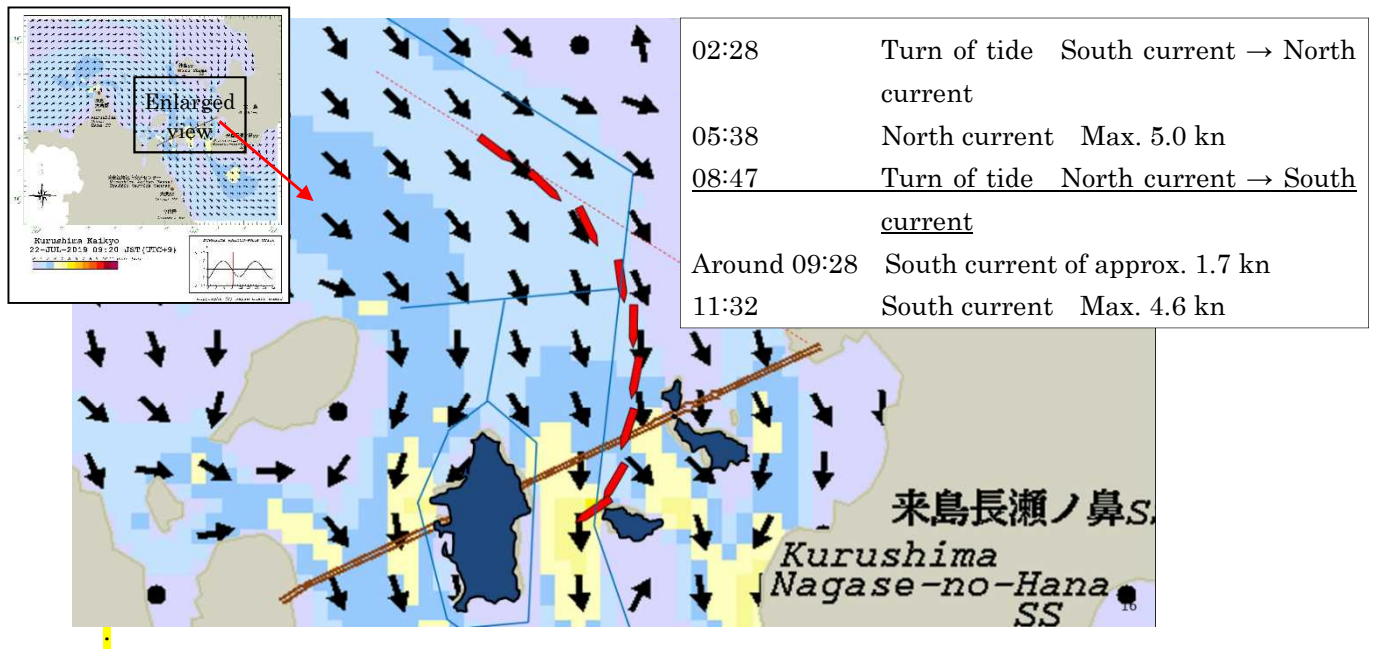
Figure 6 Tide and Navigation Track in Kurushima Kaikyo at 09:20

According to tide tables for 2019 published by Japan Coast Guard (Pub. No. 781, published in February 2018), the Japan Coast Guard website, and the Vessel's navigational track chart, the tides were as follows. (See Figure 6)

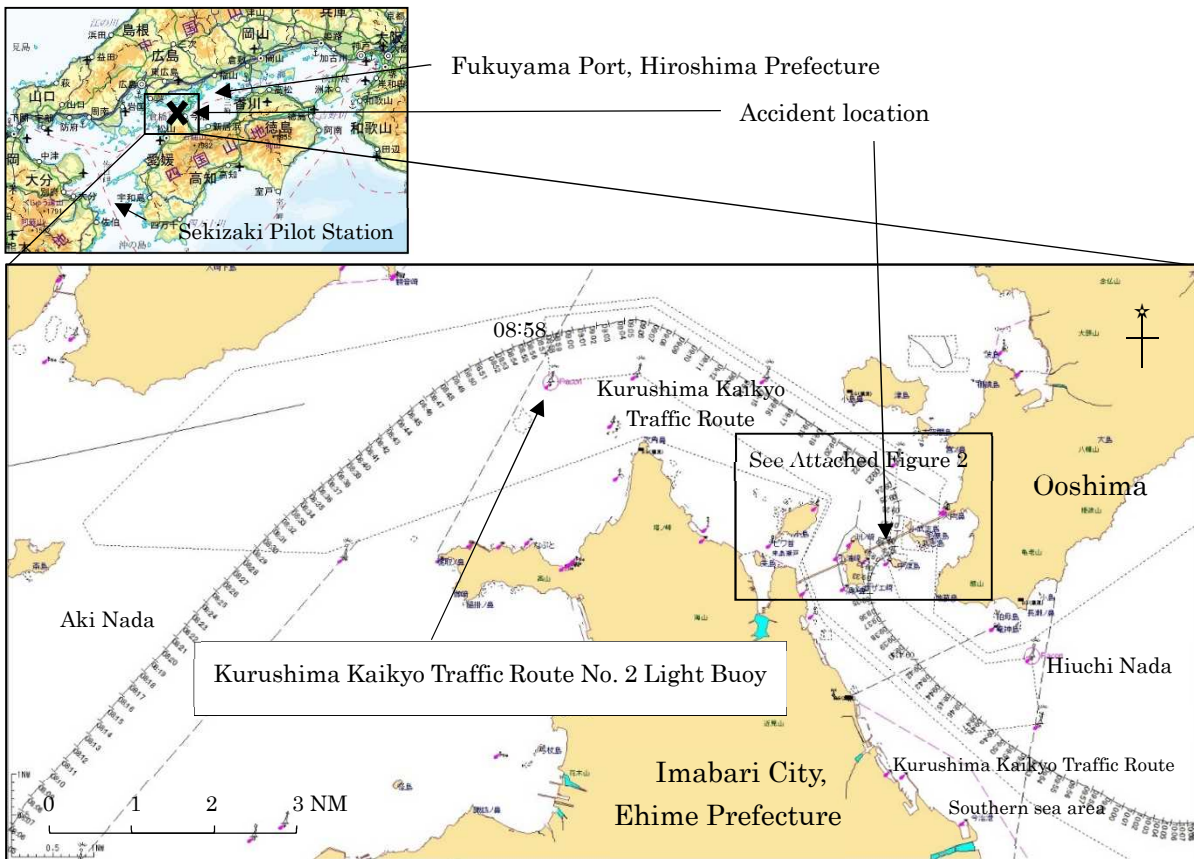
Attached Figure 1 Navigation Track (Overall View)

The Vessel rode over the shallows on the west side of Nakato Shima with her rudder still to port and passed the narrowest part of Naka Suido, after which Pilot A admitted to running aground when asked about grounding by Kurushima MARTIS via VHF. The Vessel headed toward the southern side of the Kurushima Kaikyo Traffic Route under instructions by Kurushima MARTIS with Pilot A still providing pilotage and, at around 10:15, anchored to check for damage and undergo inspection by Japan Coast Guard.
