MA2022-07

**MARINE ACCIDENT
INVESTIGATION REPORT**

| Summary of the Accident | The cargo vessel CHANG SHUN I adrift in the west channel of the Tsushima Strait with the main engine stopped. Since the main engine failed to start, the vessel was pushed by wind and waves and grounded on shallows on the north side of Mitsushima. The master of CHANG SHUN I was injured and the vessel sank after the hull was split into several blocks. |

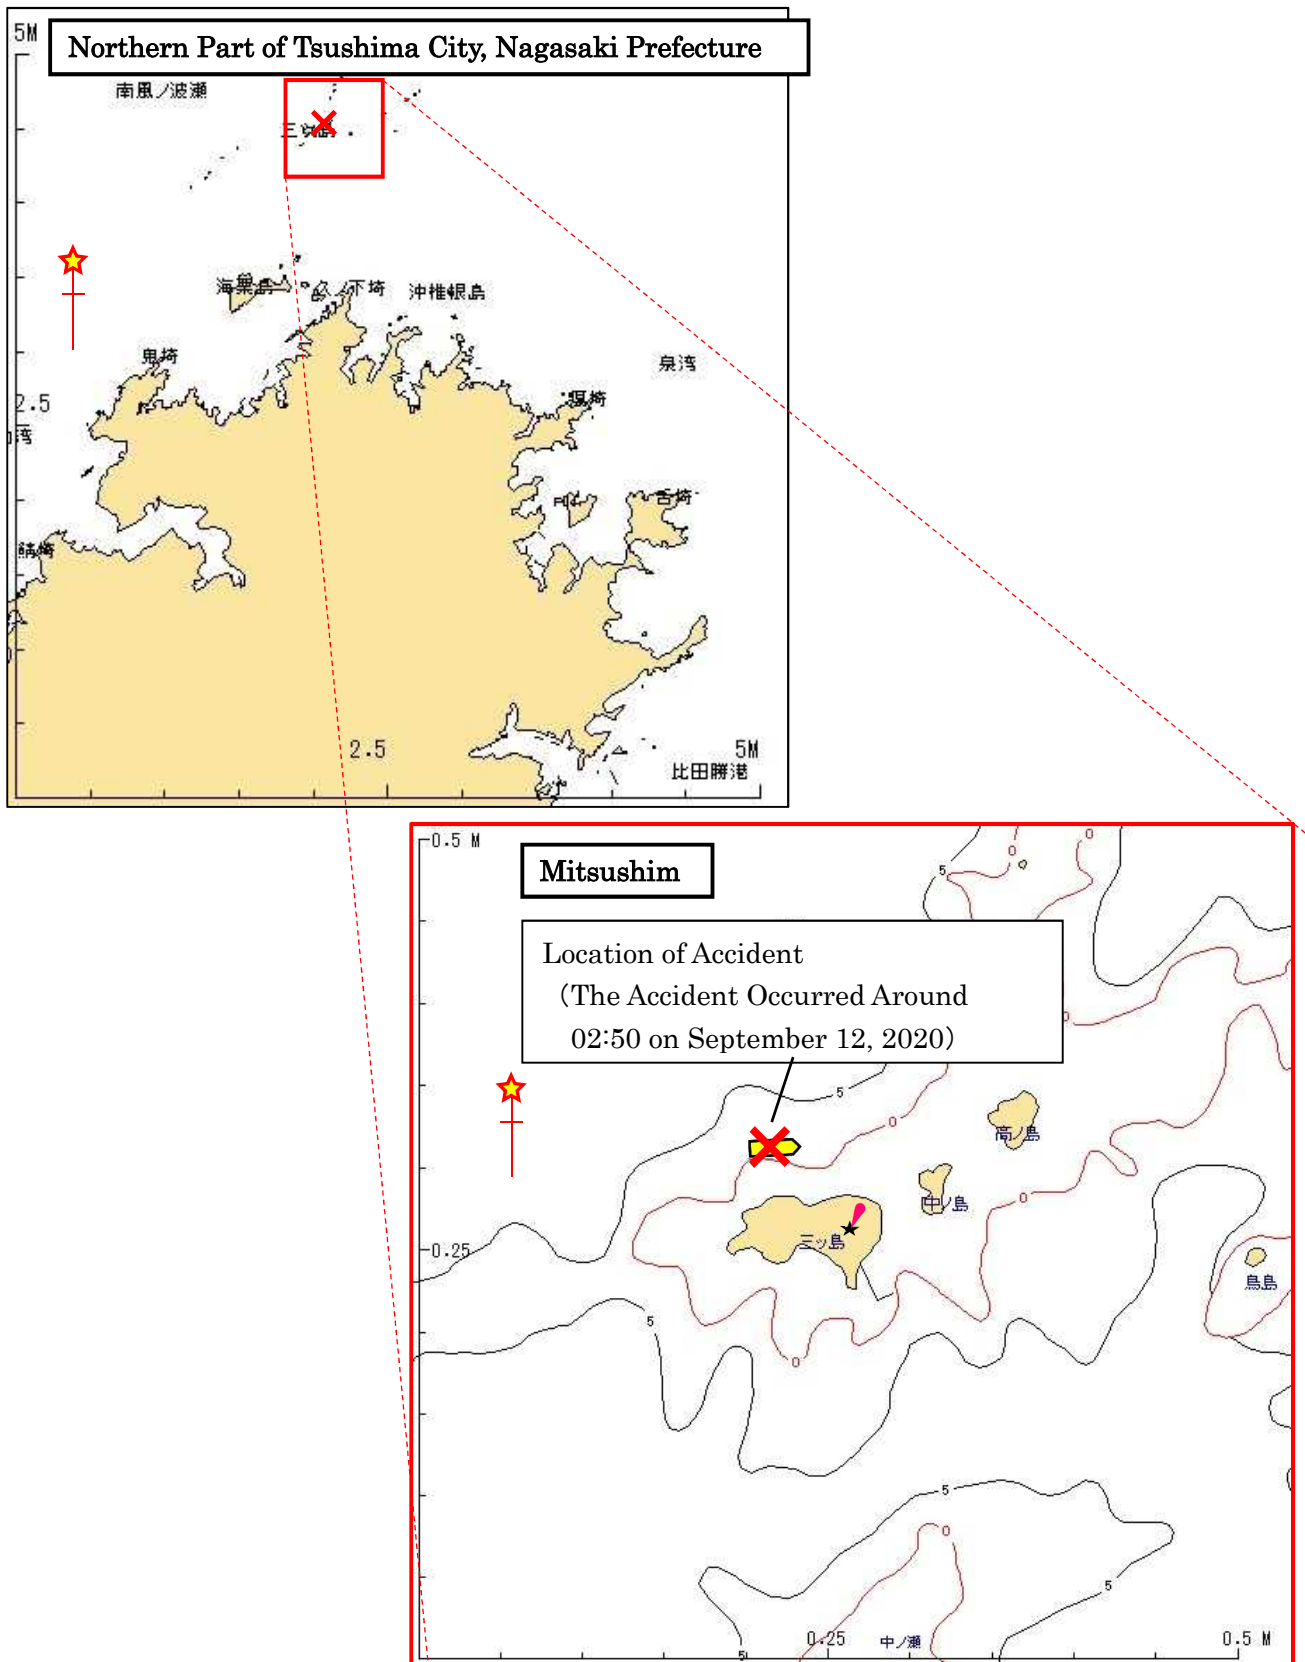
APPENDIX 1: SCHEMATIC DIAGRAM OF THE ACCIDENT

At around 02:50, the vessel grounded on shallows on the north side of Mitsushima, Tsushima City, Nagasaki Prefecture. (See Photo 1)

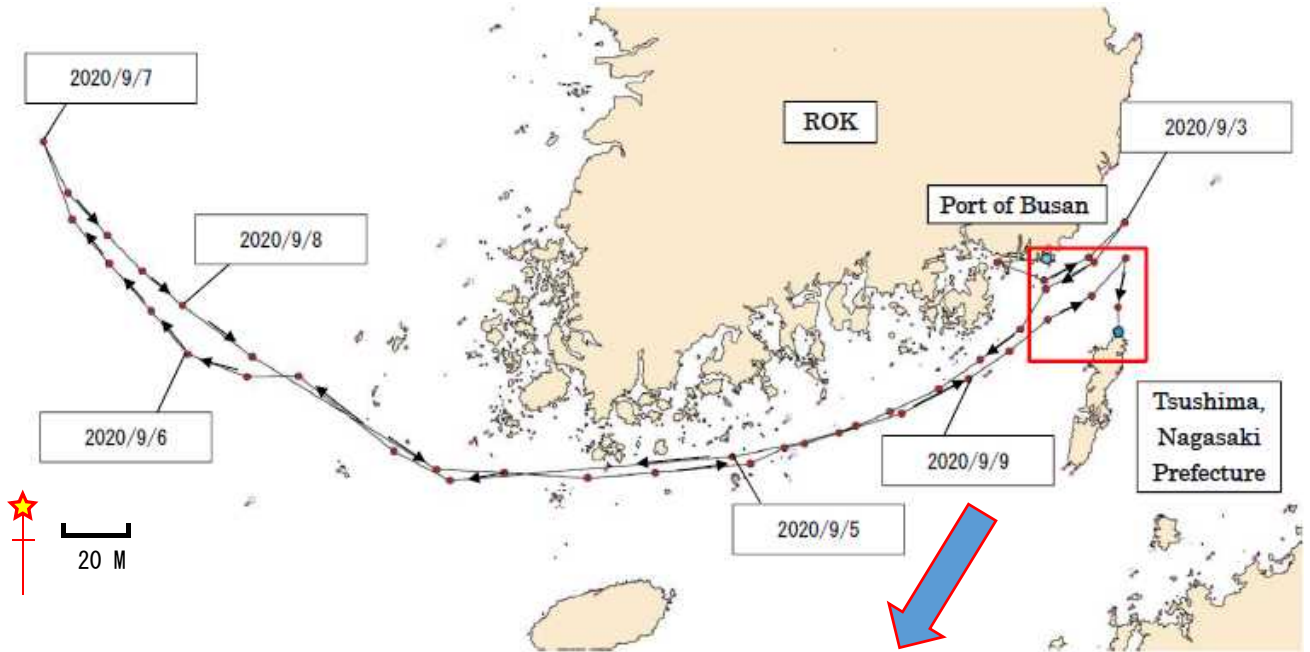
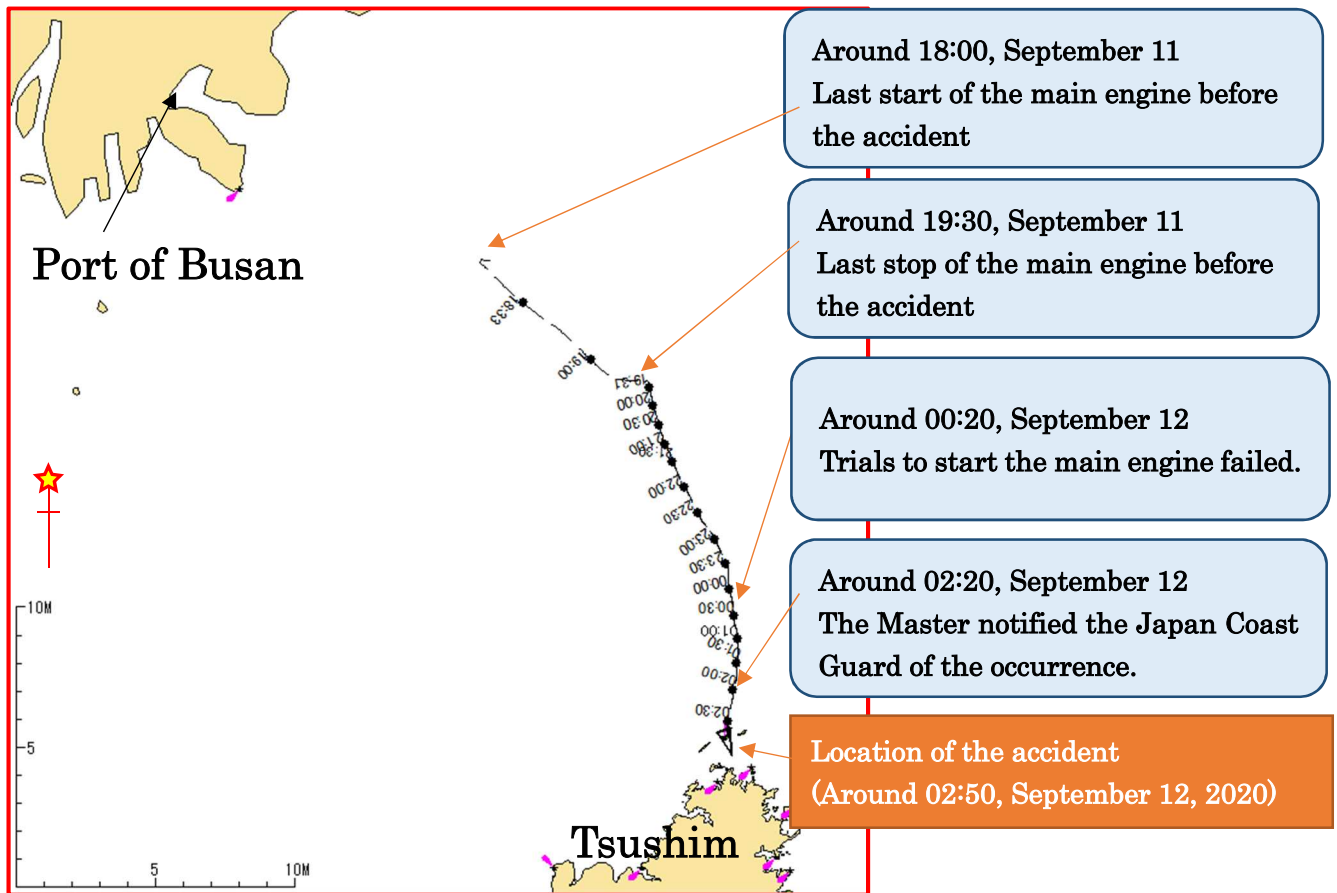
APPENDIX 2: SCHEMATIC DIAGRAM OF THE ACCIDENT PROCESS

(*Tracks from 9 hours before the accident)
