MA2024-7

# **MARINE ACCIDENT INVESTIGATION REPORT**

| <b>Accident Type</b> | Fatality of the Linesman |
| <b>Summary of Accident</b> | When the Container Ship DONGJIN FORTUNE with master and 16 crew members on board were during an operation of berthing on the Akaishi-10m berth with starboard side, a linesman who was working at the berth to connect the ship's mooring line to the bollard (hereinafter referred to as "mooring lines work") was seriously injured when he was hit by a mooring line bouncing up, and he had subsequently died. |

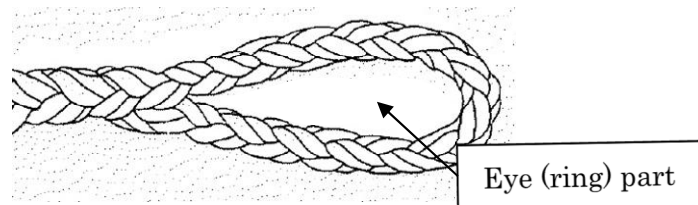
Figure 2 Schematic view of the eye (ring) part of tip of this spring line

The subject vessel approached to the berth in the berthing position while turning to the left off the northwest coast of the berth from around 07:42. At around 07:50, the eye (ring) part at the end of this spring line which was send through fairleader\*<sup>3</sup> on the starboard bow was connected to this bollard by the linesman A, linesman B and linesman C. (See Figure 2 and 3)

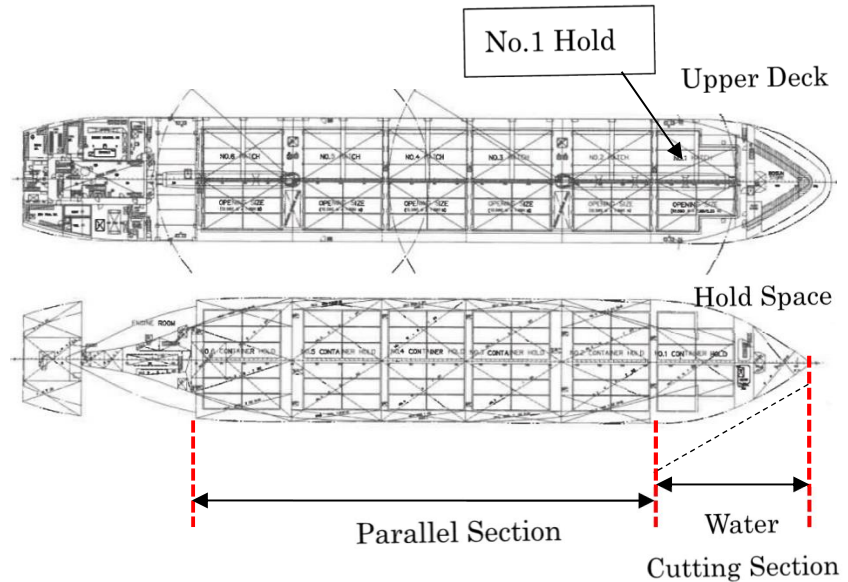
Figure 5 General Arrangement (excerpt)

general cargo ship and the upper deck reaches almost its maximum width from the bow end to the center of the No.1 hold, the slope of water cutting section from upper deck to the bottom was greater than general cargo ship. (See Figure 5.)

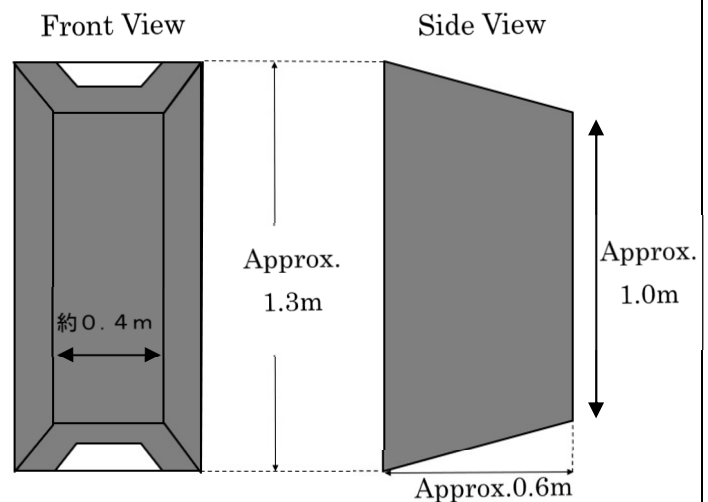
Figure 6 Imagery of the Fender

This fender was made a solid rubber<sup>\*7</sup>, and it was V-shape. The vertical length of the fender which was attached to the berth was approximately 1.3m, and the height from the mounting bottom which was fitted to the berth to the protruding part toward the sea was approximately 0.6 m. The upper and lower end portions that were contacted to the upper edge of the berth were tapered<sup>\*8</sup> with respect to the contact surface that contacts the shell plate of the vessel, and it was trapezoidal when viewed from the side.

The 12 fenders were installed at approximately 15.5m intervals at the berth. This fender was installed approximately 62 meters away from the east end of the berth, and it was 5th fender from the west. (See Figure 6 and Picture 2)
