MA2024-03

**MARINE ACCIDENT  
INVESTIGATION REPORT**

<b>Accident type</b>	Grounding
<b>Date and time</b>	Around 09:20 on January 24, 2023
<b>Location</b>	Off the northwest of Taketomi Island, Taketomi Town, Okinawa Prefecture Around 268° true bearing, 3.8 nautical miles (M) from Ryukyu Kannonzaki Lighthouse (Approx. 24°21.8'N 124°02.6'E)
<b>Summary of the Accident</b>	The cargo ship XIN HAI ZHOU 2 was drifting for the purpose of time adjustment off the west of Ishigaki Island, Ishigaki City, Okinawa Prefecture, when she was pushed by the wind and waves. She therefore started her main engine and navigation; however, she continued to be pushed without gaining sufficient propulsion or rudder effect and ran aground on a shallow reef off the northwest of Taketomi Island. XIN HAI ZHOU 2's hull subsequently broke in two at her center section.
<b>Process and Progress of the Investigation</b>	The Japan Transport Safety Board appointed an investigator-in-charge and two other marine accident investigators to investigate this accident on January 24, 2023. January 26 and 27, 2023: Interviews January 28, 2023: On-site investigation February 1, 7 to 9, 14, and 15; March 3 and 31; April 19 and 2

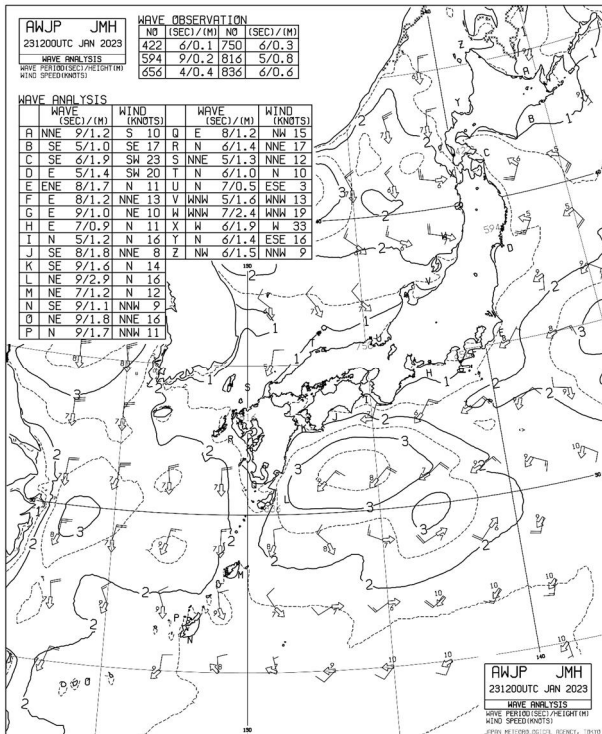
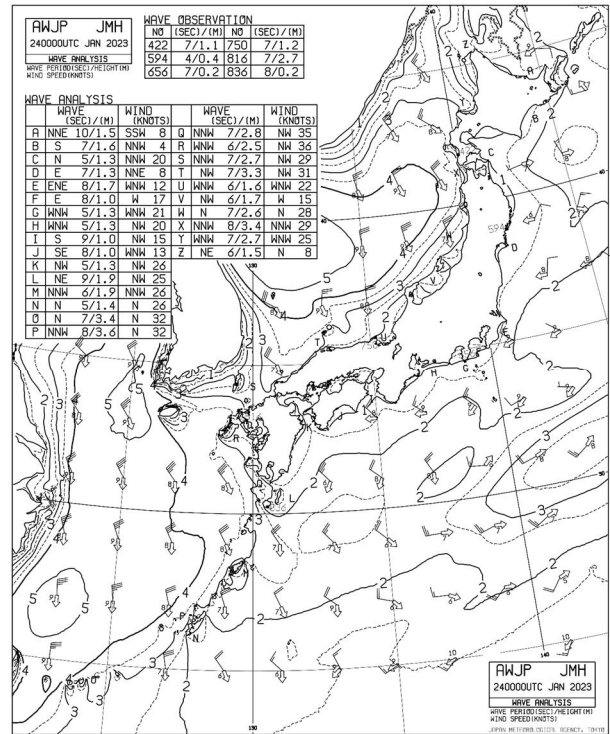
### Annex Figure 2 Coastal Wave Analysis Chart

(4) According to the coastal wave analysis chart, significant wave heights in the sea area near the location of the accident were under 2 meters at 21:00 on January 23 and between approximately 2 and 3 meters at 09:00 on January 24. (See Figure 2 and Annex Figure 2 Coastal Wave Analysis Chart)

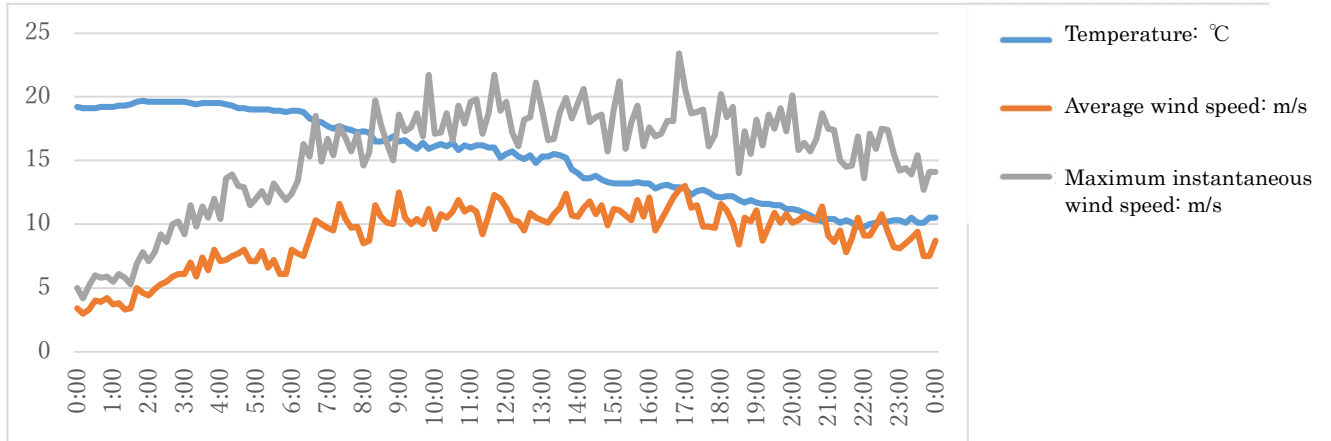
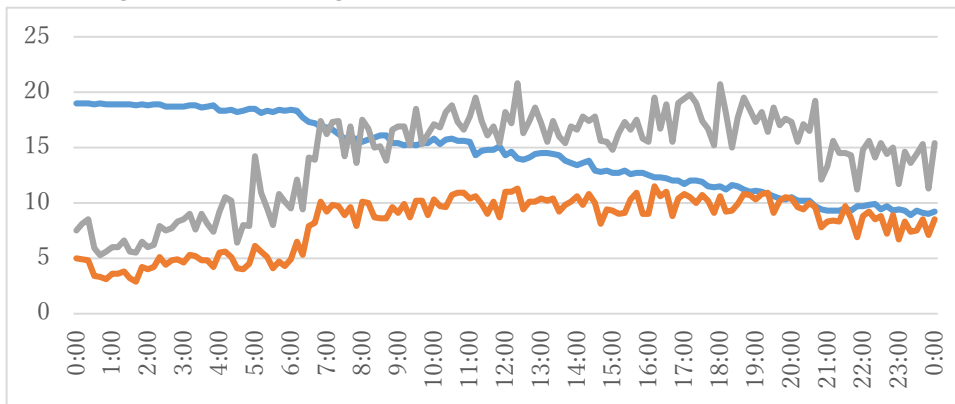
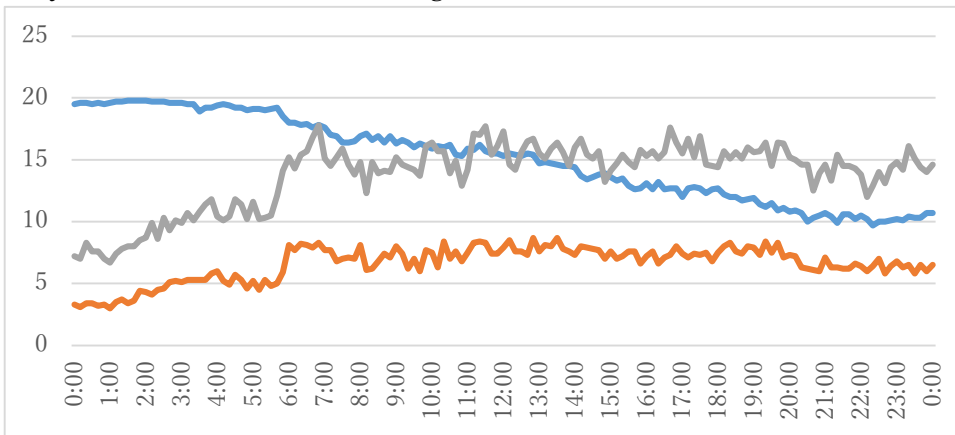
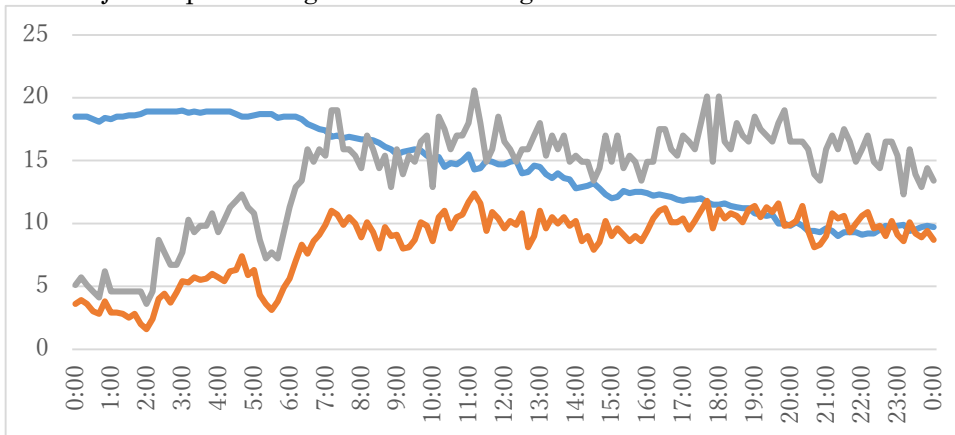
Annex Figure 3 AMeDAS Observations  
(January 24, 2023)

wind subsequently gained intensity at Iriomote Island and Ishigaki Island as well, and at 09:00, the wind speed was 13 m/s at Ishigakijima Meteorological Observation Station, located approximately 6.8 M east-southeast of the accident site. (See Figure 3 and Annex Figure 3 AMeDAS Observations)
