MARINE ACCIDENT INVESTIGATION REPORT

Vessel Type and Name: Roll-on/roll-off cargo vessel Byakko

Vessel Type and Name: Chemical tanker ULSAN PIONEER

Accident Type: Collision

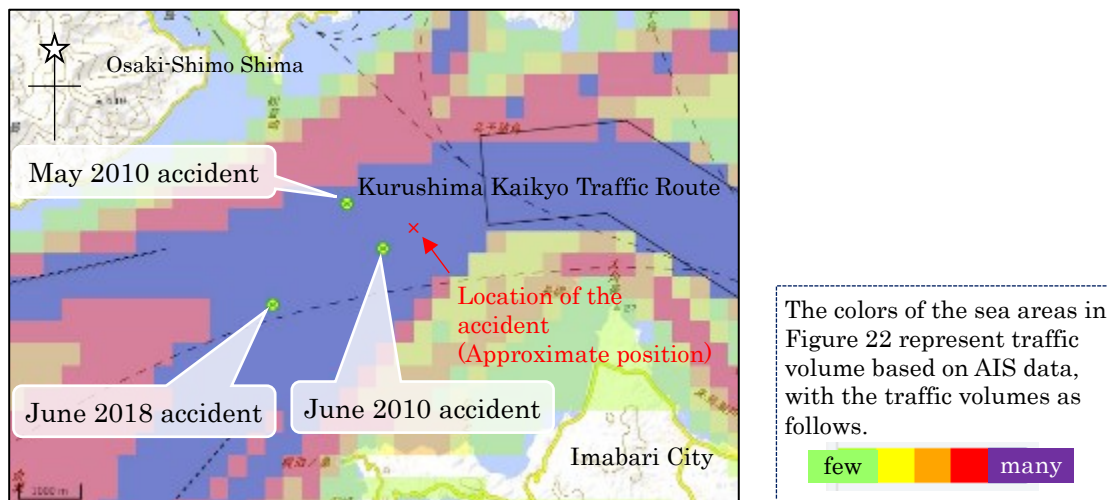
Figure 22 Locations of collisions involving cargo ships or tankers near the west entrance of the route (3 cases)

Since October 2008, three collisions involving cargo ships or tankers (excluding small vessels under 20 gross tons) have occurred near the west entrance of the Kurushima Kaikyo Traffic Route. All accidents took place at night during the southward tidal current in the Kurushima Strait. (see Figure 22)

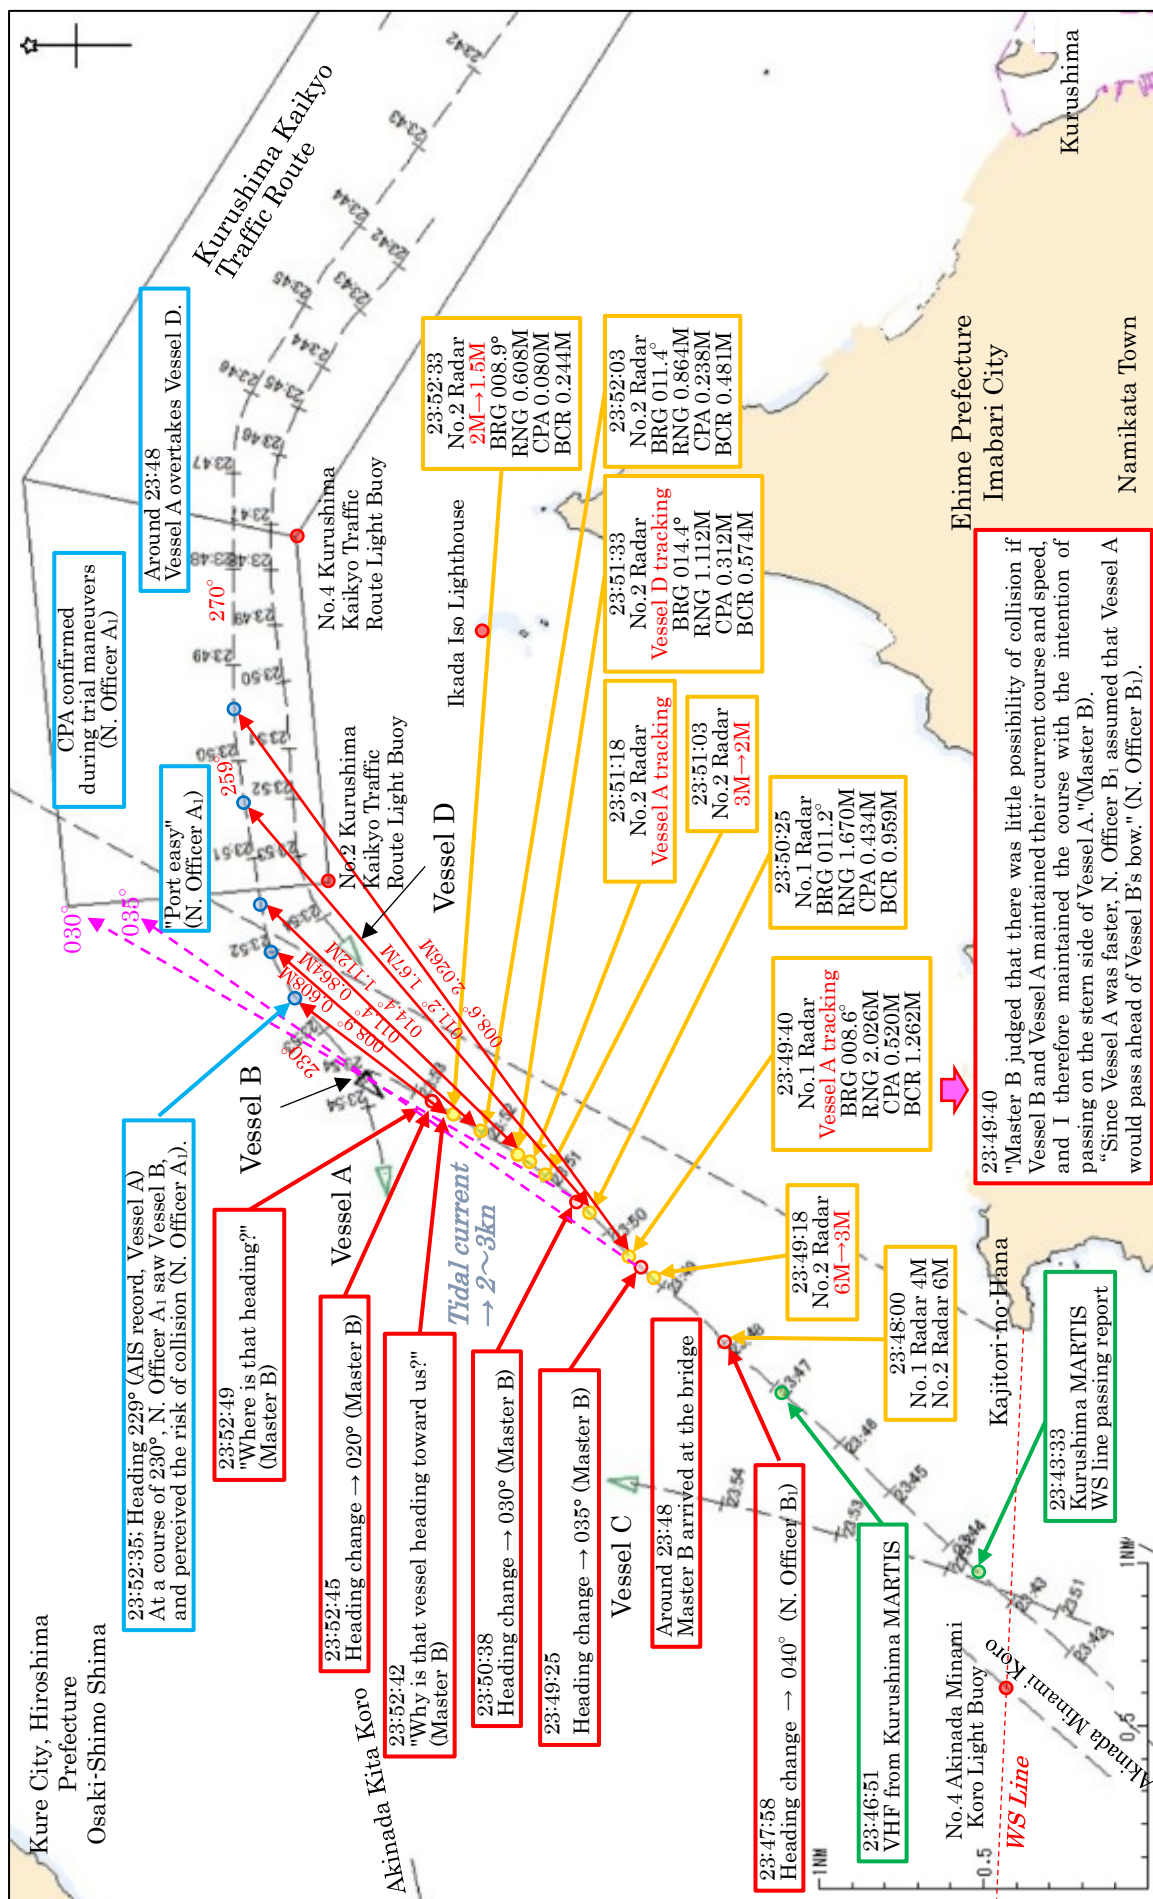
Figure 23 Course of events leading to the accident involving Vessel A and Vessel B (from around 23:43)

- viii) Between around 23:53:17 and 23:53:41, Vessel B turned to port, changing course from approximately 029° to approximately 022° (heading: 335° from 021°), while navigating at a speed between approximately 14.3 and 13.6 kn.

- ix) At around 23:53:38, Vessel B collided with Vessel A while turning to port at around 13.6 kn.

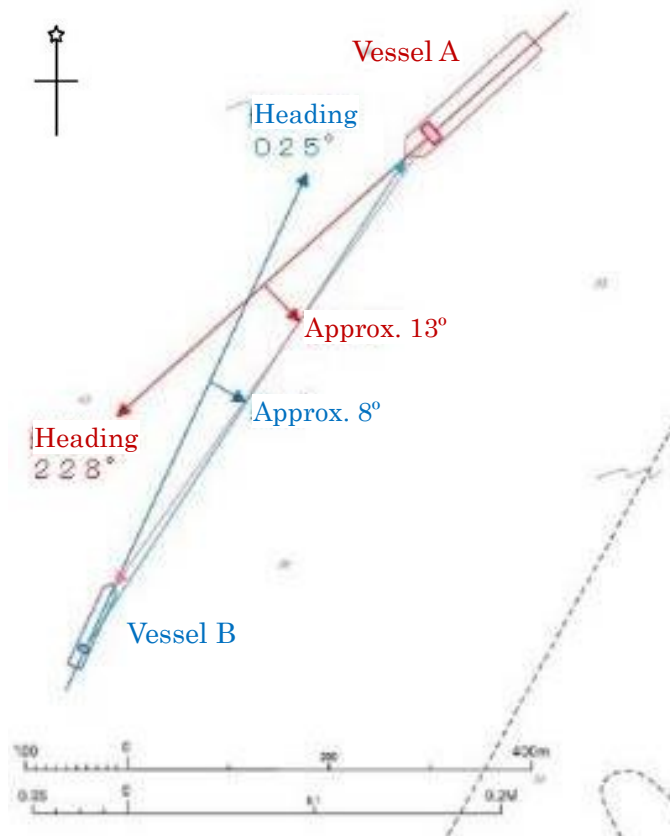
Figure 26 The relative position of Vessel A and Vessel B just before the collision (at around 23:53)

- b. According to the AIS records of Vessel A and Vessel B and the VDR record of Vessel B, the relative positions of the two vessels at around 23:53 were as shown in Figure 26. The heading of Vessel A was 228° and the heading of Vessel B was 025° , with Vessel A seeing Vessel B's bow approximately 13° to the port bow and Vessel B seeing Vessel A's bow approximately 8° to the starboard bow. (See Figure 26)

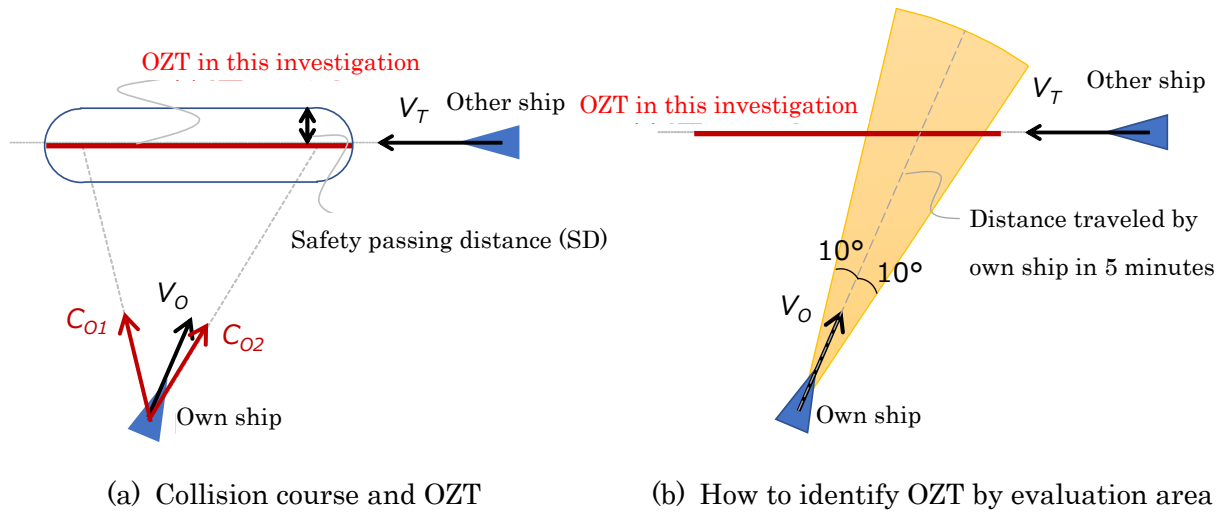
Figure 2. 1 OZT concept and evaluation method

- ✓ Based on the literature [8], the direction from the own ship (within 10° left or right of the ship's course) and distance (within 5 min to reach the OZT point) that are deemed appropriate for identifying OZTs where there is a risk of collision are defined as the evaluation area (the sector-shaped range in Figure 2. 1(b)).
- ✓ OZTs that at least partially fall within the evaluation area are identified as "OZTs with high collision risk" and others as "OZTs with low collision risk."
- ✓ Based on the positional relationship between the own ship and the identified OZT and the time of occurrence, the degree of blockage of the ship's path and the margin of time were taken into account for the collision risk assessment.

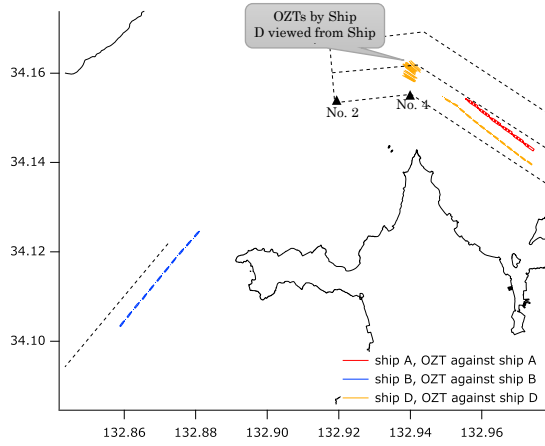
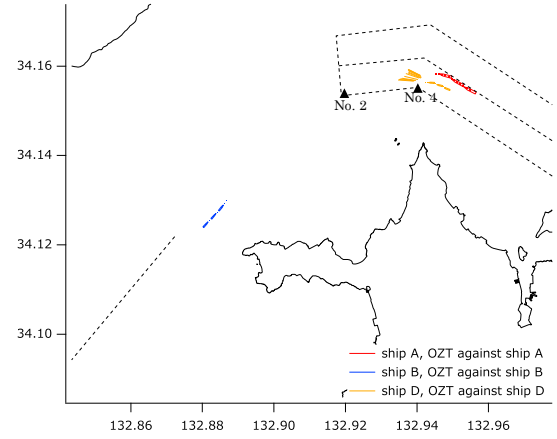
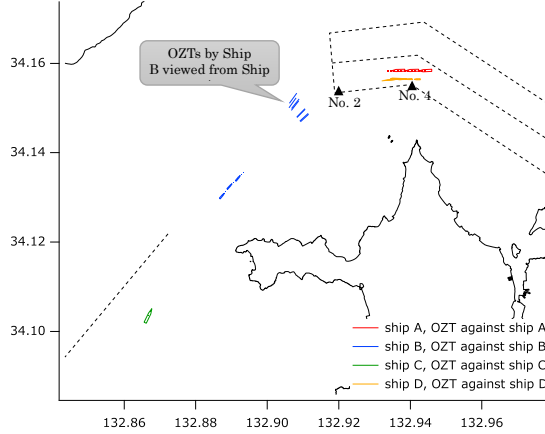
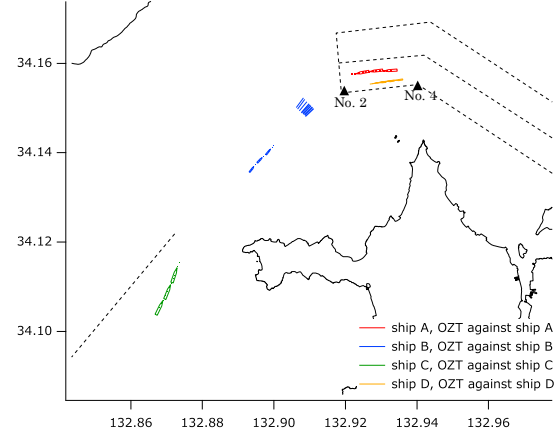
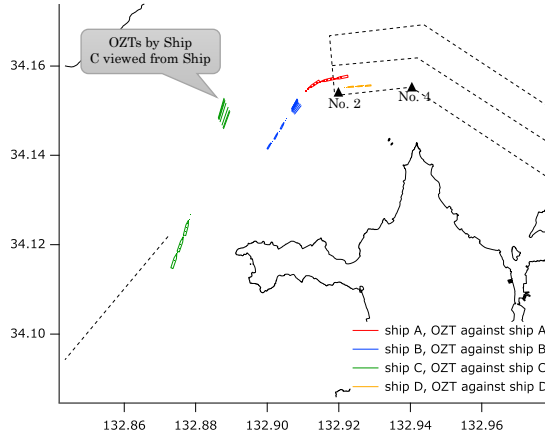
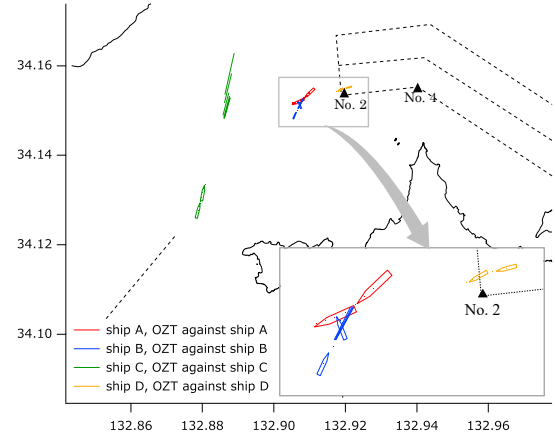
Figure 3. 2 Changes in the track and OZTs encountered by Ship A

From Figure 3. 2 (c), Ship A encountered OZT with Ship B for the first time at around 23:47 and continued to encounter OZT with Ship B until the collision. See Section 4.3 for a collision risk assessment for OZT for Ship B. Figure 3. 2 (e) shows that Ship A encountered

OZT with Ship C for the first time around 23:51 when Ship A left the Kurushima Strait Passage and continued to encounter OZT with Ship C thereafter. Observation of Figure 3. 2 (e) shows that Ship A encountered OZTs by Ships B and C at the exit of the Kurushima Strait course. Although the OZT by Ship C was more distant than the OZT with Ship B and the distance between the OZT with Ship B and the OZT with Ship A was considered to be sufficient for Ship A to be able to navigate, it cannot be said that the OZT by Ship C had no effect on the navigation of Ship A.

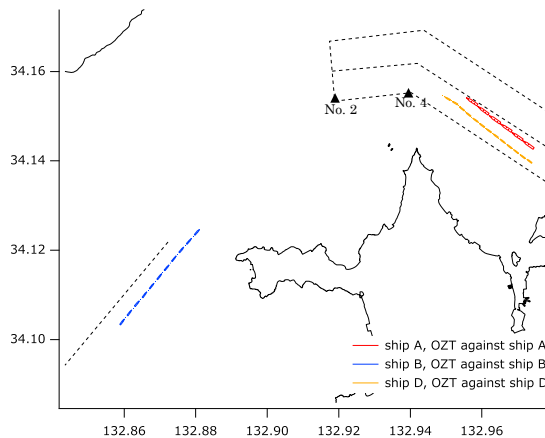
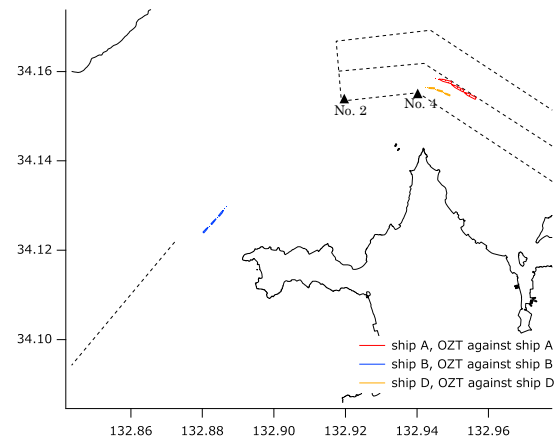
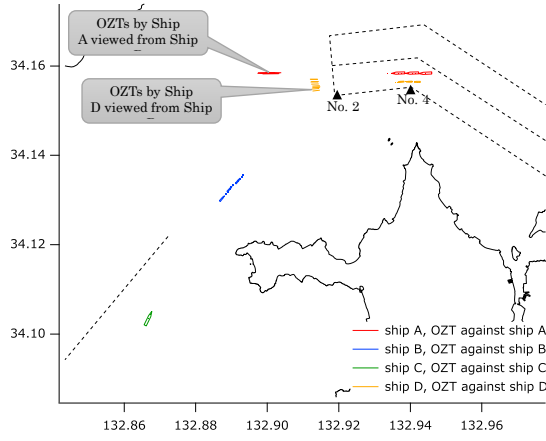
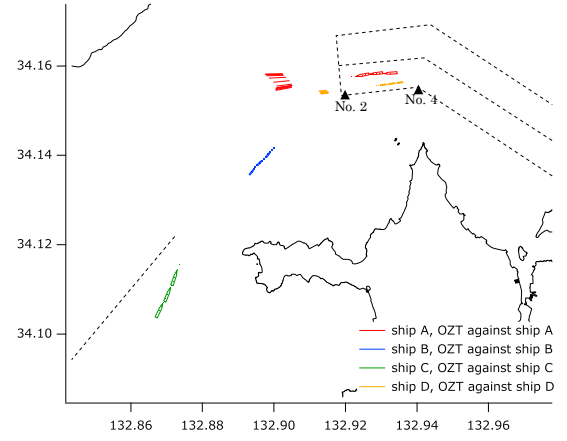
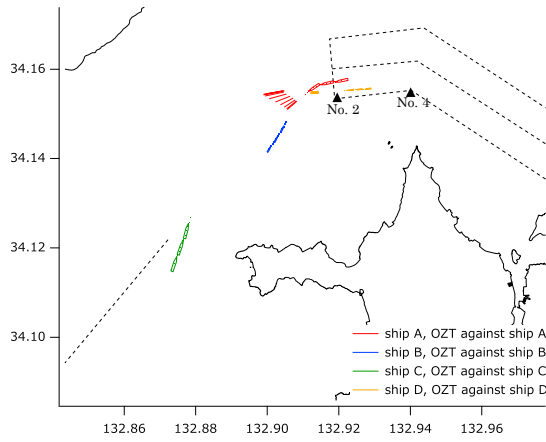
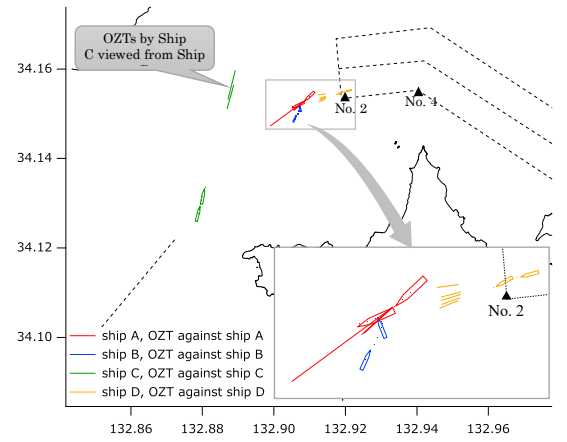
Figure 3.3 Changes in the track and OZT encountered by Ship B

From Figure 3. 3 (c), Ship B encountered the OZT between ship D and Ship A for the first time at around 23:47. From Figure 3. 3 (d), Ship B encountered the OZTs by Ship A and Ship D until around 23:50, when Ship A was navigating in the Kurushima Strait. During these periods, the OZT by Ship D was on the course of Ship B and the OZT by Ship A was on the port side of the course of Ship B, and considering the course that Ship B could have taken to enter from the north side of the Kurushima Strait Passage, it cannot be said that the OZT by Ship D had no effect on the navigation of Ship B.

The time when Ship B encountered the OZT by Ship C is around 23:53 from Figure 3. 3 (f), and it is considered that the OZT had little effect on the navigation of Ship B.

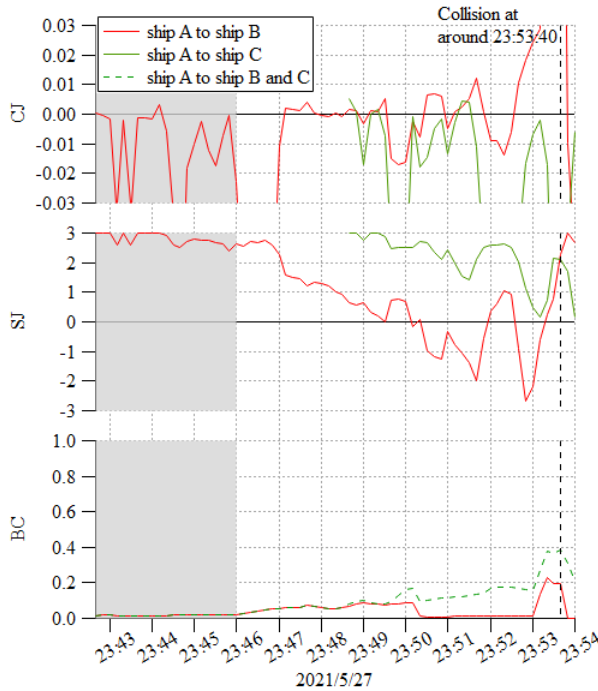
Figure 4. 4 Changes in collision risk assessment index over time (Ship A)

alone after about 23:49. This suggests that the influence of the third ship (Ship C) may have increased the maneuvering difficulty level somewhat, but the maximum value was approximately 0.39 just before the collision, which is considered to have been lower than the maneuvering difficulty level for Ship B relative to Ship A, as described below.

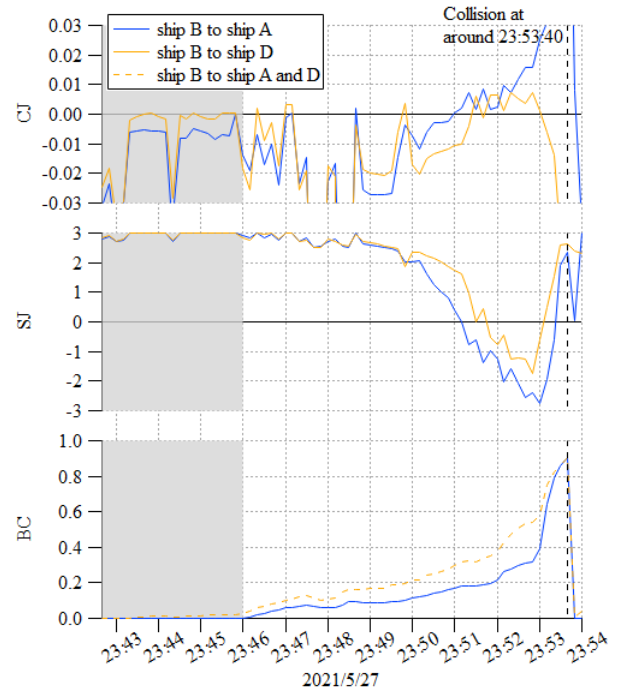
Figure 4. 5 Changes in collision risk assessment index over time (Ship B)

Regarding the BC value for Vessel A, the CPA dropped below 0.25 due to Vessel A's turning port (Attachment 1, Figure 4.3), and then began to rise rapidly from around 23:52 (Attachment 1, Figure 4.5). From around 23:53 onward, it was assessed that the maneuvering difficulty for Vessel B had increased such that avoiding a collision by any maneuvering became almost impossible. This is more likely that be due to the fact that after around 23:53, the heading course of Vessel B was blocked by Vessel A due to the exclusive area that had been formed around Vessel A (Attachment 1 (Figure 3.3 (f))). These values are probably largely consistent with the risk of collision perceived by the crew members.

Observations were made for Ship B. Only for ship A, the graph value had been continuously increasing since around 23:46, before Ship A changed its heading at No. 4 light buoy, suggesting the possibility that the ship was in a state of increasing maneuvering difficulty. In particular, the value increased sharply just before 23:53, and the maximum value was approximately 0.90 just before the collision, suggesting that the ship was in a situation that could hardly be avoided by any maneuvering. When a third ship (Ship D) is considered, the trend is similar to the case of only Ship A. However, it is possible that the third ship (Ship D) had an effect on the degree of maneuvering difficulty in the time period before approximately 23:53.

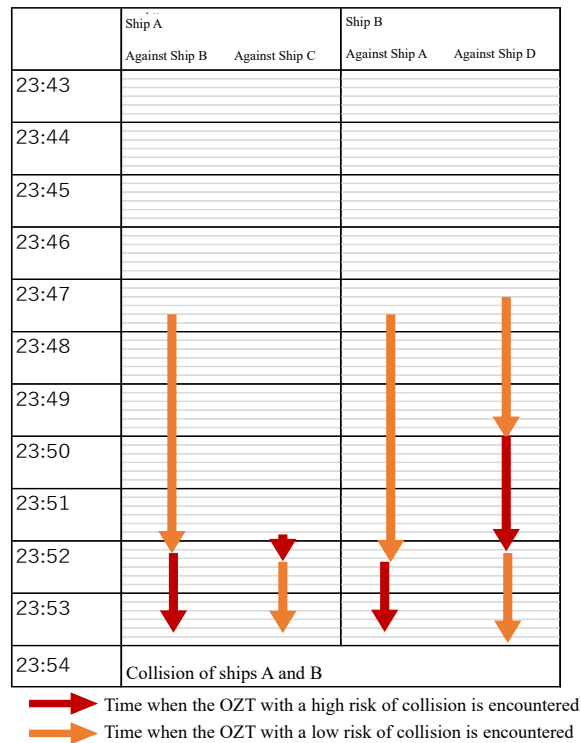
Figure 4. 6 Risks and timelines of OZTs encountered by ships A and B

Observations are made about Ship B in conjunction with Figure 3. 3. Ship B encountered the OZT with Ship A since 23:47:40, and until around 23:52:10 it encountered the OZT with a low risk of collision on the port side of Ship B's bow. Due to Ship A changing its heading by approximately 30° at the exit and Vessel B changing its heading slightly, they encountered the OZT with a high risk of collision, almost directly in front of Ship B from approximately 23:52:10 to 23:53:30. Ship B is considered to have been in a situation where the margin of time was gradually shortening as the position of the OZT gradually moved closer to the course of Ship B from the time it first encountered the OZT. In particular, it is possible that the risk of collision was extremely high after about 23:52:10.

For the third ship (Ship D), the first OZT was encountered at 23:47:20, followed by the low collision risk OZT until 23:49:50, the high collision risk OZT from 23:50:00 to 23:52:00, and then again, the low collision risk OZT until 23:53:40. However, based on Figure 3. 3, from around 23:50 onward, since the OZT's position was farther away than the OZT of Ship A, it is possible that there was a relatively large margin of time before a collision or abnormal approach with Ship A occurred.

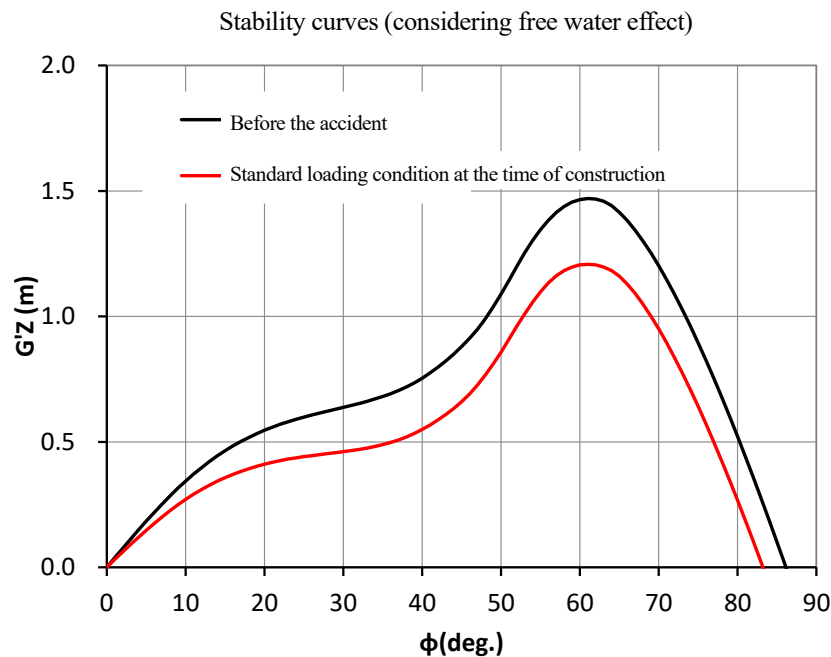
Fig. 1.1.1 Stability curves (before accident and standard loading condition at the time of construction)

Figure 1.1.1 shows the results of the stability calculation (righting lever $G'Z$) considering the free water effect in the various tanks of the ship before the accident using the weight and center of gravity shown in Table 1.1.1. The calculation results of the metacentric height ($G'M$), draft (df: bow draft, da: aft draft, dm: average draft), seawater inflow angle (ϕ_{W2}), and No. 2 deck (upper deck) port end submergence angle (ϕ_{D2}) at the center of the hull, taking into account the effects of free water, are summarized in Table 1.1.2. The seawater inflow location is at a ventilation system installed on the mooring deck at No. 2 deck level.

Figure 1.1.1 and Table 1.1.2 also show, for reference, the calculation results for the standard loading condition at the time of construction described in the stability documents. These diagrams show that before the accident, the ship's initial stability ($G'M$) and stability at large heeling ($G'Z$) were in good condition compared to the standard loading condition when the stability performance was verified at the time of construction.

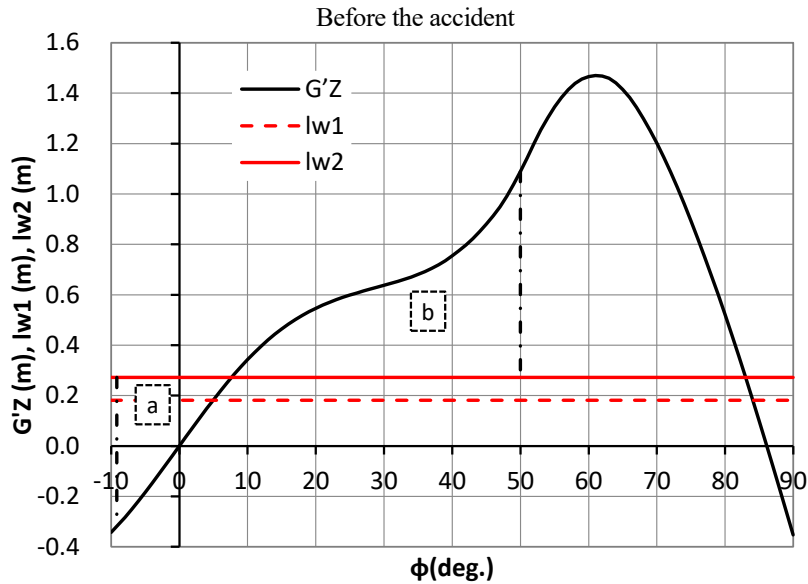
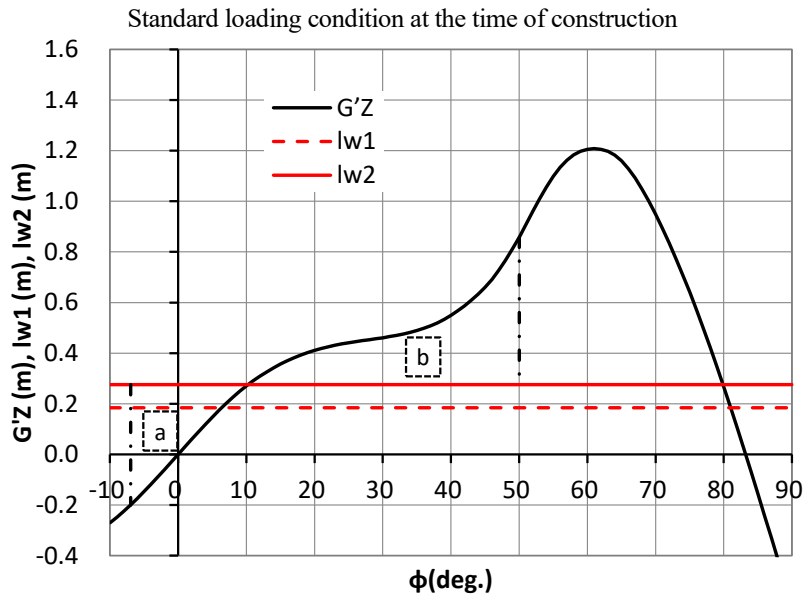
From Table 1.2.1, Figure 1.2.1 and Figure 1.2.2, it can be seen that the ship, in the condition before the accident, 1) met the stability criteria and 2) had a better stability performance than when it left port in the standard loaded condition at the time of construction.

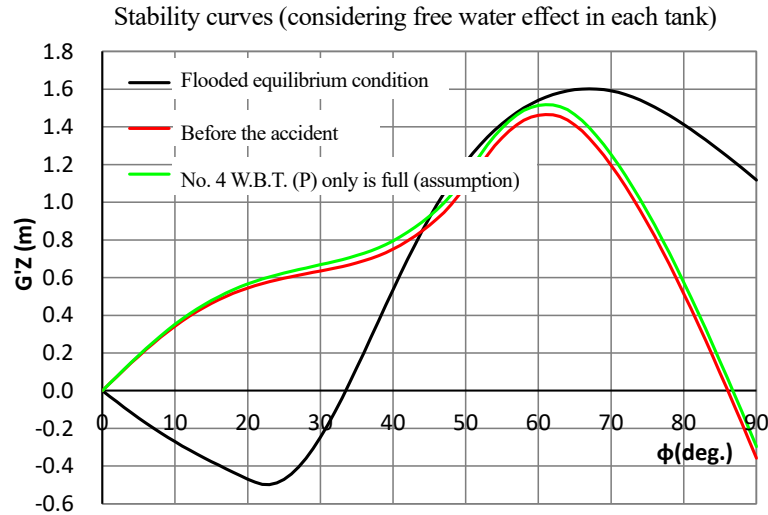
Figure 2.2.1 Stability curves (situation up to the time when the captain decided to abandon the ship)

In the equilibrium state with the flooded areas being No. 4 W.B.T. (P) and the vehicle compartments on decks B3 to B1, the upright state becomes unstable when the metacentric height is negative (G'M = -1.64 m: Table 2.2.2), and the ship becomes stable at an heel of approximately 33° (an intersection of the stability curve shown in Figure 2.2.1 with the horizontal axis other than the origin). The submergence angle ϕ_{D_1} at the port end of No. 1 deck shown in Table 2.2.2 is approximately 10°, which means that the port end of No. 1 deck is submerged in water in the tilted stable condition, and it is possible that water may enter the vehicle compartment of No. 1 deck from the assumed damage to a part of the deck.

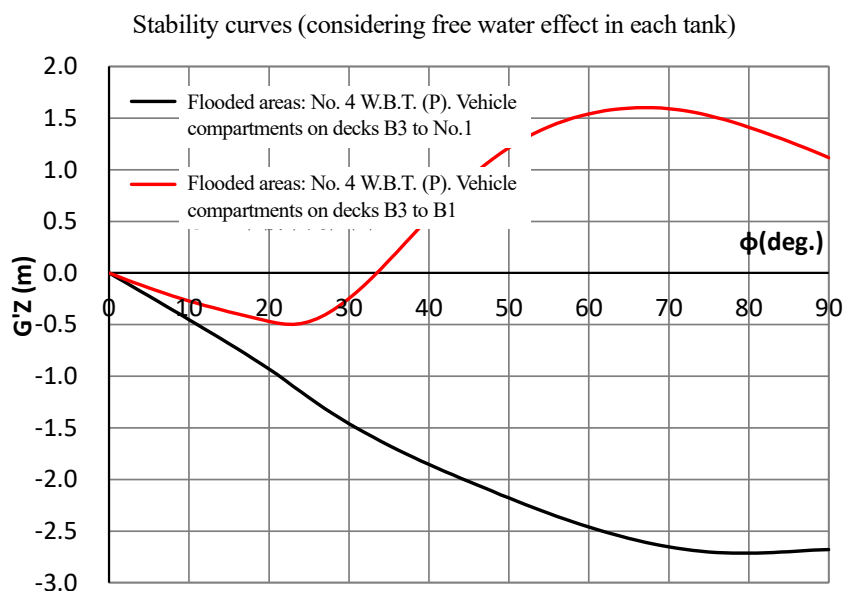
Figure 2.2.2 Stability curves (situation when the ship turned sideways: final state (equilibrium state))

First, the flooding of the vehicle compartment of No. 1 deck in addition to B2 deck and B1 deck was treated using the lost buoyancy method with a flooding rate of 90%, and the final state (equilibrium state) was examined. In this case, the displacement and center of gravity used to calculate the stability taking into account the effects of flooding of the ship were

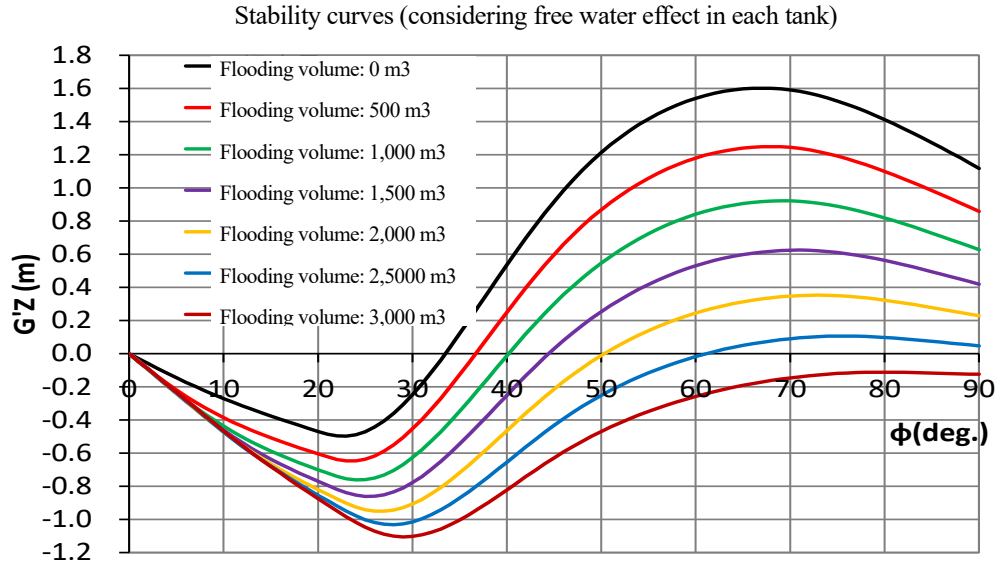
Figure 2.2.3 Stability curves (Situation when the ship is overturned: intermediate stage of flooding into No. 1 deck vehicle compartment)

Figure 2.2.3 shows the restoring force (righting lever G'Z that also takes into account the free water effect in various tanks) calculated based on the weight and center of gravity shown in Table 2.2.6 and taking into account flooding of the No. 1 deck vehicle compartment.

The restoring force taking into account the flooding of the No. 1 deck vehicle compartment shown in Figure 2.2.3 was calculated in the stability calculation program by adjusting the volume in the onboard tank (corresponding to the flooded water in the No. 1 deck vehicle compartment) so that the liquid level is horizontal according to the ship's attitude while keeping the volume constant, and then including the weight moment of flooding evaluated using the volume center in the calculation of the ship's stability (restoring moment).

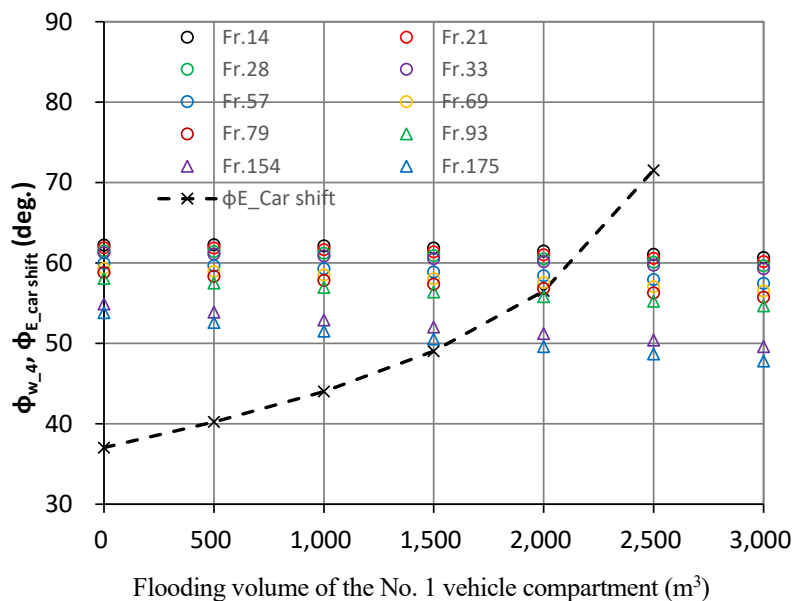
Figure 2.3.1 Submerged water angle of the upper surface of the ventilators on No. 4 deck

In Section 2.2.3(2), it was assumed that the No. 1 deck around the breach in the outer shell plating near the center of the port side of the ship was also damaged by the collision. Figure 2.3.1 shows the results of the calculation of the submergence angle (ϕ_{w_4}) of the top surface of the ventilators on the No. 4 deck for the condition studied for the intermediate stage of flooding, where the amount of flooding from the damage to the No. 1 deck vehicle compartment was taken as a parameter. Since the ventilators are distributed over a wide area near both port and starboard sides on No. 4 deck, Figure 2.3.1 shows the submerged angles of the topsides of 10 representative ventilators from frame numbers Fr.14 to Fr.175 (Fr.14 on the aft side and Fr.175 on the fore side). For comparison, the figure also shows the hull heeling angle ($\phi_{E_car\ shift}$) at which the restoring force and heeling moment are quasi-statically balanced for each flooding condition.

The following facts can be inferred from Figure 2.3.1.

- 1) When the flooding volume in No. 1 deck vehicle compartment exceeds 1,500 m³, the top of the ventilation system on the fore side (F. 175) will be submerged, and flooding will begin in each deck vehicle compartment.
- 2) When the flooding volume reaches 2,000 m³, the top of the ventilators from Fr.79 to Fr.175 will be submerged.
- 3) When the flooding volume reaches 2,500 m³, the topsides of all ventilators on the port side on deck No. 4 will be submerged, and the vehicle compartments on decks No. 1 to No. 3, where no damage was observed on the outer shell plating, will be also completely flooded

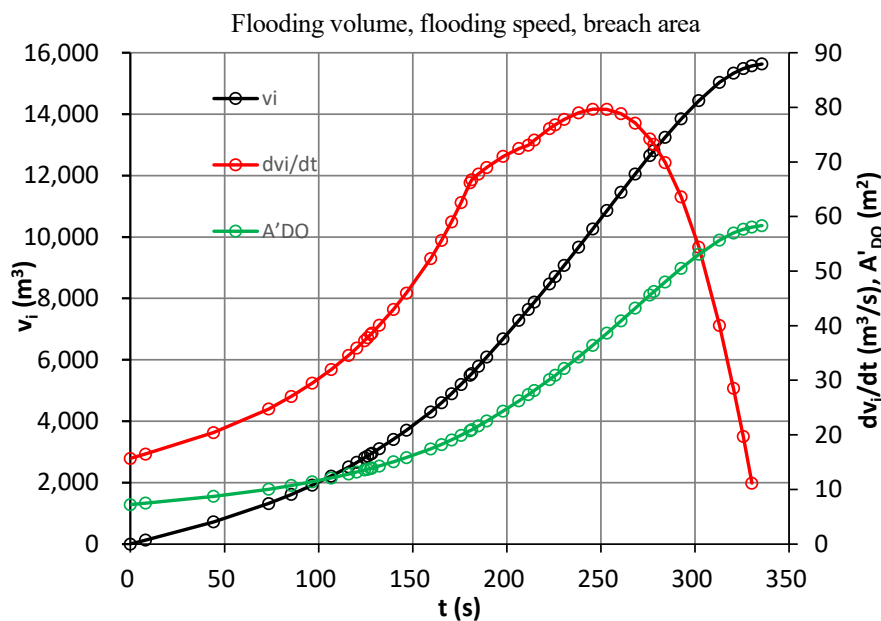
Figure A1.1 Volume of water in the ship v_i , the flooding rate dv_i/dt , and the area of the breach below the waterline above the B2 deck A'_{DO}

The ship began to heel immediately after collision, and the situation of flooding into the ship is assumed to be different from the situation shown in Figures A1.1 and A1.2, where the trim and heel do not change due to flooding into the ship and the hull is assumed to settle uniformly. However, the flooding inside the ship caused by the breach of the ship's outer shell plating caused by the collision reached an equilibrium state by the time the captain decided to abandon the ship (approximately 7 min after the collision). It is possible that the amount of flooding was large enough to exceed the displacement before the accident occurred.

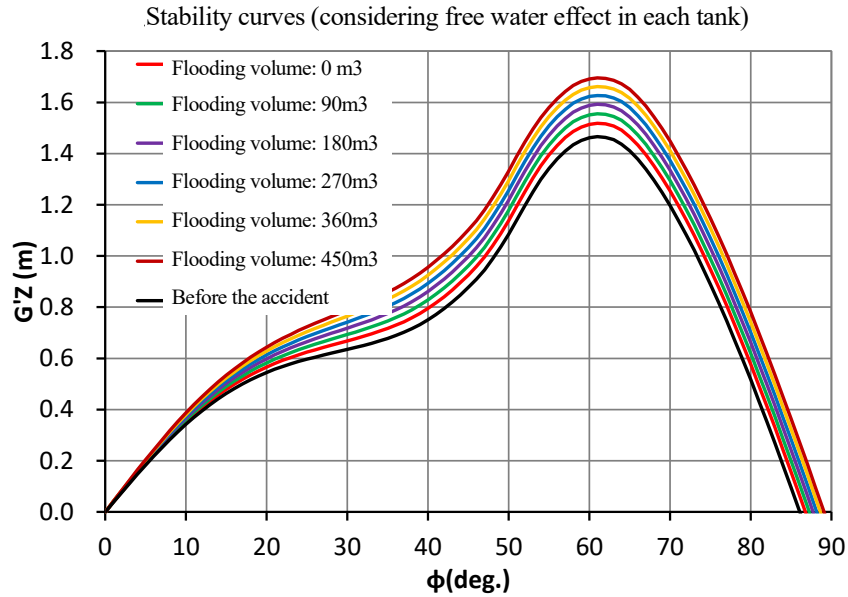
Figure A2.1.1 Restoring force curve (when inboard flooding is treated as a heavy object)
(Intermediate stage of flooding: Immediately after the occurrence of the breach due to collision)

Figure A2.1.1 shows the results of calculating the restoring force with the weights and centers of gravity shown in Table A2.1.2. The restoring force (restoring lever G'Z) shown in Figure A2.1.1 takes into account the free water effects of the various tanks. Table A2.1.3 summarizes the calculation results for metacentric height (G'M), draft (df: fore draft, da: aft draft, dm: mean draft), sea water inflow angle (ϕ_{W_2}), submergence angle at the port end of No. 2 deck (upper deck) at the center of the hull (ϕ_{D_2}), and submergence angle at the port end of B1 deck ($\phi_{D_{B1}}$) at the center of the hull, taking free water effects into consideration. Figure A2.1.1 and Table A2.1.3 also show the calculation results for the pre-accident condition for reference.

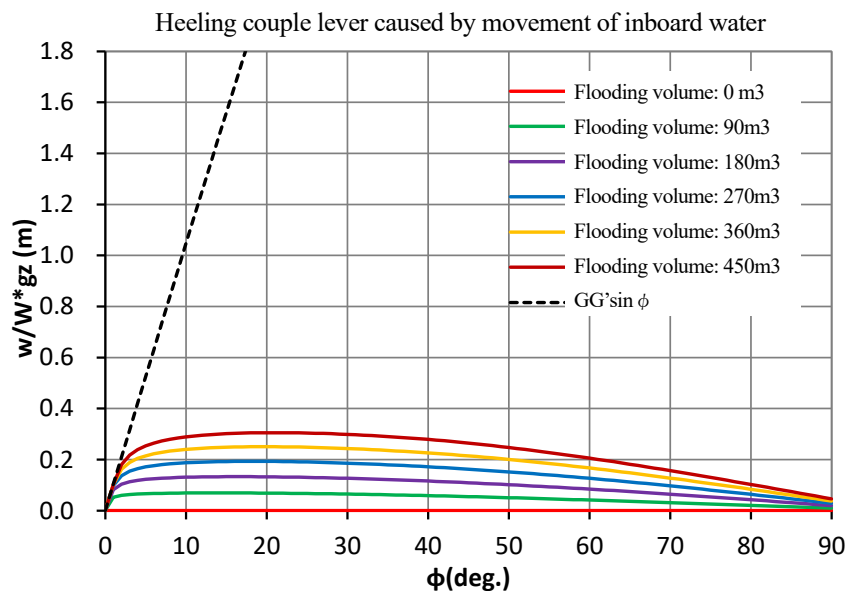
Figure A2.1.2 Heeling couple lever due to movement of flooding in the ship (intermediate stage of flooding: Immediately after the occurrence of the breach due to collision)

Figure A2.1.2 shows the calculated heeling moment ($w \cdot gz$) due to the movement of seawater in the equivalent rectangular parallelepiped tanks divided by the ship's displacement W . In the figure, the heeling couple lever is shown by the dashed line when the flooding volume (the amount of water in the tank) is 90 m^3 and the tank is treated as a so-called free-water effect. Since the assumed flooding volume (the amount of water in the tank) is small, it can be seen that the treatment as a free water effect can only be applied to a very small range of heeling angles of about 1° .

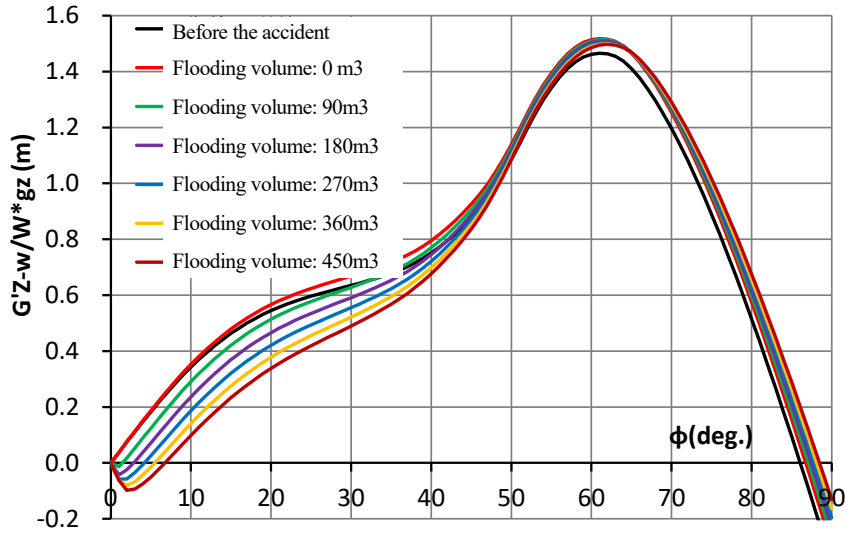
Figure A2.1.3 Restoring force curve (including the heeling couple lever due to movement of inboard flooding)

Figure A2.1.3 shows the restoring force ($G'Z - w/W \cdot gz$) considering the effect of inboard flooding. From Figure A2.1.3, it can be seen that the upright state becomes unstable due to flooding of the ship, and the ship stabilizes at the tilted state (the intersection of the restoring force curve shown in Figure A2.1.3 and the horizontal axis other than the origin).

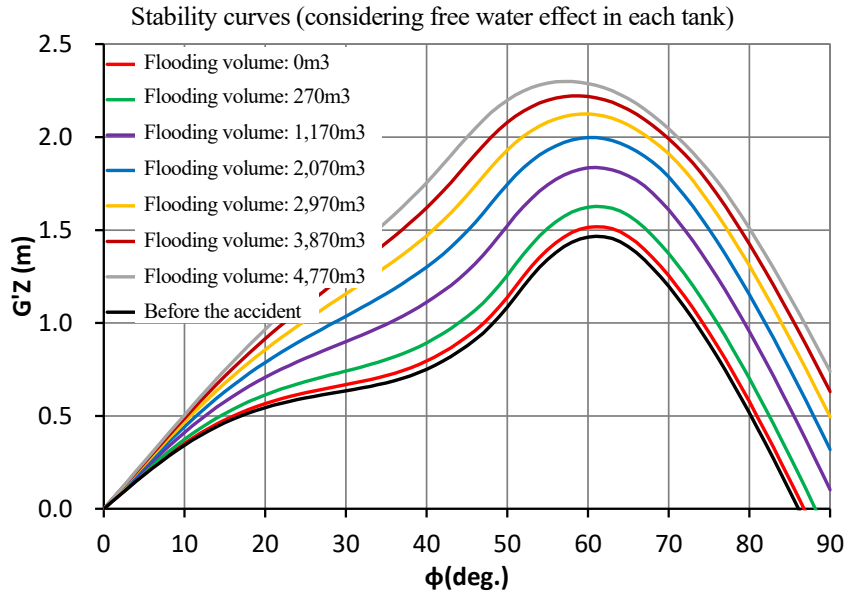
Figure A2.2.1 Restoring force curve (when inboard flooding is treated as a heavy object)
(Intermediate stage of flooding: after the port end of B1 deck is submerged)

Figure A2.2.1 shows the results of calculating the restoring force with the weights and centers of gravity shown in Table A2.2.2. The restoring force (restoring lever G'Z) shown in Figure A2.2.1 also takes into account the free water effects of the various tanks. Table A2.2.3 summarizes the calculation results for metacentric height (G'M), draft (df: fore draft, da: aft draft, dm: mean draft), sea water inflow angle (ϕ_{W_2}), submergence angle at the port end of No. 2 deck (upper deck) at the center of the hull (ϕ_{D_2}), and submergence angle at the port end of No. 1 deck (ϕ_{D_1}) at the center of the hull, taking free water effects into consideration.

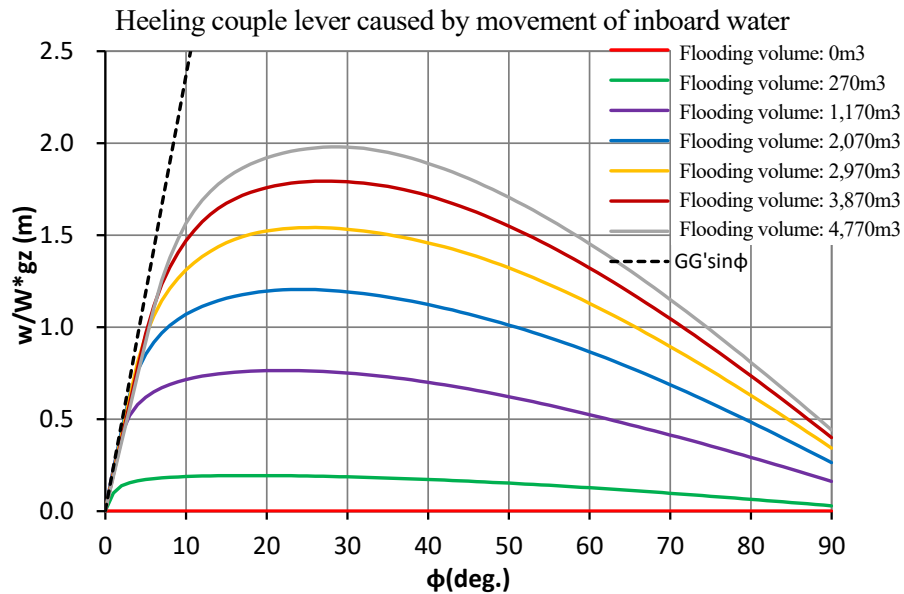
Figure A2.2.2 Heeling couple lever caused by movement of inboard water
(Intermediate stage of flooding: after the port end of B1 deck is submerged)

Figure A2.2.2 shows the calculated heeling moment ($w \cdot gz$) due to the movement of seawater in the equivalent rectangular parallelepiped tanks divided by the ship's displacement W . In the figure, the dashed line shows the heeling couple lever when flooding is treated as a so-called free water effect, assuming that the total amount of flooding in the vehicle compartments (amount in the tank) is $1,170 \text{ m}^3$ and flooding in all vehicle compartments from deck B3 to deck B1

occurs. Since the estimated volume of flooding (amount in the tank) was small, it was clear that the free water effect could only be treated as being applicable to an extremely small range of inclination angles of about 2° .

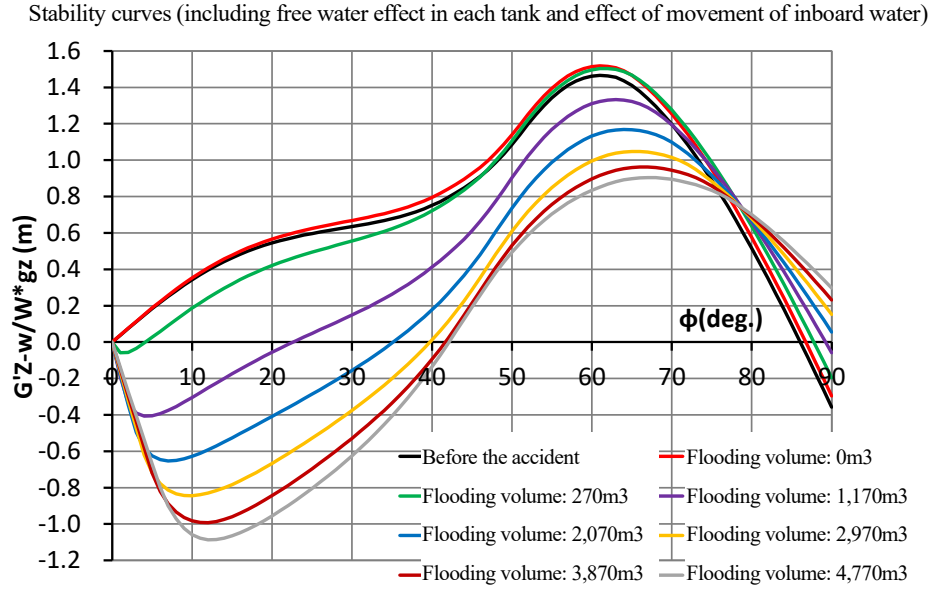
Figure A2.2.3 Restoring force curve (including the heeling couple lever due to movement of inboard flooding)
(Intermediate stage of flooding: after the port end of B1 deck is submerged)

Figure A2.2.3 shows the restoring force ($G'Z - w/W \cdot gz$) considering the effect of inboard flooding. From Figure A2.2.3, it can be seen that the upright state becomes unstable due to flooding of the ship, and the ship stabilizes at the tilted state (the intersection of the restoring force curve shown in Figure A2.2.3 and the horizontal axis other than the origin). In particular, for a total flooding volume (volume in the tank) of $2,970 \text{ m}^3$ or more, assuming that B1 deck vehicle compartment is also flooded, the heeling angle in the stable state is estimated to be 35° or more, which is larger than the port end submerged water angle ϕ_{D_1} for No. 1 deck shown in Table A2.2.3 even when no heeling moment is applied.
