**MARINE ACCIDENT  
INVESTIGATION REPORT**

Vessel type and name: Container Vessel CONTSHIP UNO

Vessel type and name: Cargo vessel Izumi Maru

Accident type: Collision

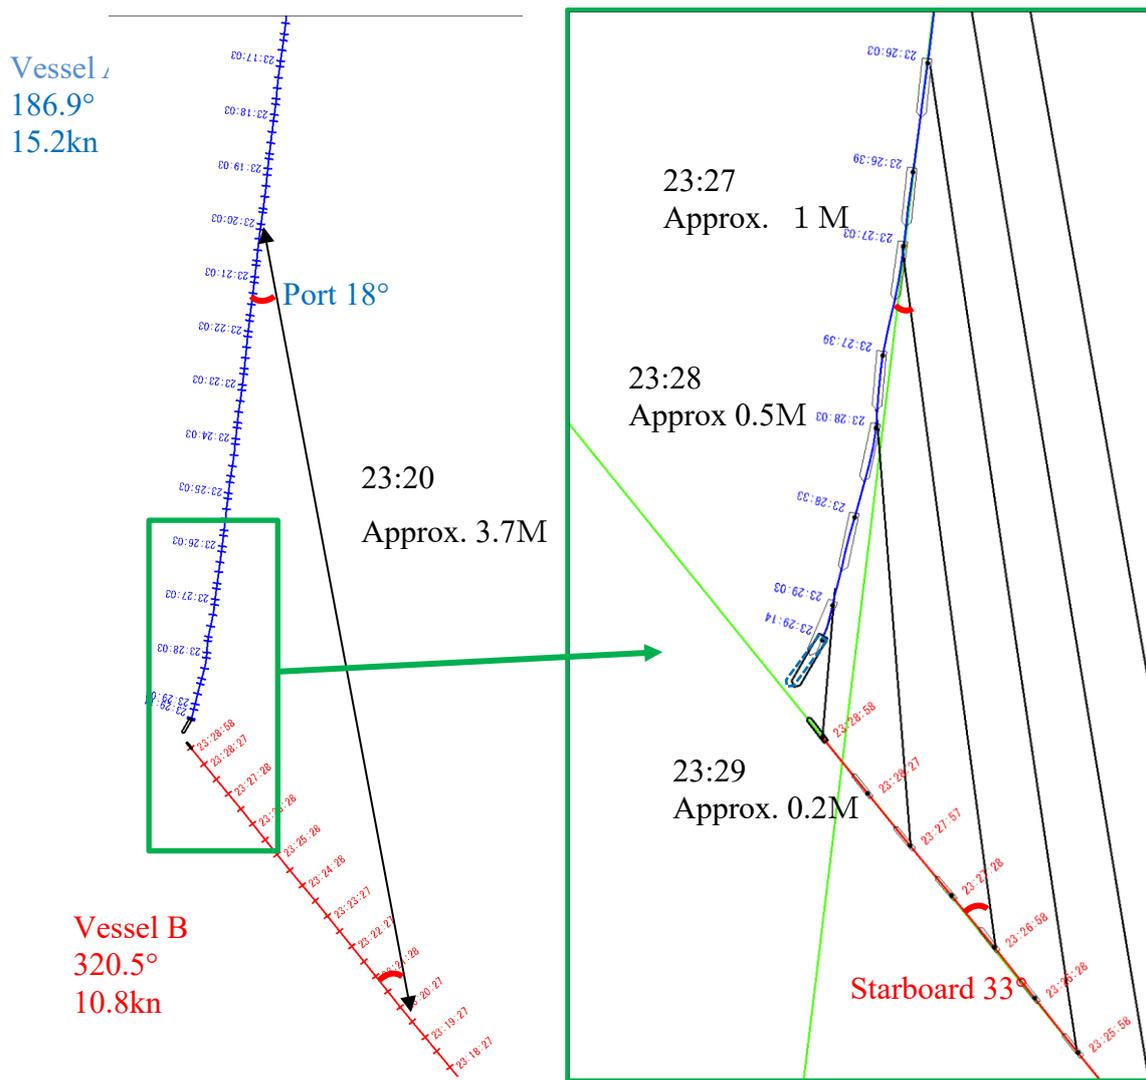
Figure 4: The Two Ships Approaching Each Other (Based on Vessel A VDR Records and Vessel B AIS Records)

\*The light green lines indicate the extension of the original planned course.

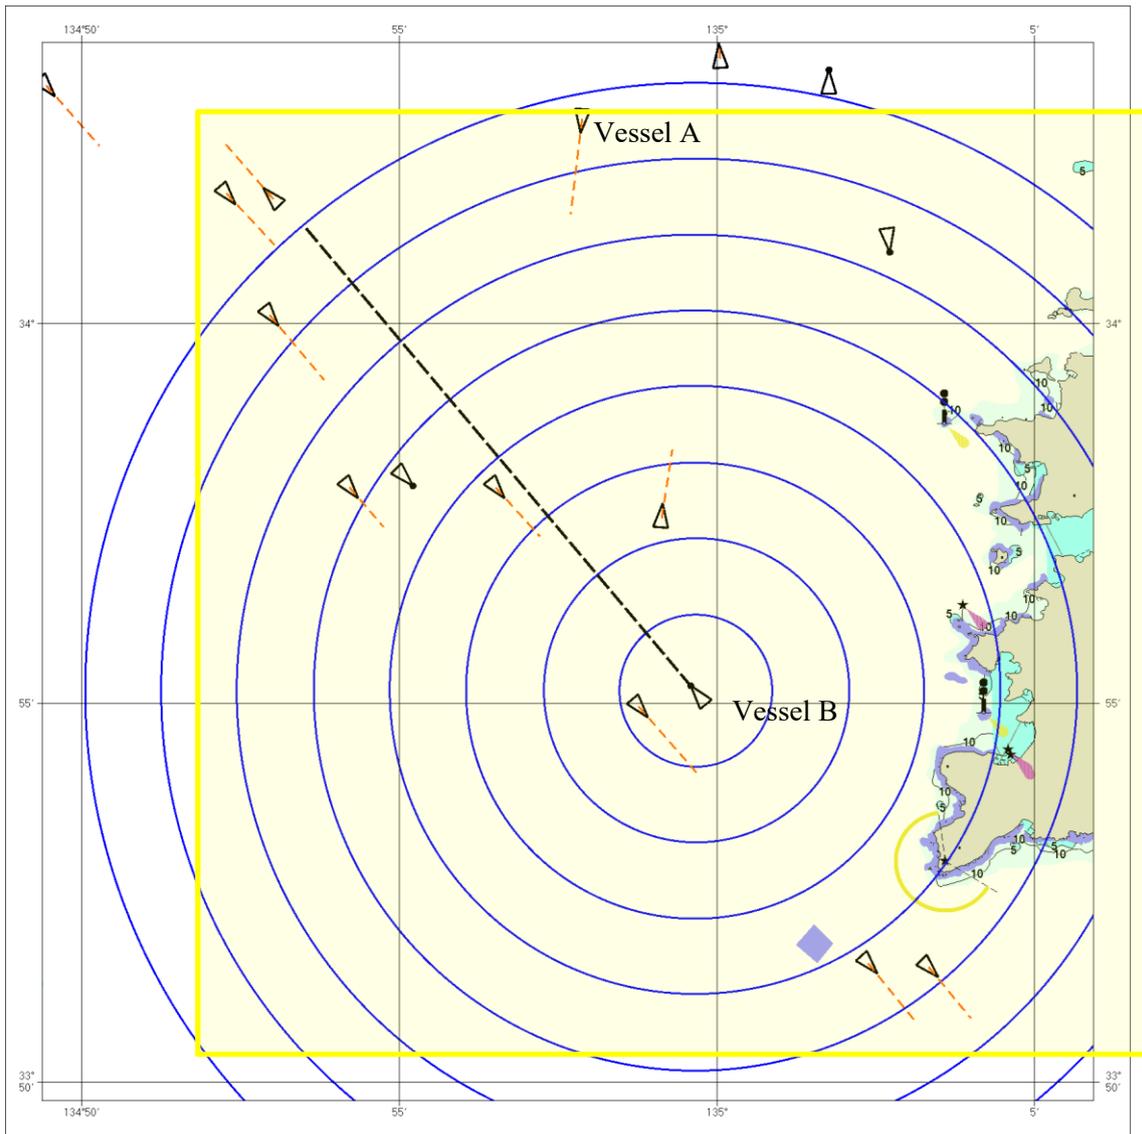
Figure 6: Overview of Vessel B's Surroundings

According to AIS records, the situation around Vessel B at 23:10 was as shown in Figure 6.

(A depiction based on AIS records at 23:10, showing concentric circles at 1M intervals centered on the GPS antenna position of Vessel B, with true motion vectors for each vessel displayed over a 5-minute period. The area within the yellow frame represents the radar display range when set to a 6M range off-center, showing up to approximately 8M ahead of the bow.)

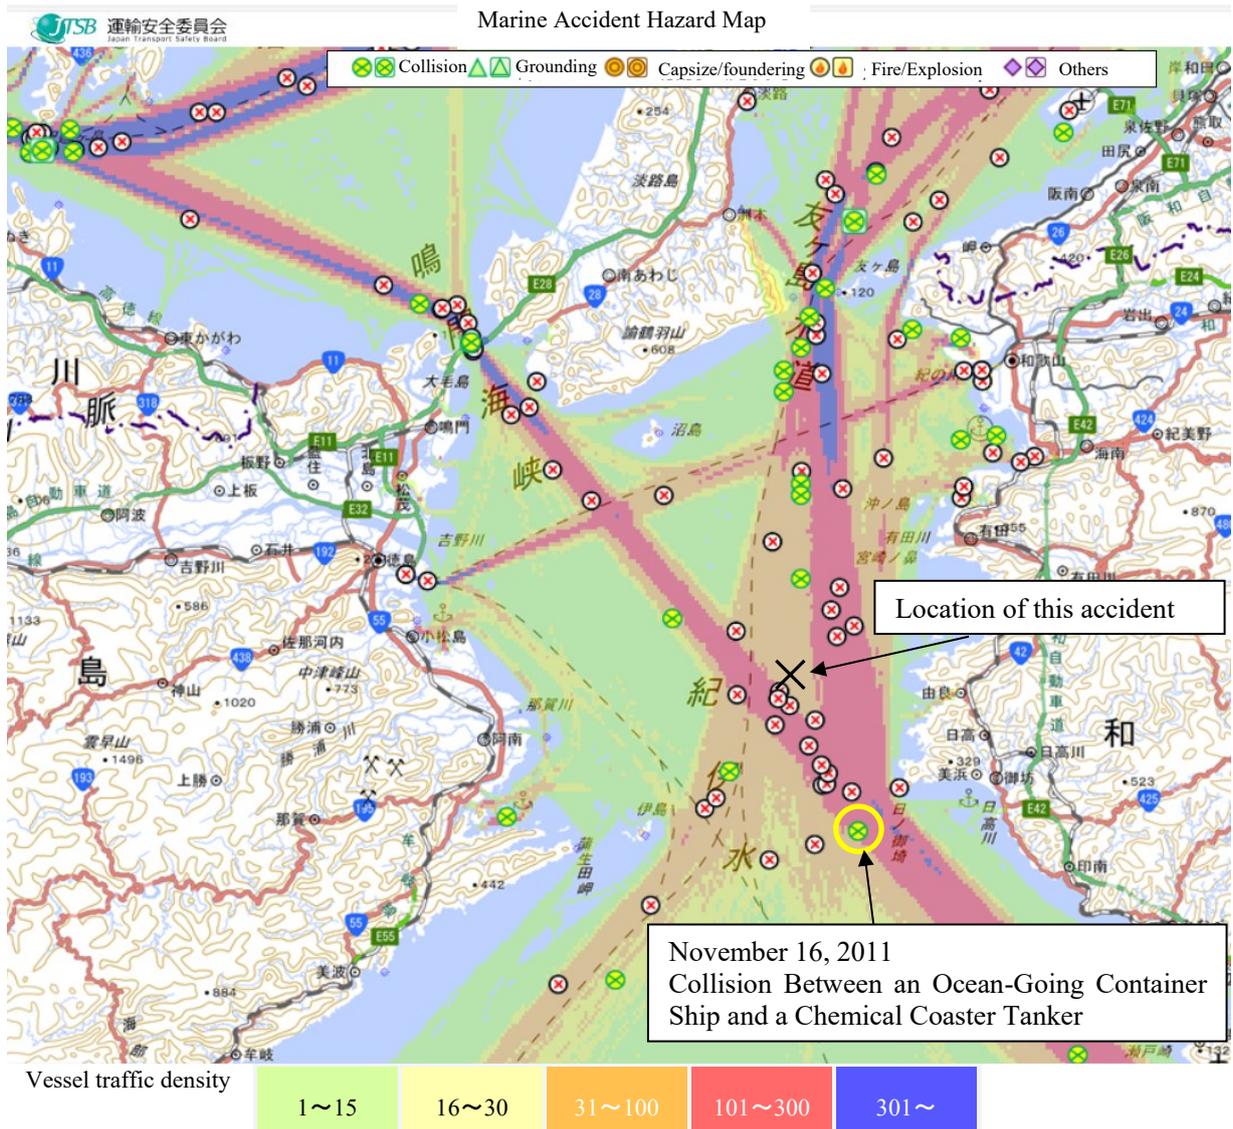
Figure 12: Ship Traffic Density and Collision Accident Locations in Kii Suido

According to the Japan-Marine Accident Risk and Safety Information System (J-MARISIS) on JTSCB's website, overlaying AIS data on vessel traffic density and collision accidents involving vessels of 500 gross tonnage or more produced the results shown in Figure 12.

White circles with a red "x" (○) symbol in Figure 12 indicate accidents that occurred prior to October 2008.

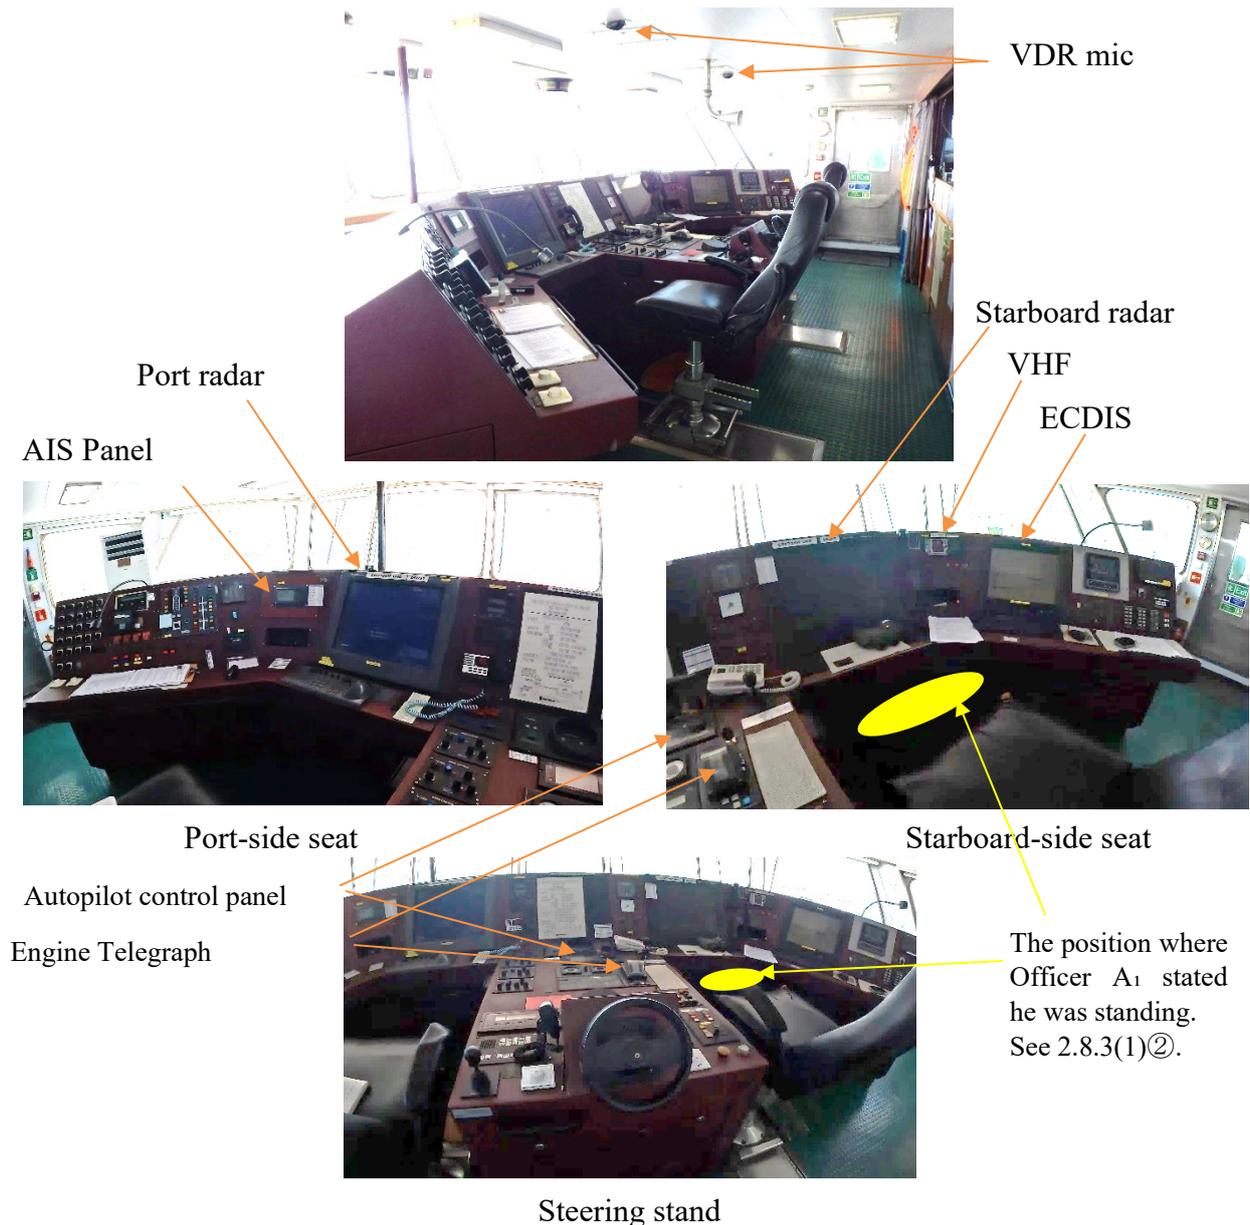
Figure 13: Bridge of Vessel A

On the bridge, a steering stand was positioned in the center, with control seats arranged on both the port and starboard sides. In front of the starboard-side seat was the starboard radar, on its right side was the Electronic Chart Display and Information System (ECDIS), and on its left were the autopilot control panel, engine telegraph lever, and other equipment. In front of the port-side seat was the port radar and other devices. (see Figure 13).

According to Master A's statement, at the time of the accident, the bow thruster was out of order and could not be used. However, there were no other defects or malfunctions in the hull, machinery, or equipment that would have affected vessel operation during the accident.

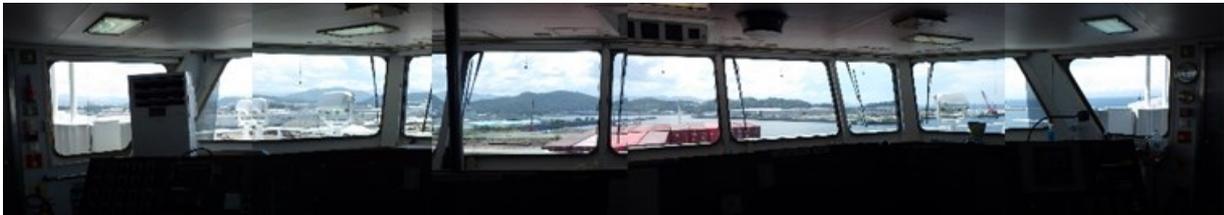
Figure 15: Visibility from Vessel A's Bridge

According to on-site investigations and the plan, visibility from the bridge toward the bow was obstructed by the loaded containers, making the sea surface beyond approximately 270m from the bow a blinded area. However, there were no other obstacles hindering lookout visibility in other directions.

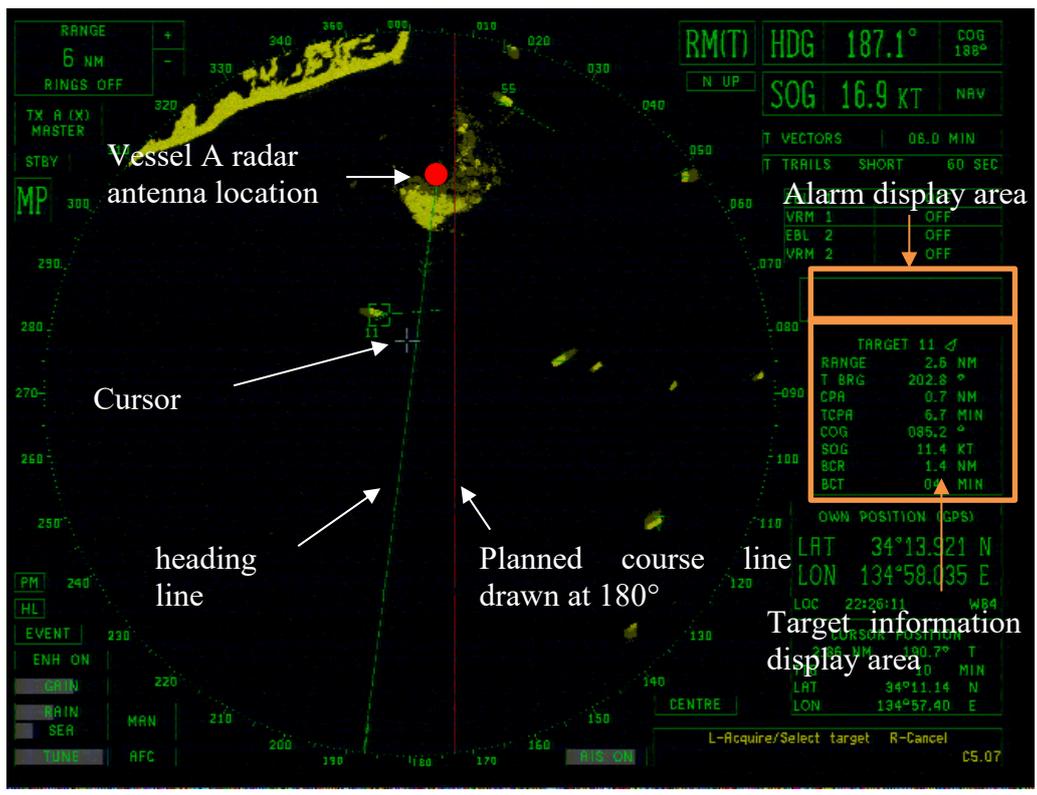
① 22:26:11 (When Master A handed over the watch to Officer A<sub>1</sub>)

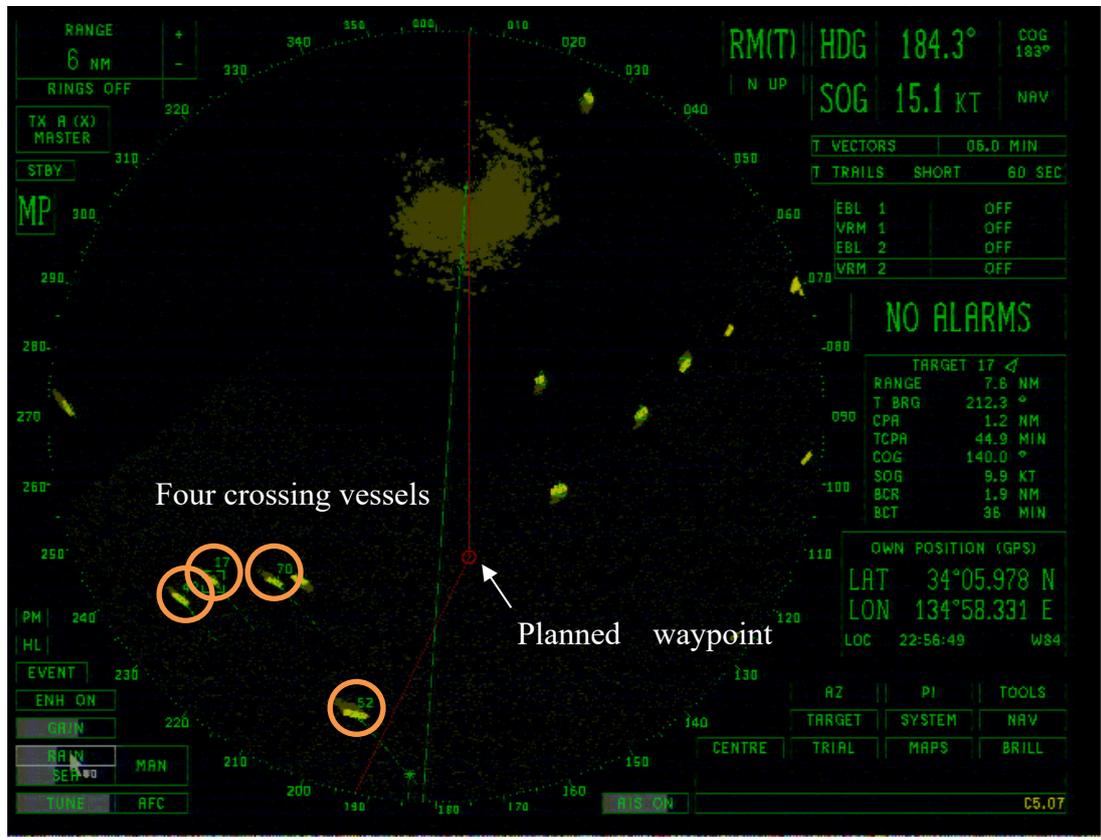
② 22:56:49 (Four crossing situation vessels detected)

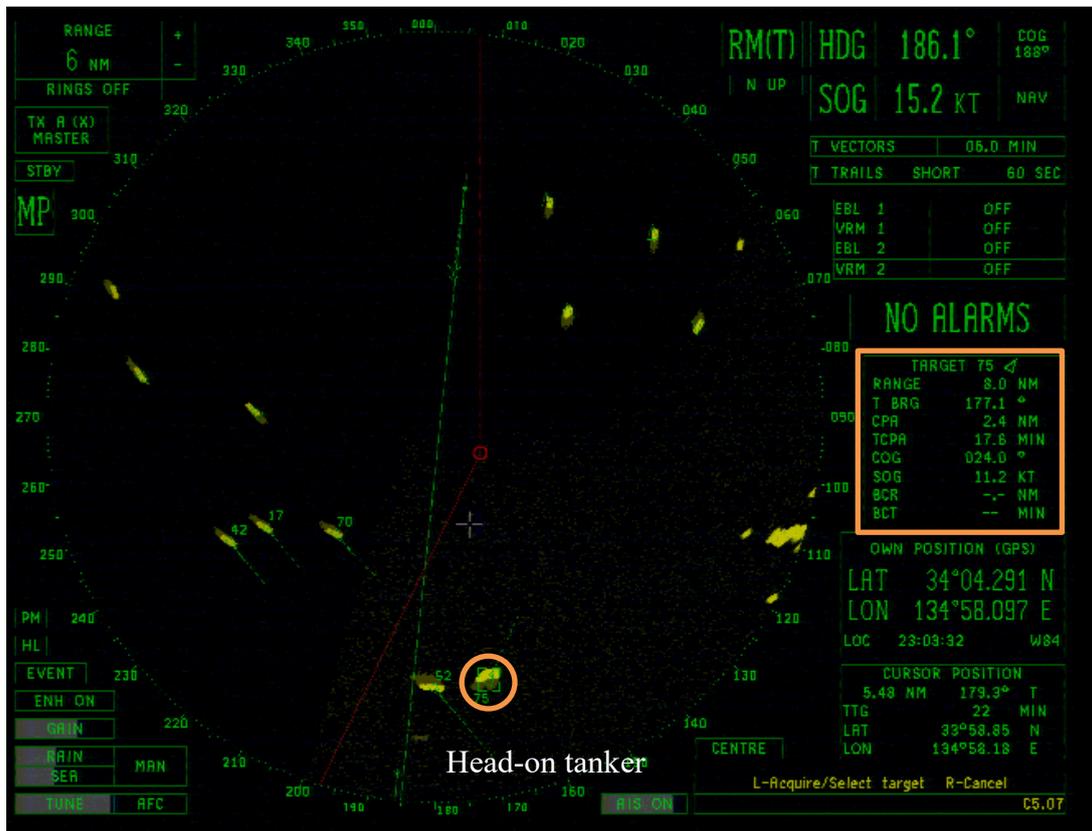
③ 23:03:32 (Head-on tanker detected)

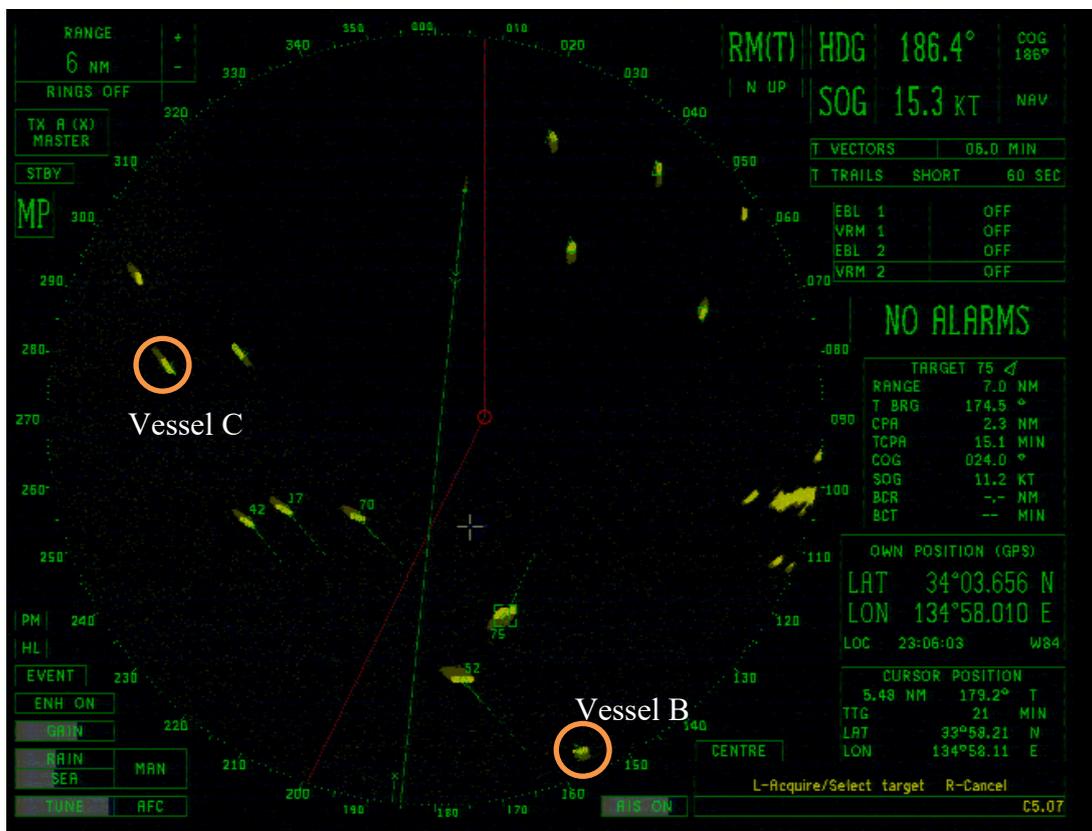
④ 23:06:03 (Vessel B's silhouette enters the range)
