MA2025-4

MARINE ACCIDENT INVESTIGATION REPORT

Vessel Type and Name: Bulk Carrier EVER FELICITY

Accident Type: Injury and Fatality of Stevedores

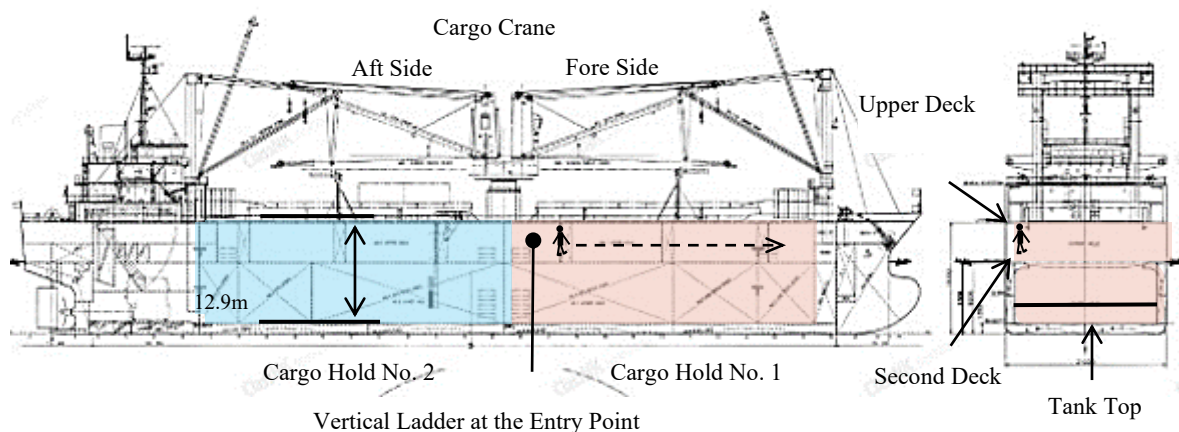
Figure 2 – Overview of Vessel Structure

Note: The second deck inside the cargo hold is walkable.

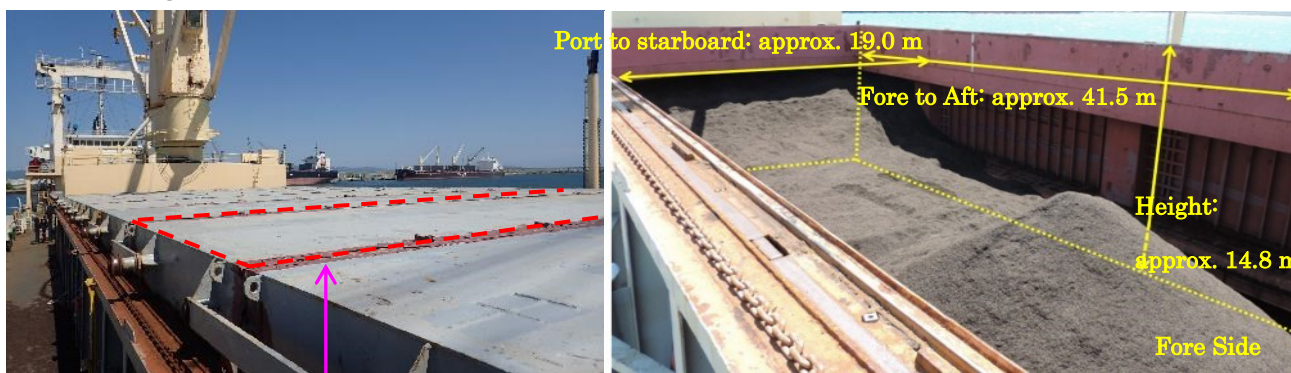
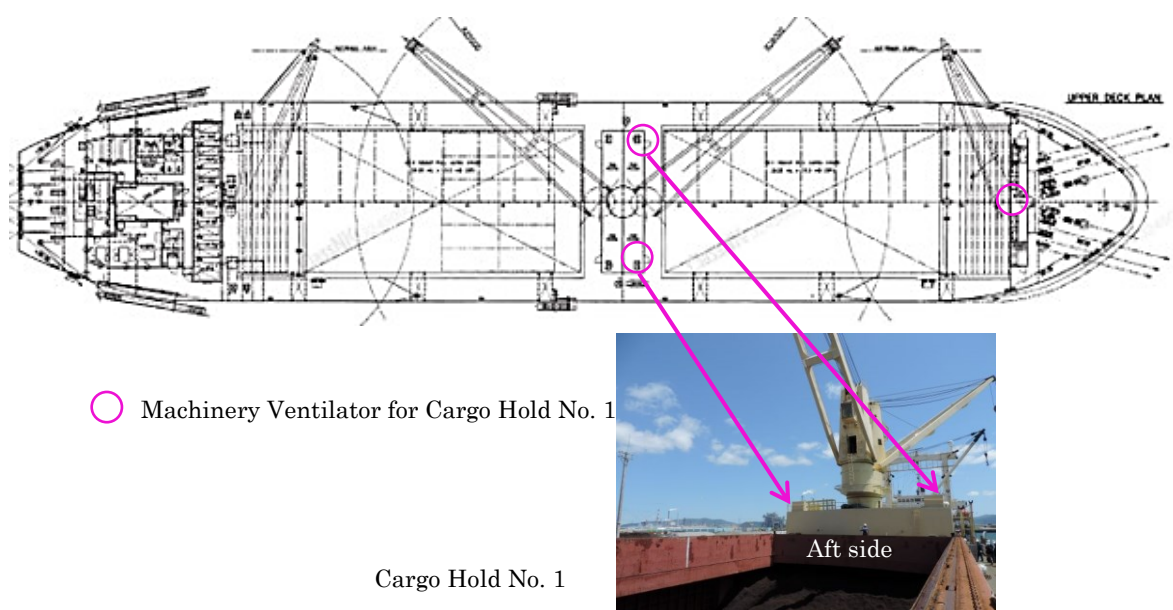
Figure 5 - Hull Structure and Equipment

In No.1 CH, a total of three mechanical ventilators were installed for the purpose of forced ventilation and humidity control—one unit for exhaust located at the fore side, and two units for both supply and exhaust located in the machinery room at the center of the upper deck. Air supply and exhaust inlets were installed in the ventilation boxes located below each mechanical ventilator.

At the time of the accident, the Vessel had no abnormalities in its hull, machinery, hatch covers, or other cargo-handling equipment and related systems.
