RA2019-1-II

**RAILWAY ACCIDENT
INVESTIGATION REPORT**

**Train Derailment Accident between Tarui station and Ozaki station
of the Nankai Line of Nankai Electric Railway Co., Ltd.**

January 31, 2019

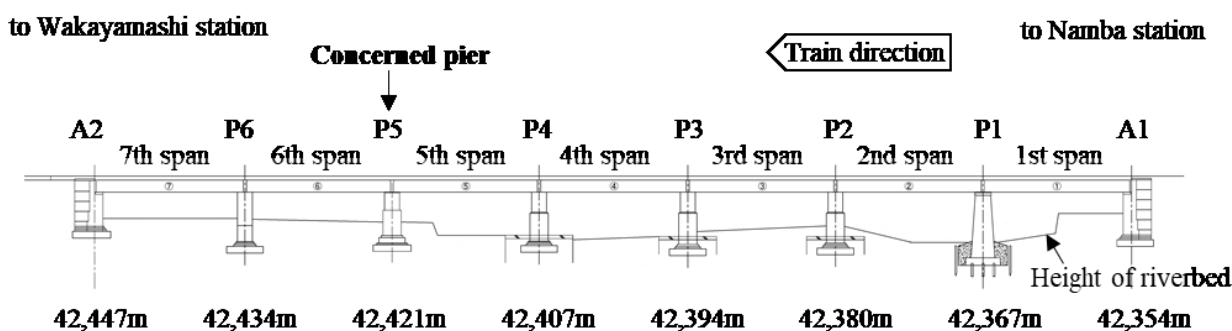
Figure 1. Side view of the down track bridge of the concerned bridge

The down track bridge of the concerned bridge was completed in 1918. The upper structure^{*6} composed of the 7 spans deck plate girder^{*7}, which the bridge length was 93.6 m and the span lengths were from 12.9 m to 13.6 m. The substructure^{*8} were composed of the pier P1 which was constructed by concrete and the pile foundation^{*9} type, and the piers P2 to P6 and the abutments^{*10} A1 and A2 which were constructed by the bricks and the spread foundation^{*11} type. Here, the pier P1 had originally constructed by bricks and the spread foundation type when the down track bridge of the concerned bridge had completed but it was rebuilt in about 1935. Here, the piers and abutments were named as "P" and "A", respectively, with the numbers counted in turns from the direction of Namba station.

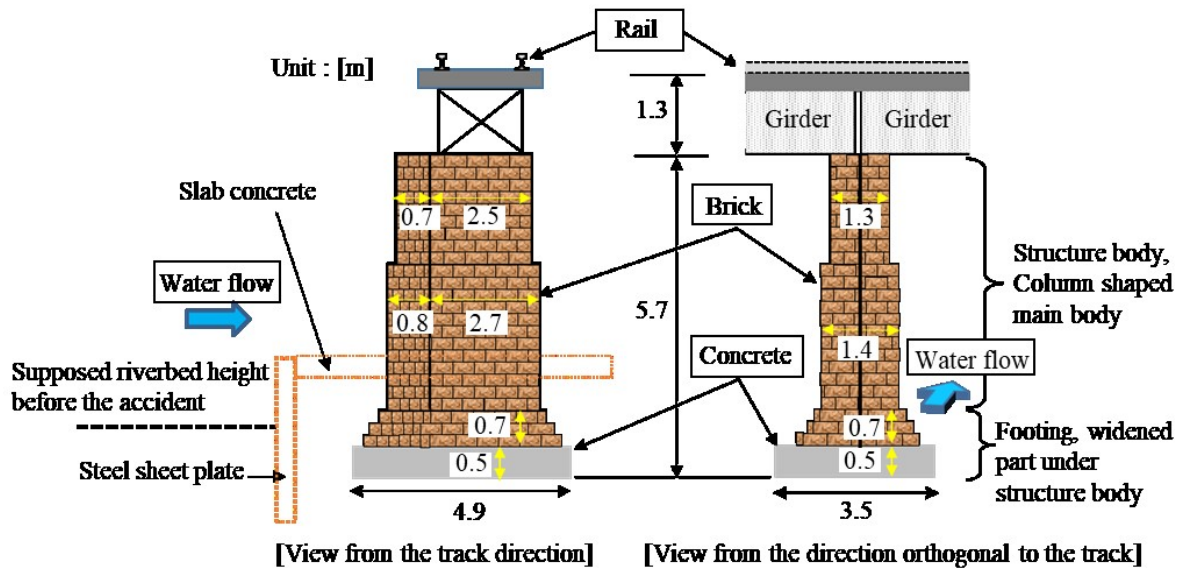
Figure 2. Shape of the concerned pier, restored diagram

As describe in the following 2.4.1.2 (1), the pier P5 of the down track bridge, *hereinafter referred to as "the concerned pier"*, had been subsided and tilted. In addition, the foot protection^{*12} was constructed for the concerned pier as the scour protection work to reinforce the durability against scouring for the foundation of the piers.

Completion	1918
Materials	The bricks and the concrete
Foundation	The spread foundation
Dimensions	As shown in Figure 2

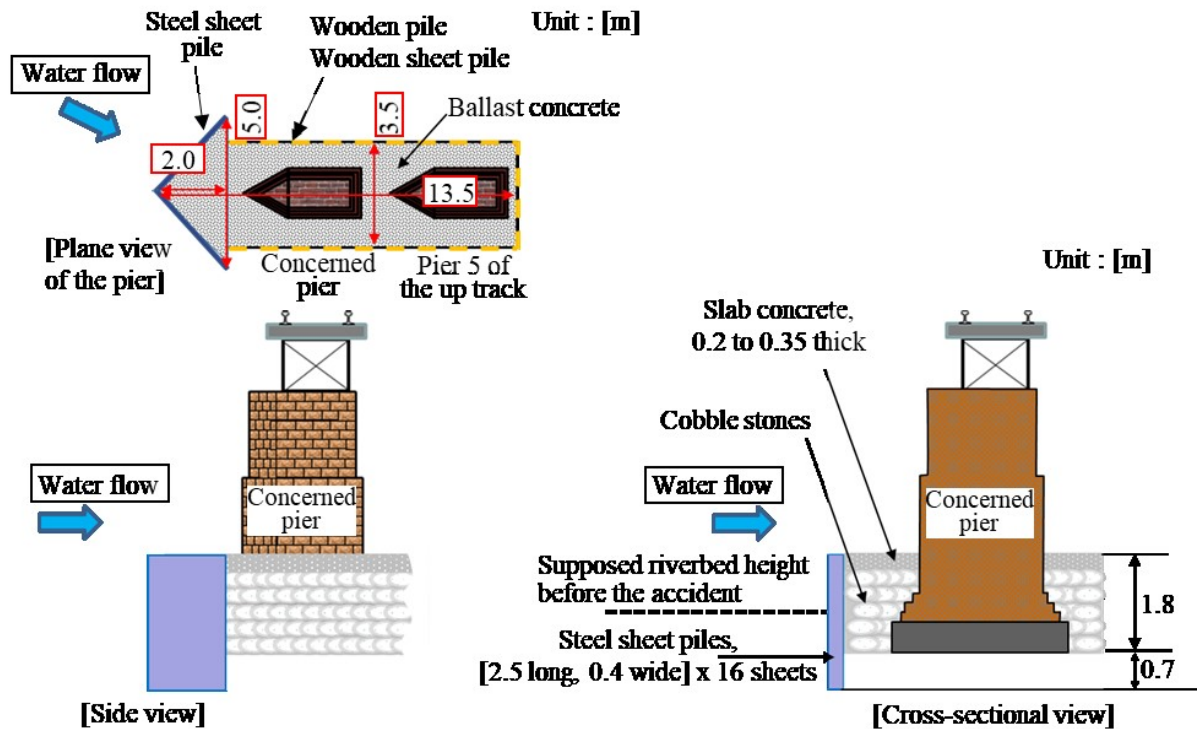
Figure 3. Shape of the foot protection of the concerned pier, restored diagram

Completion	About 1954
Materials	Concrete, cobble stones ^{*13} , steel sheet pile ^{*14} , wooden pile, wooden sheet pile
Dimensions, etc.	As shown in Figure 3

As described in 2.3.2.4, the structure of the foot protection of the concerned pier was that the steel sheet piles were driven into the ground only in the upstream side, and there were the soldier piles using the log piles in the side of the concerned pier where the steel sheet piles were not driven into the ground, as confirmed in the photograph, *i.e.*, Attached Figure 7. Then, it is highly probable that the foot protection of the concerned pier was composed of the soldier beams and lagging structure using the log piles and the wooden plates^{*48}. As the damages such as washed away of the cobble stones, etc., were found in these part in 2012, it is probable that the damages had started from the part of the soldier beams and lagging structure using the log piles and the wooden plates, where it was fragile compared to the steel sheet piles, as the riverbed had been subsided and the foot protection had been exposed due to the erosion by the flowing water after 2008, when the water route became to concentrate to around the concerned pier.

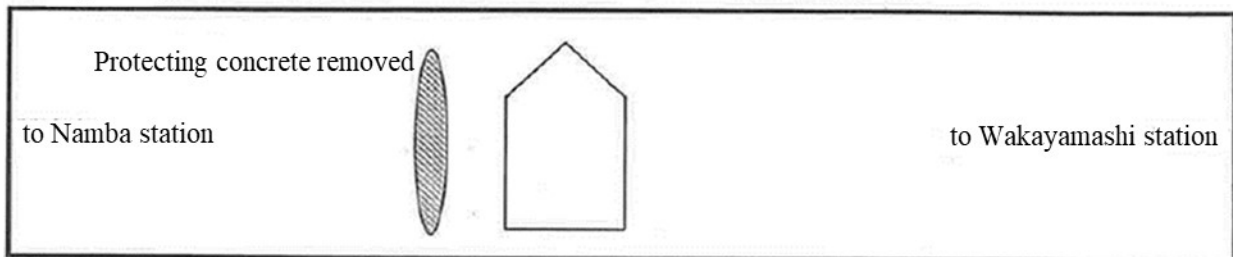
Figure 4. Check list of the whole structures for the concerned pier, extracted

The extraction of the check list for the concerned bridge implemented on June 13, 2017, was shown in Figure 4. The check list was made in the format to write down the existence of the unusual status for each item to be inspected for the substructure, *i.e.*, subsidence, tilting, scoured and subsided riverbed^{*20}. There was the description as "protecting concrete removed" in the remark column of the item "scoured", but all columns for the inspected results were checked as "nothing".

In addition, there was the description as "protection concrete removed" but all columns for inspected results were checked as "nothing", same as in Figure 4, in the inspected results for the substructures, in the inspection records for the concerned bridge implemented on May 17, 2013 and May 29, 2015.

According to the company, "nothing" in the column for inspected results indicates that there is no unusual status, and the judgment of the healthiness is class S. In addition, the "protection concrete" means the floor deck concrete for the foot protection, and the description as "protection concrete removed" were written in the remark column because the floor deck concrete was found as coming loose and falling, when checked in the opportunity as received the report from the inhabitants on the unusual status of the foot protection in October 2012. However, the foot protection was not the main body of the pier, then the company did not include the foot protection as the target to be judged the healthiness in the check list. Therefore, there was no record that the investigated results for the unusual status in the foot protection was reflected to the judgment of healthiness.

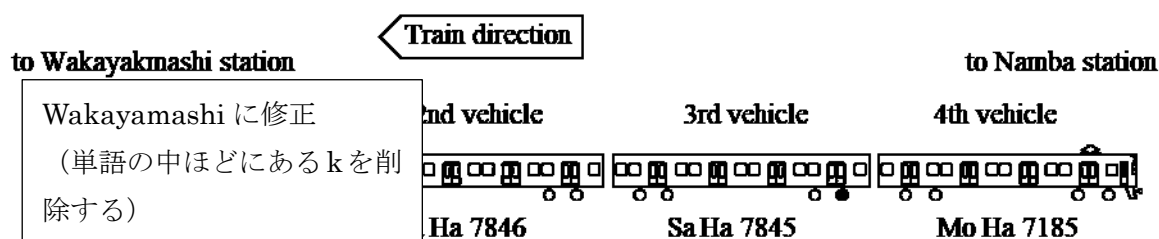
Figure 5. The trainset of the concerned train

● : The wheel axle supposed as restored after running as being derailed.

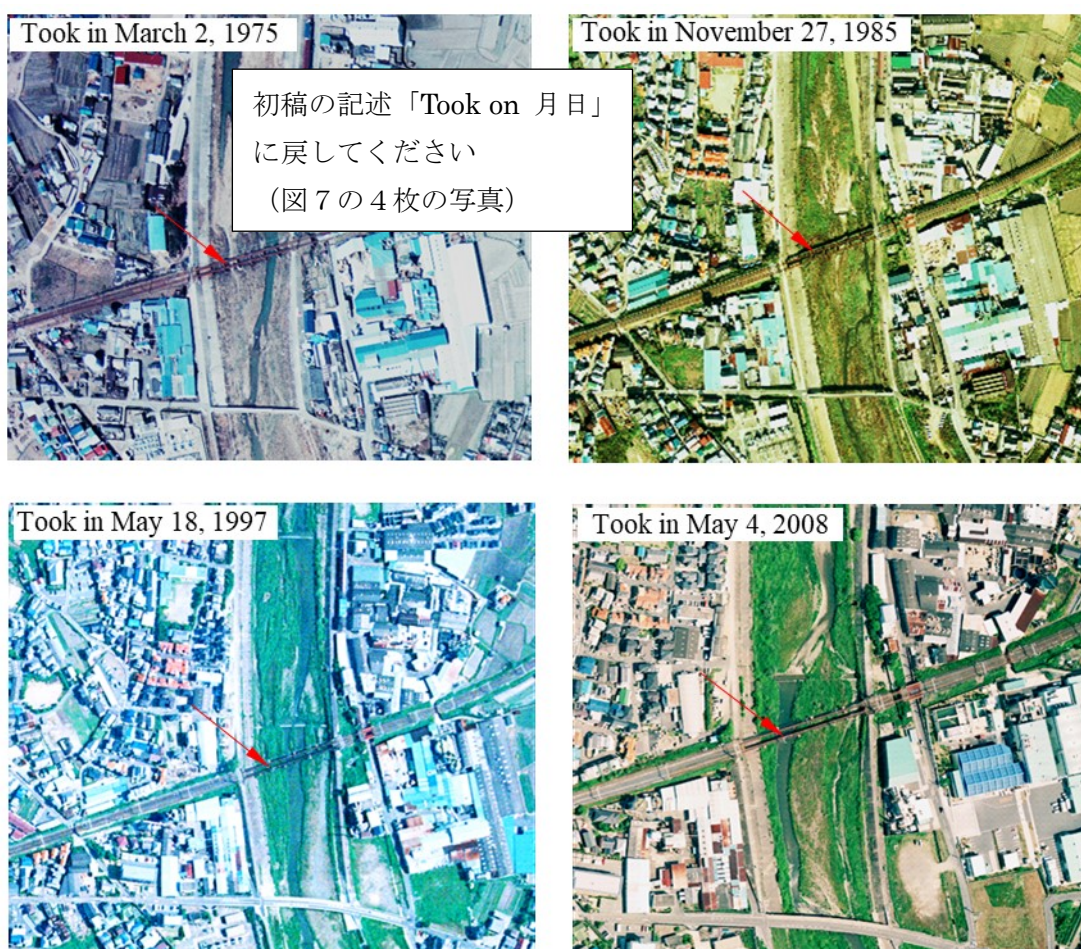
Figure 7. Change of the water routes from 1975 to 2008

provided from the company, were shown in Table 7, and a part of the aerial photographs corresponding with these change were shown in Figure 7. In addition, the changes of the rough positions of the sand bar^{*31} in the direction to Wakayamashi station after 2009 were drawn on the aerial photograph taken in 2008 as shown in Figure 8.

Time	Changed status of the water route
About 1935	Water route existed in around the pier P1
About 1954	Water route existed in around the pier P1
March 1975	Water route moved to around the piers P1 to P2
November 1985	Water route moved to around the pier P1 to abutment A1, and the fixing of vegetation on sand bar was advanced.
May 1997	Water route moved to around the piers P3 to P4
April 2006	Water routes existed in around P1 and in around the piers P4 to P5
May 2008	Water route existed only in around the piers P4 to P5, and the fixing of vegetation in around the piers P2 to P4 were advanced.
2012 to 2016	Water routes enlarged toward Wakayakashi station of the piers P4 to P5, and the fixing of vegetation on sand bar was advanced.

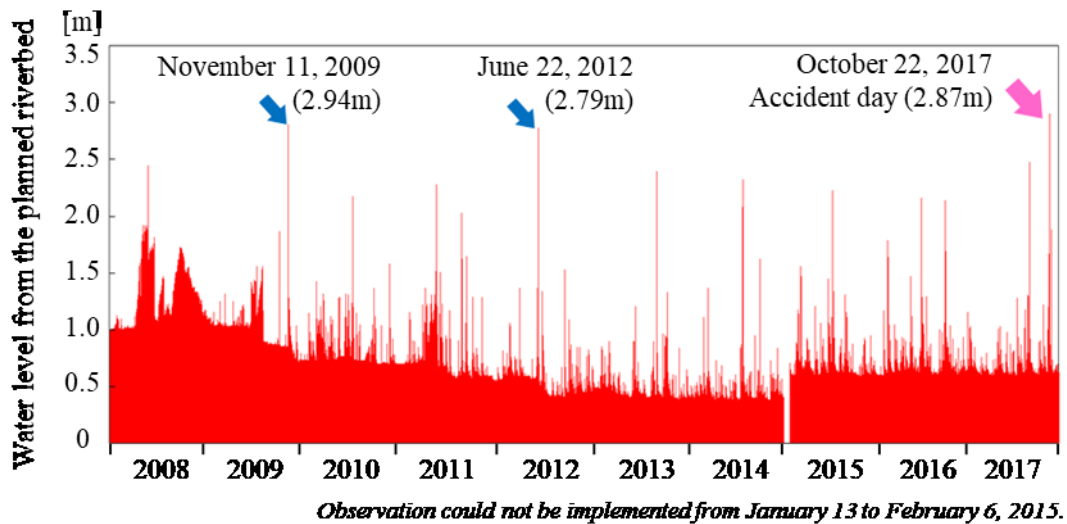
Figure 13. The change of water level at Onosatogawa bridge from 2008 to 2017.

According to the company, the highest water level observed in the company's water gauge after it was installed in 1990, was 1.79 m beneath girder, measured on July 4, 1995, and it was the 12th time that the water level exceeded 2.50 m beneath girder, which was the value to issue the caution alarm as described in the following paragraph 2.6.2, was observed. Here, after 2008 when the water route became to exist in around the concerned pier, the rise of water level observed in this case was the 3rd highest, *i.e.*, the highest rise was 2.00 m beneath girder observed on November 11, 2009, and the second highest rise was 2.02 m beneath girder observed on June 22, 2012.

In addition, the water level observatory "Onosatogawa bridge" administrated by Kishiwada Civil Engineering Office of Osaka Prefecture, located at about 700 m upstream from the concerned bridge, has been observing the water level from the planned height of riverbed. According to the observed records, *hereinafter referred to as "the observed record by Osaka Prefecture"*, the changed status of the water level from 2008 to 2017 were as shown in Figure 13. The frequent rises of water level were observed in the observed period including the remarkable rises of water level in November 11, 2009, and June 22, 2012, in addition to the water level in the concerned accident, provided that the observation could not be implemented from January 13 to February 6, 2015.

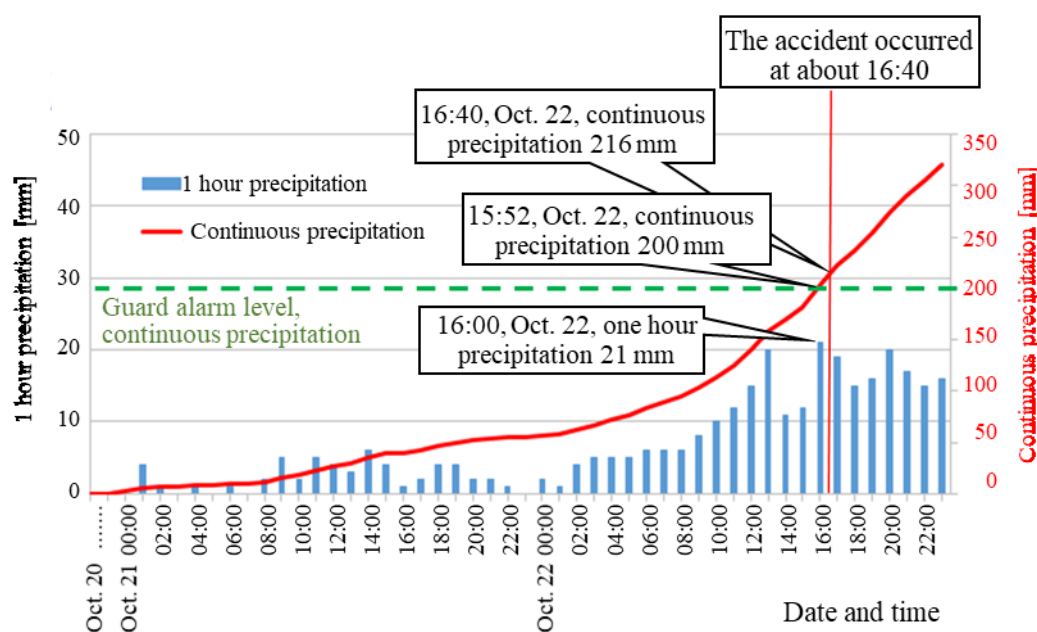
Figure 15. Observed data in the Yoshiminosato rain gauge

According to the observed record of the Yoshiminosato rain gauge, observation of the precipitation started from 21:10 on October 20. The maximum value of "the 1 hour precipitation for each hour"^{*43}, hereinafter referred to as "the 1 hour precipitation", until to the occurrence of the accident was 21 mm observed at 16 o'clock on October 22, and the maximum continuous precipitation^{*44} was 216 mm. [Refer to Figure 15]

As the continuous precipitation reached to the value to issue the caution alarm, i.e., 200 mm, at 15:52 on October 22, the dispatcher reported this information to the relevant sections. Here, the operation control was not implemented until to the occurrence of the concerned accident.

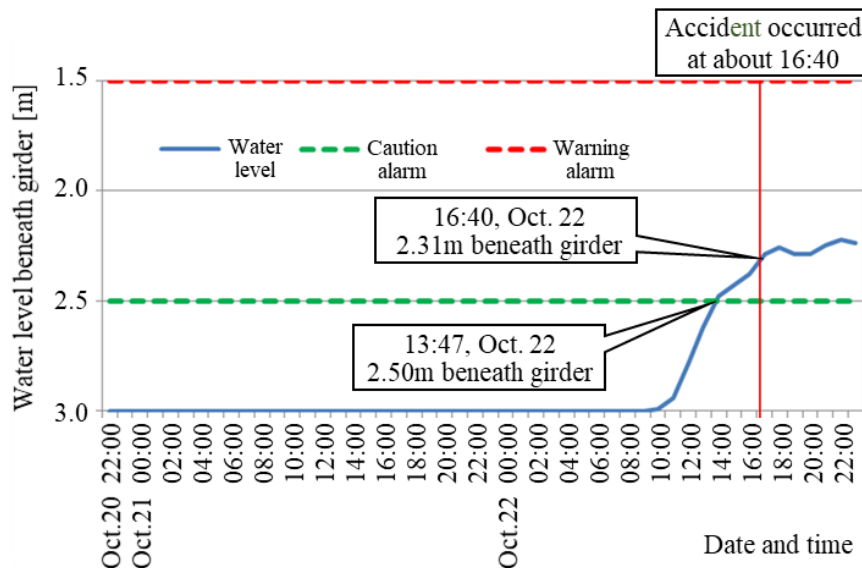
Figure 16. Observed data of the company's water gauge and the values to issue the operation control

The company's water gauge observes the water level when it exceeded 3.00 m beneath girder, as the specification. On October 22, 2017, the water level became to exceed 3.00 m beneath girder from about 10 o'clock and increased to 2.31 m beneath girder by about 16:40. [Refer to Figure 16]

As the water level beneath girder had reached to the level to issue the caution alarm, *i.e.*, 2.50 m beneath girder, at 13:47, the operation dispatcher reported this information to the relevant sections. Here, the operation control had not been implemented until to the occurrence of the concerned accident.

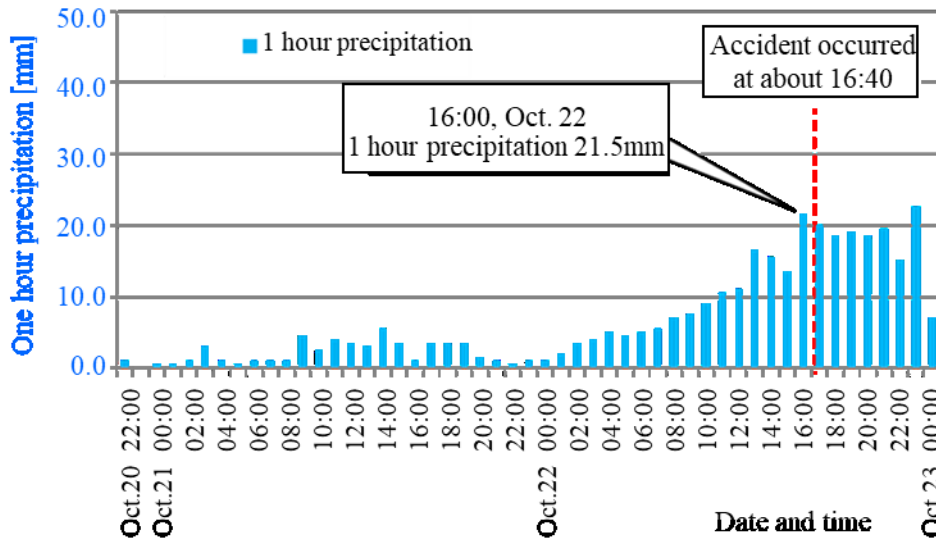
Figure 17. One hour precipitation from 22:00, Oct. 20 to 0:00, Oct.23, 2017 in AMeDAS[#] Kumatori
[#] "AMeDAS" is the abbreviation of the Automated Meteorological Data Acquisition System of the JMA, composed of about 1,300 meteorological observatories in the whole Country.

Based on these data, the precipitation had been observed from 22:00 on October 20, 2017, the maximum one hour precipitation was 21.5 mm at 16:00 on October 22, 2017 near the occurrence of the concerned accident, and the one day precipitation of the same day was 281.5 mm.

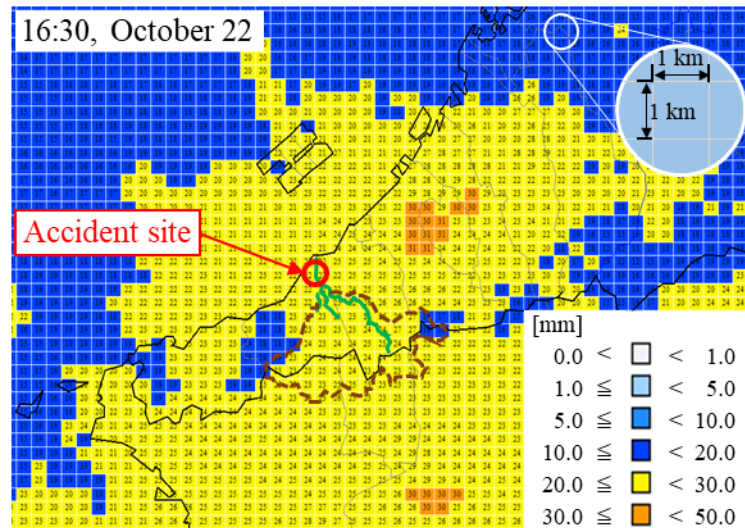
Figure 19. Analyzed precipitation in around the accident site

concerned accident in around the accident site, was as shown in Figure 19. Based on these data, the precipitation in around the accident site was 20.0 to 30.0 mm per an hour.

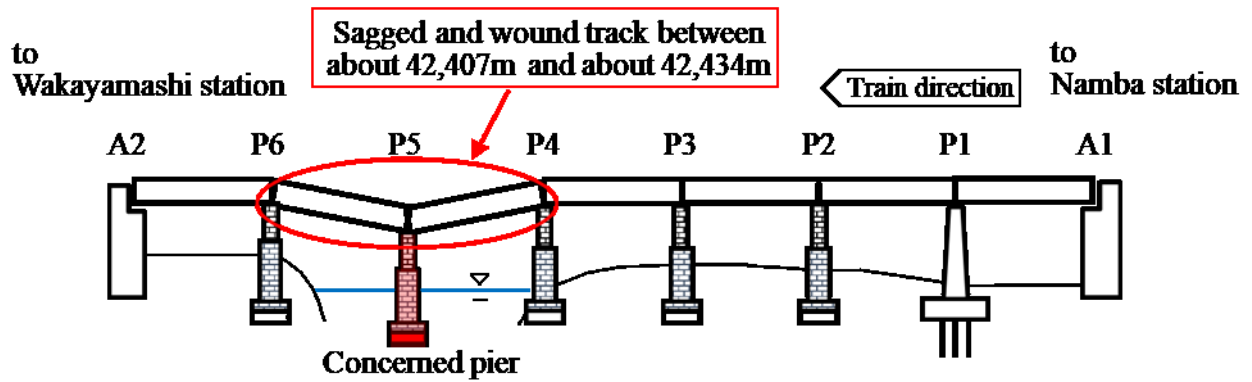
Attached Figure 6. Status of the Accident Site

The concerned pier had been subsided and tilted to left, *i.e.* toward upstream, and two girders suspended by the concerned pier were in the status as being displaced caused by the subsided and tilted concerned pier.

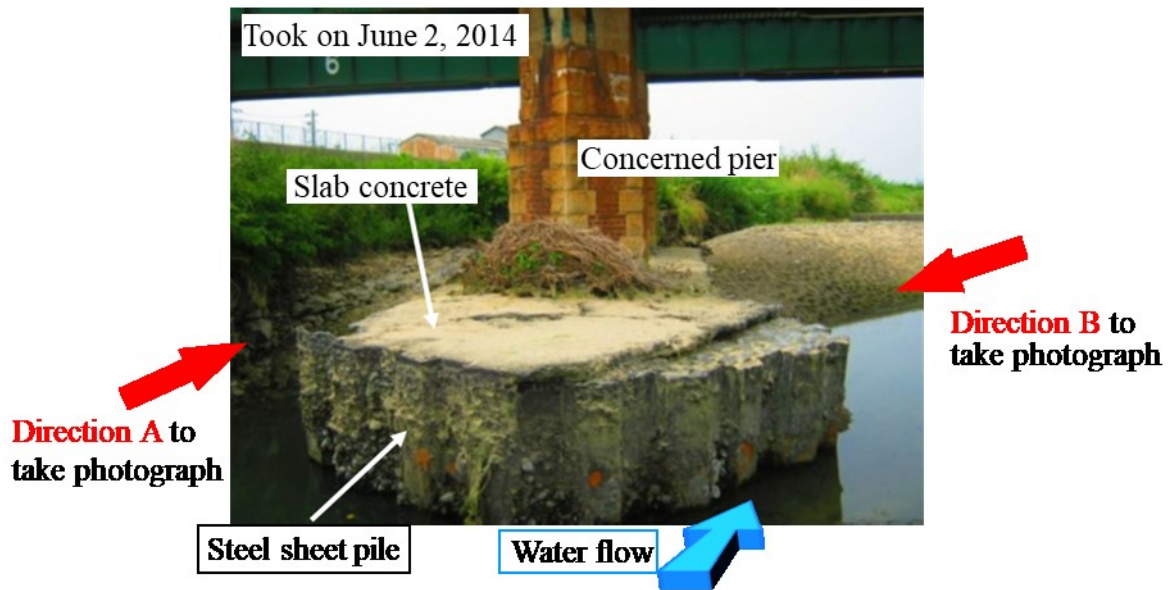
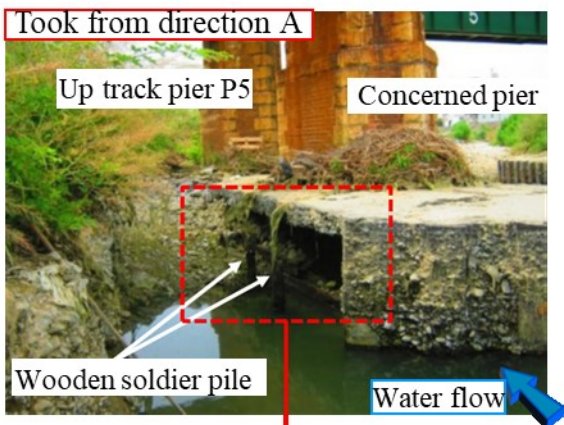
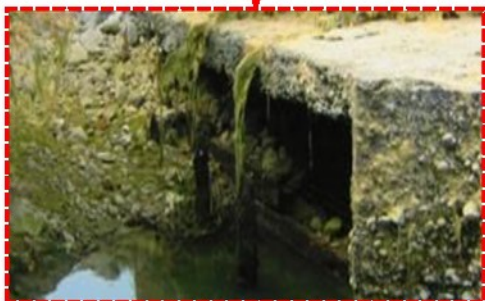
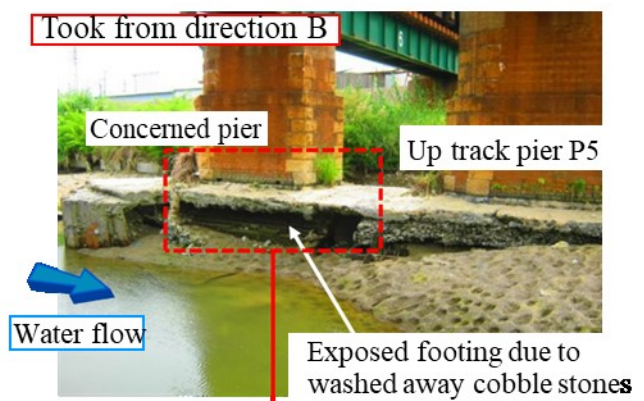
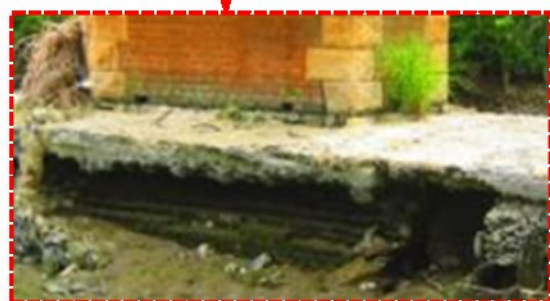
Attached Figure 8. Image of Changes of the Water Route in around the Concerned Bridge

* Red colored part indicates the concerned pier
