~ Accident that the train derailed caused as the side beam of the bogie of the wagon had been pushed up on the ice and snow ~

Railway operator : Japan Freight Railway Company
 Accident type : Train derailment
 Date and time : At about 02:09, February 24, 2018
 Location : In the premises of Tomamu station, Sekisho Line, Shimukappu Village, Yufutsu District, Hokkaido

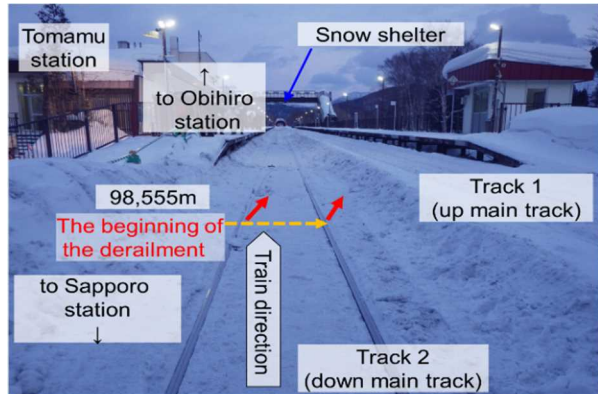
At about 03:55, February 24, 2018, while the snowplow motor car of Hokkaido Railway Company, dispatched for the snow removal works, arrived at the down line main track in Tomamu station of Sekisho Line, the staff for track maintenance boarded on the snowplow motor car received the communication that the turnout in the station could not be switched from the train dispatcher. Therefore, the staff for track maintenance checked the turnout and found the traces that the train had derailed and had been running.

In order to identify the derailed train, the wheels in the trains passed the concerned place were inspected, and the trace as derailed and continued running, was found in the wheel of the 1st axle in the front bogie of the 3rd vehicle of the High Speed Freight 2077 train, started from Sapporo Freight Terminal station bound for Obihiro Freight station of Japan Freight Railway Company, operated before the previous train of the snowplow motor car. The 2077 train had passed Tomamu station at a velocity of about 49 km/h, at about 02:09, February 24, 2018. In the investigation implemented after that, the restored trace of the train was found in around the turnout in the station.

It is probable that the accident occurred as the flange of the right wheel of the 1st axle in the front bogie of the 3rd vehicle climbed over the right rail and derailed at the place where large amount of ice and snow were stacked on the track, while the train was passing the straight track section in the premises of the station, and after that the train restored in the turnout while passing in the status as derailed.

It is somewhat likely that the 1st axle in the front bogie of the 3rd vehicle of the train derailed because the side beam of the front bogie of the 3rd vehicle was pushed up over the ice and snow stacked on the railway track, at the same time, the wheel flange was raised up by the hard ice and snow which had existed in around the flangeway.

It is somewhat likely that large amount of ice and snow had been stacked on the railway track in around the place where the derailment accident occurred, related with a large amount of snow fall and stacked snow in the previous day of the concerned accident, and that the snow removal works had not been implemented for 6 days before the occurrence of the accident.

Here, it is required to pay special attention for the ice and snow formed higher than the height of rail surface in outside gauge in the track section where the freight trains are operated, considering the position of the side beam of the wagons that caused the concerned accident, when the snow removal works are implemented.
