RAILWAY ACCIDENT INVESTIGATION REPORT

Train Derailment Accident between Shibukawa Station and Shikishima Station, Joetsu Line, East Japan Railway Company

July 30, 2020

Railway operator: East Japan Railway Company
Accident type: Train derailment
Date and time: At about 22:53, June 28, 2019
Location: Around 98,246 m from Omiya station, between Shibukawa station and Shikishima Station, double track, Joetsu Line, Shibukawa City, Gunma Prefecture

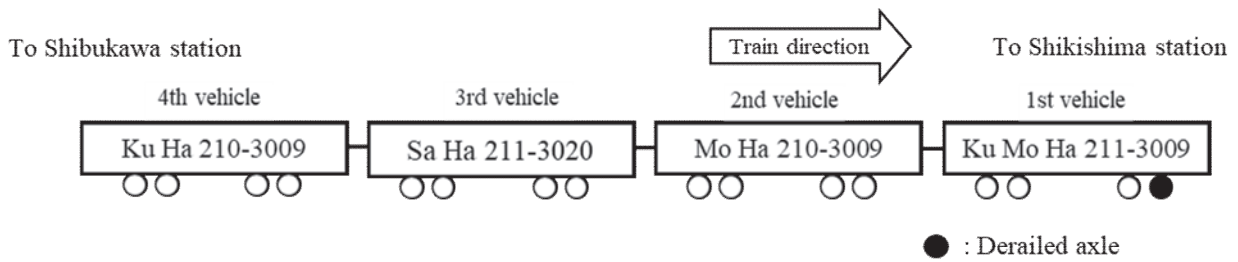
Figure 1. Outline of the train

The first axle of the front bogie of the first vehicle of the train derailed to left.

The major specifications of the vehicles are as follows. Figure 1 shows the outline of the train and the derailed axle.

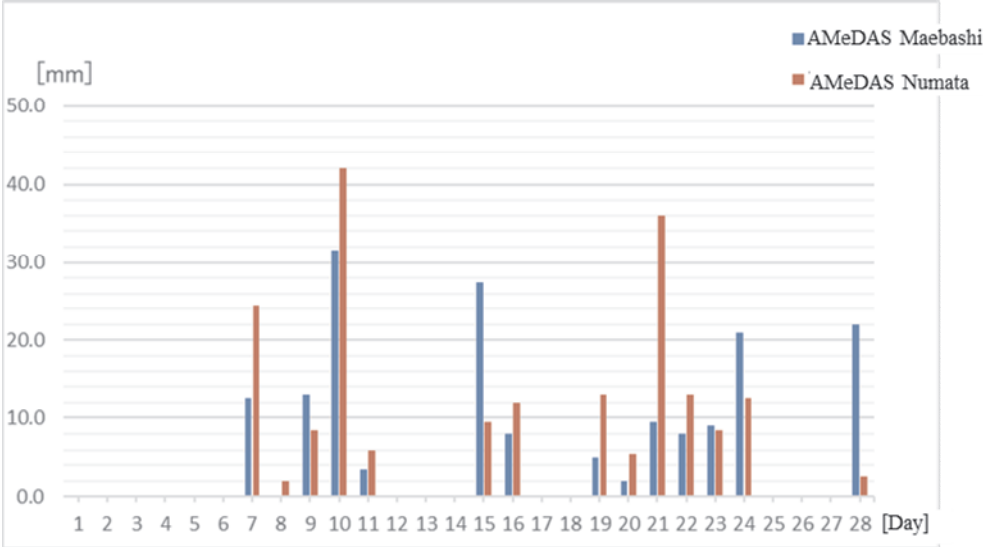
Figure 2 Daily precipitations in June 2019 (AMeDAS Maebashi, AMeDAS Numata)

According to the records of the Japan Meteorological Agency Maebashi Regional Meteorological Observatory, *hereinafter referred to as "the AMeDAS Maebashi"*, located in about 15 km south of the accident site, and the Japan Meteorological Agency Numata Regional Meteorological Observatory, *hereinafter referred to as "the AMeDAS Numata"*, located in about 15 km north of the accident site, the daily precipitations in June, 2019, and the hourly precipitations of June 28, 2019 were as shown in Figures 2 and 3, respectively. According to these figures, the hourly precipitation of 14 mm that was the maximum on the accident day was recorded at AMeDAS Maebashi from 21:00 to 22:00 on June 28.

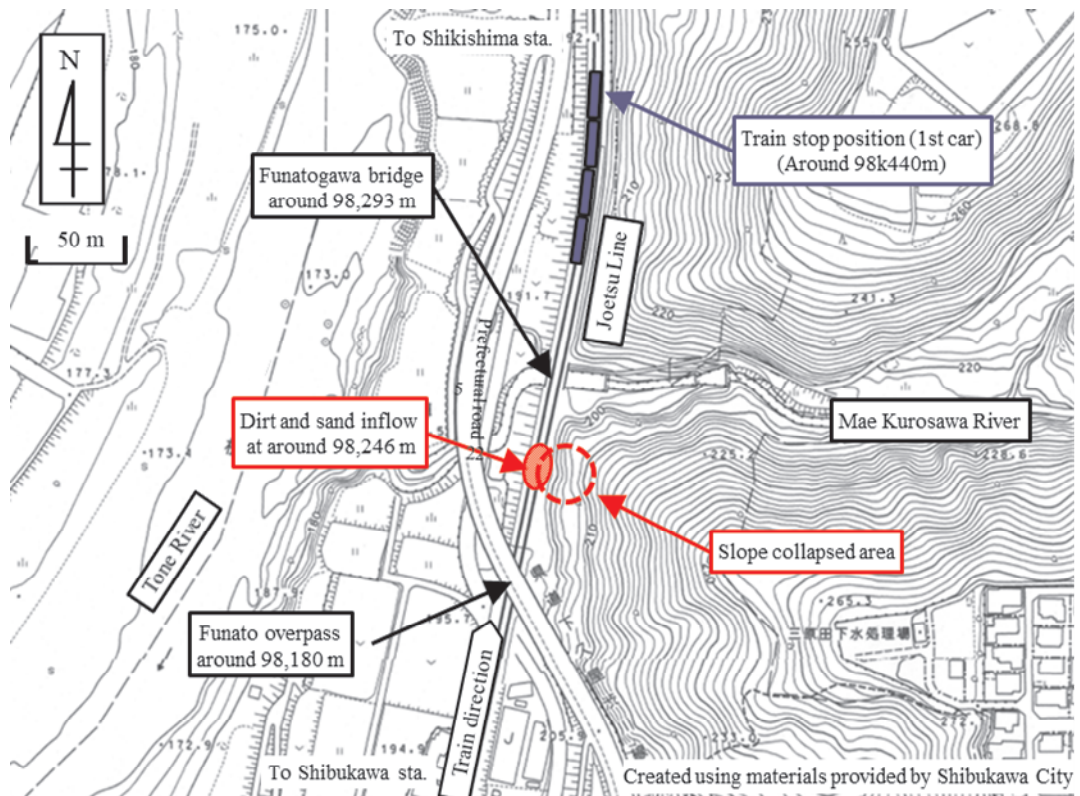
Attached Figure 2. Plane View of the Track in around the Accident Site

- (i) There were two consecutive damages, considered as caused by being contacted by the wheel flange, in the direction of travel on the head of the bolts of the rail fastening devices on the outside of left rail of the down track in around 98,251 m.
- (ii) There were intermittent traces, considered as caused by being scratched by the wheel flanges, on the leaf springs of the rail fastening devices on outside of left rail from around 98,252 m to around 98,440 m.
- (iii) A part of the PC sleepers in around 98,262 m and in around 98,340 m were damaged.
- (iv) The cable protection covers in around 98,340 m and in around 98,365 m were

damaged.

No running traces by the wheel flanges leading to derailment were found on the top surface of the rail before and after the inflowing place of earth and sand.

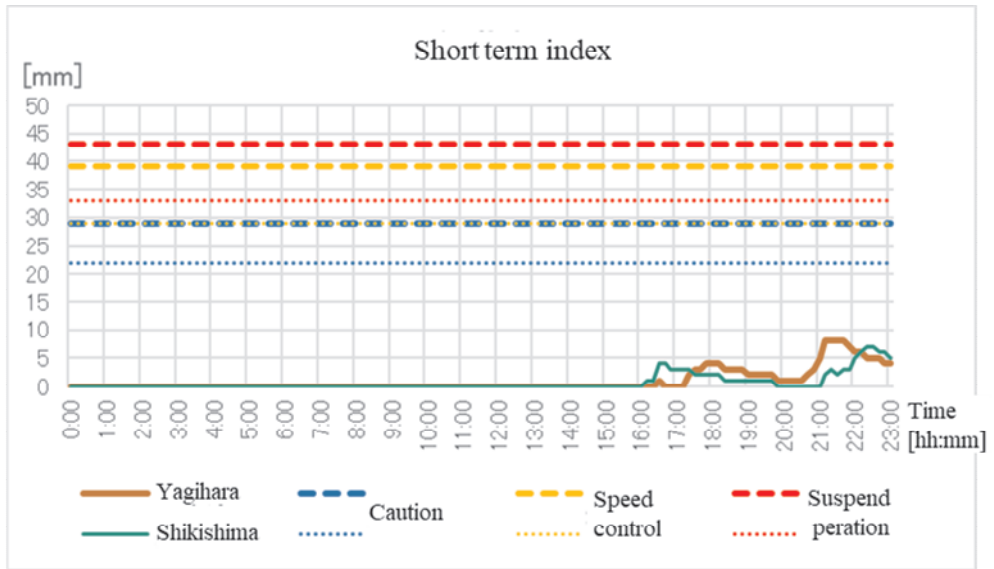
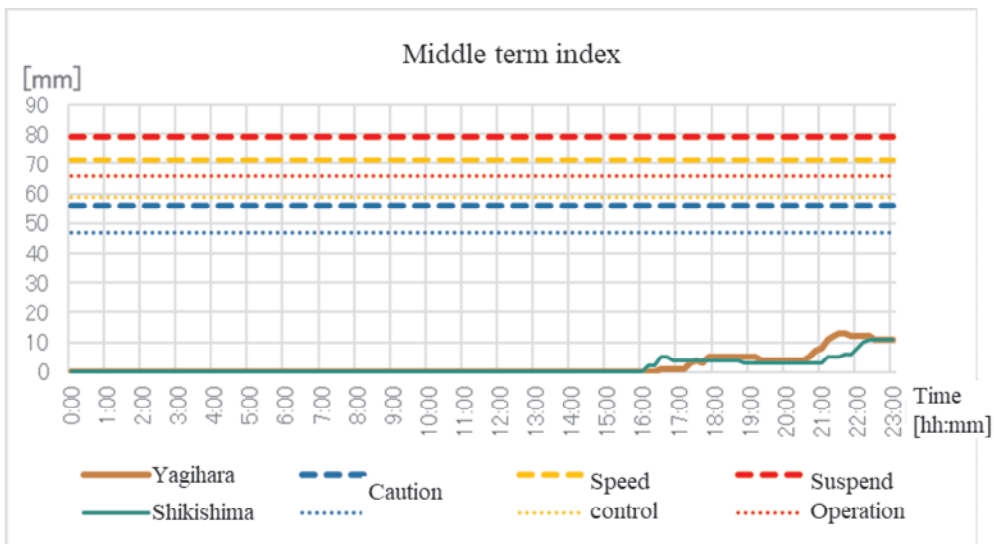
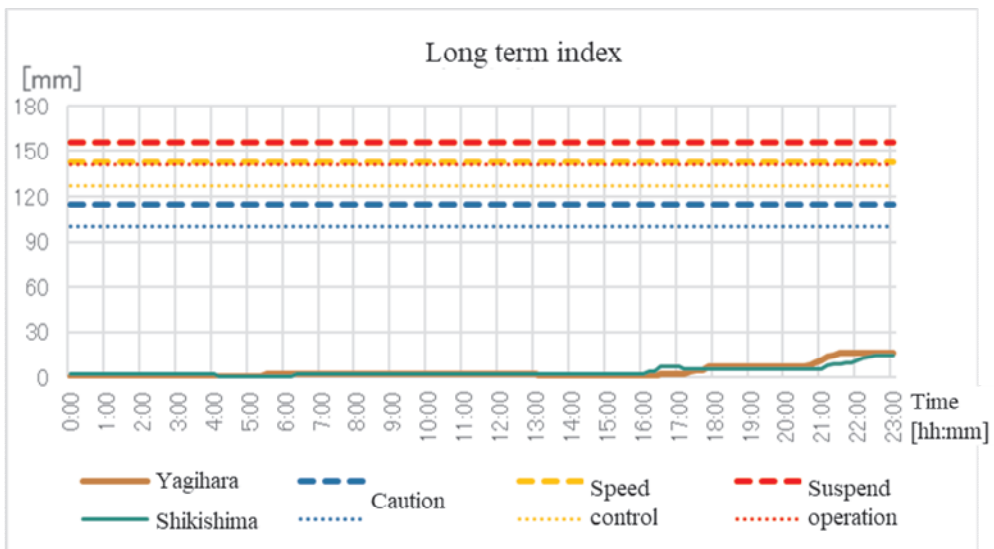
Attached Figure 10. Shikishima and Yagihara Effective Rainfall

According to the "Disaster Security Standards for Railway Tracks, Regulations" and "Guidelines for Operation Control for Rainfall, Conventional Lines", of the company stipulated to implement operation controls and disaster security during rainfall, *hereinafter referred to as "the operation control, etc."*, based on the effective rainfall^{*14}, which is calculated based on the precipitation observed by the rain gauges installed along the railway track at about 10 km intervals as a standard. The operation control, etc., was categorized in 3 categories, *i.e.*, the caution, the speed control, and the operation suspension, and the procedures shown in Table 2 are performed according to the standard value of the effective rainfall, *i.e.*, standard value to be
