"The accident that the train derailed because the gauge widened significantly while the train was running in the curved track"

Railway operator : Aizu Railway Co. Ltd.
 Accident type : Train derailment
 Date and time : About 19:08, December 24, 2019
 Location : Around 26,888 m from the origin in Nishi-Wakamatsu station, between Tonohetsuri station and Yagoshima station, single track, Aizu Line, Shimogo Town, Fukushima Prefecture

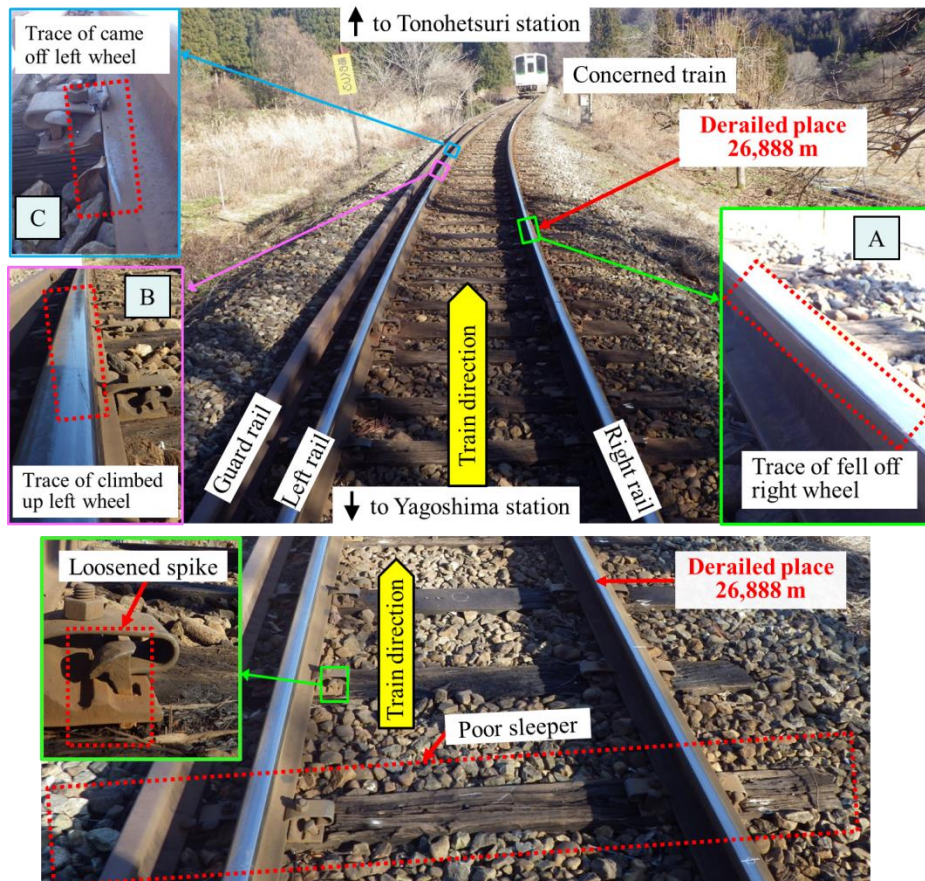
At about 19:08 on Tuesday, December 24, 2019, while the one-man operated inbound 3160D train, composed of one vehicle and started from Tobu-Nikko station bound for Aizuwakamatsu station, of Aizu Railway Co. Ltd., was passing the 200 m radius right curved track between Yagoshima station and Tonohetsuri station at the velocity of about 44 km/h, the driver of the train felt the impact, then operated the emergency brake to stop the train.

When inspected the vehicle after stopped, it was found that the 1st axle in the front bogie of the vehicle had been derailed to left.

It is probable that the concerned accident was caused as that right wheel of the 1st axle in the front bogie fell to inside gauge because the gauge widened significantly while the train was passing through the 200 m radius right curve.

It is probable that the gauge widened significantly because the rail tilting and the lateral displacement of rails occurred due to the lateral force acted while the train was running caused by the continuously existed poor sleepers and the floating spikes in the rail fastening devices, in addition to the large track irregularity of gauge in the concerned curved track.
