RA2021-1-I

# **RAILWAY ACCIDENT INVESTIGATION REPORT**

**Railway accident with casualty in the premises of Shin-Sugita station,  
Kanazawa Seaside Line, the Yokohama Seaside Line Co., Ltd.**

Railway operator           Yokohama Seaside Line Co. Ltd.  
Accident type               Railway accident with casualty  
Date and time               About 20:15, June 1, 2019  
Location                     In the premises of Shin-Sugita station, Kanazawa Seaside Line,  
                                  City of Yokohama, Kanagawa Prefecture

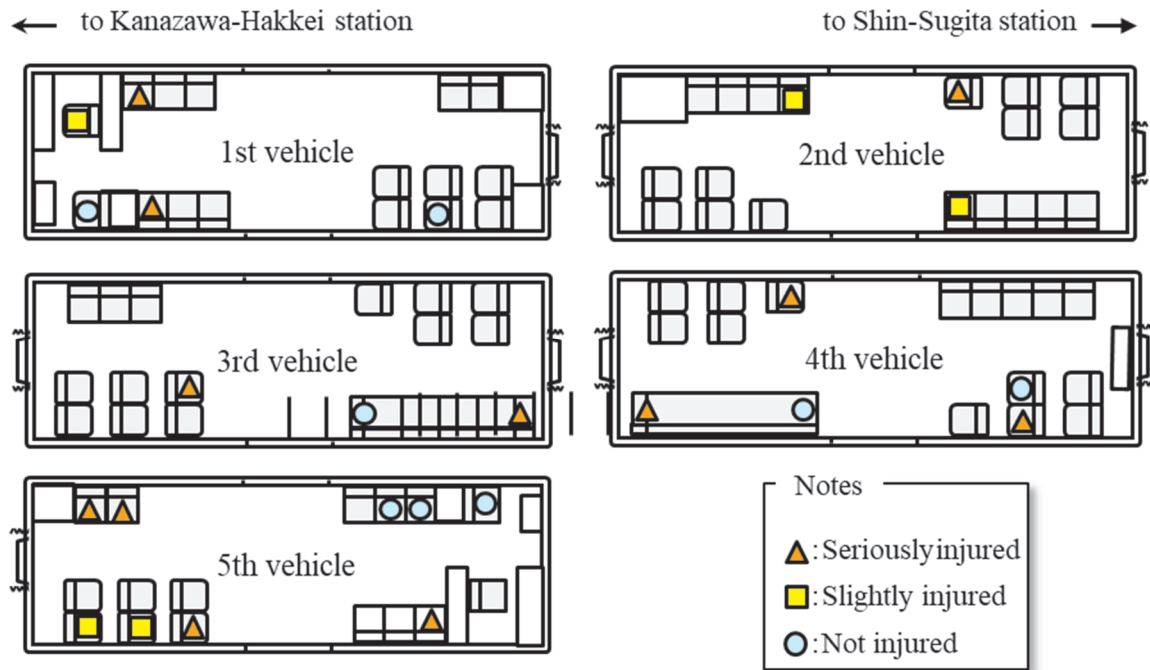
Figure 1. Boarded positions of the passengers

There were 25 passengers boarded on the Train, among them, 17 passengers were injured, including the seriously injured\*<sup>7</sup> 12 persons. The boarded status of the passengers in the 1st vehicle to the 5th vehicle was shown in Figure 1, and the status of the injuries of the passengers was shown in Table 4. *Hereinafter the words "front", "rear", "left", "right" are defined based on the running direction of the outbound train bound for Kanazawa-Hakkei station, and the vehicles are counted from the front.*

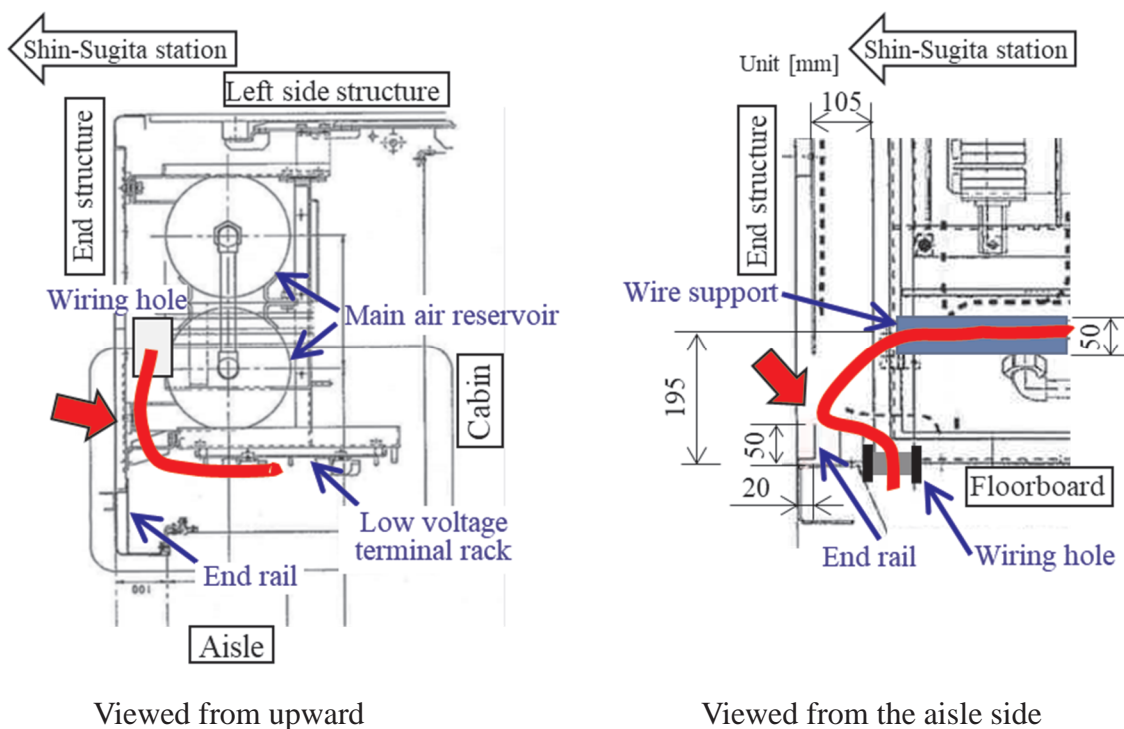
Figure 6. Device layout and wired route of bundle of cables in the Device Room

In the Device Room, two main air reservoirs <sup>\*28</sup> and the low voltage terminal base in the aisle side are installed, and the total about 340 electric wires and cables, hereinafter referred to as "*the*

*electric wires, etc.*", lifted through the wiring hole to above the floor, are divided into the groups for each connecting object in around the wiring hole. Among these, the electric wires, etc., wired in the aisle side via the neighborhood of the end structure in the Device Room, were gathered in 4 bundles of cables using the protecting materials using the rubber bands and fastening bands, respectively, and piled up vertically and fastened into a large bundle of cables, and fixed to the cable support in the rack to attach the low voltage terminal base, *hereinafter referred to as "the low voltage terminal rack"*. After this accident, the wired route of the F cable which had been connected to the low voltage terminal rack was investigated after this accident by removing from the bundle of cables toward the wiring hole and found that the F cable had been in the lowest bundle of cables among four bundles of cables, near to the end rail. [Refer to Figure 6 and 7]

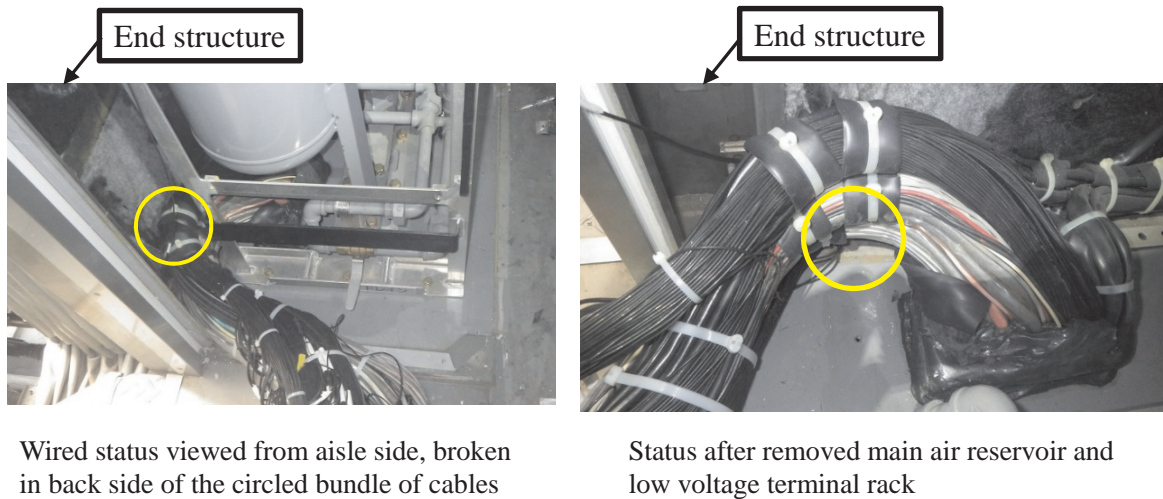
Figure 7. Status of inside of the Device Room, when investigated

In addition, Figure 7 shows the status that the electric wires, etc., connected to the low voltage terminal base, were removed and the belt to fasten the lowest bundle of cables was removed, in order to investigate the route of the F cable.

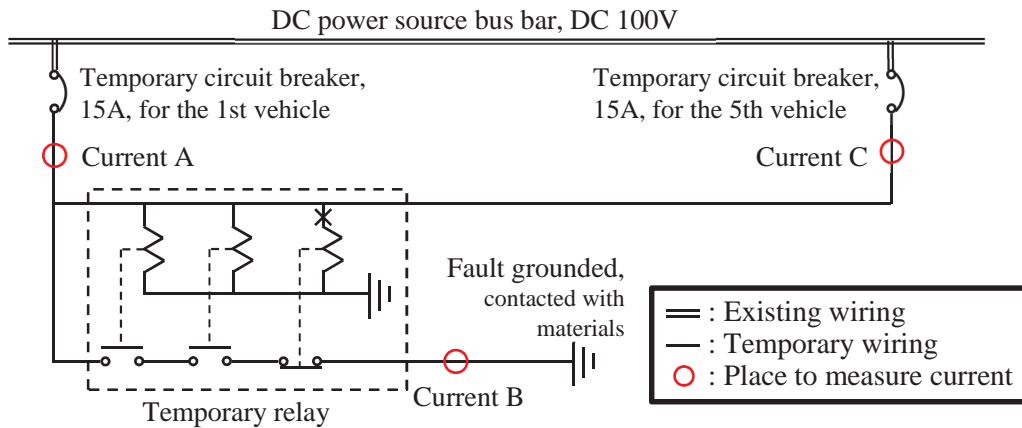
Figure 12. Connection diagram in the test to reenact the ground fault

It was considered as possible that the DC 100 V in the DC power source bus cable had fault grounded<sup>\*34</sup> to the end rail through the F cable, from the broken status of the F cable described in 2.5.1. Then, the reproduction test to comprehend the status when the cable was broken, using the vehicle in the other set composed of the 2000 series vehicles different from the Vehicle, *hereinafter referred to as "the test set"*, was implemented by installing the wires of the same kind as the F cable, and applying DC 100 V to let fault grounded to the material attached to the vehicle.

In the reproduction test, the temporarily wired electric wire was wired through the circuit breakers and the signal relays, which are same kind as the control circuit breaker, temporary installed in the 1st vehicle and the 5th vehicle in the test set, *herein after referred to as "the temporary circuit breaker" and "the temporary signal relay"*, respectively, and the currents were measured at three points, *i.e.*, each temporary circuit breaker and in around the grounded place. [Refer to Figure 12]

When the temporary electric wire covered by the flawed insulator was made to contact with the parts made of the same material and thickness as the end rail fixed to the body structure, the spark was generated and the temporary electric wire was broken. The tip of the broken temporary electric wire was discolored a little as same as the F cable in the Vehicle, and the part corresponding to the end rail was melted and damaged in the place contacted with the temporary electric wire. [Refer to Figure 13]

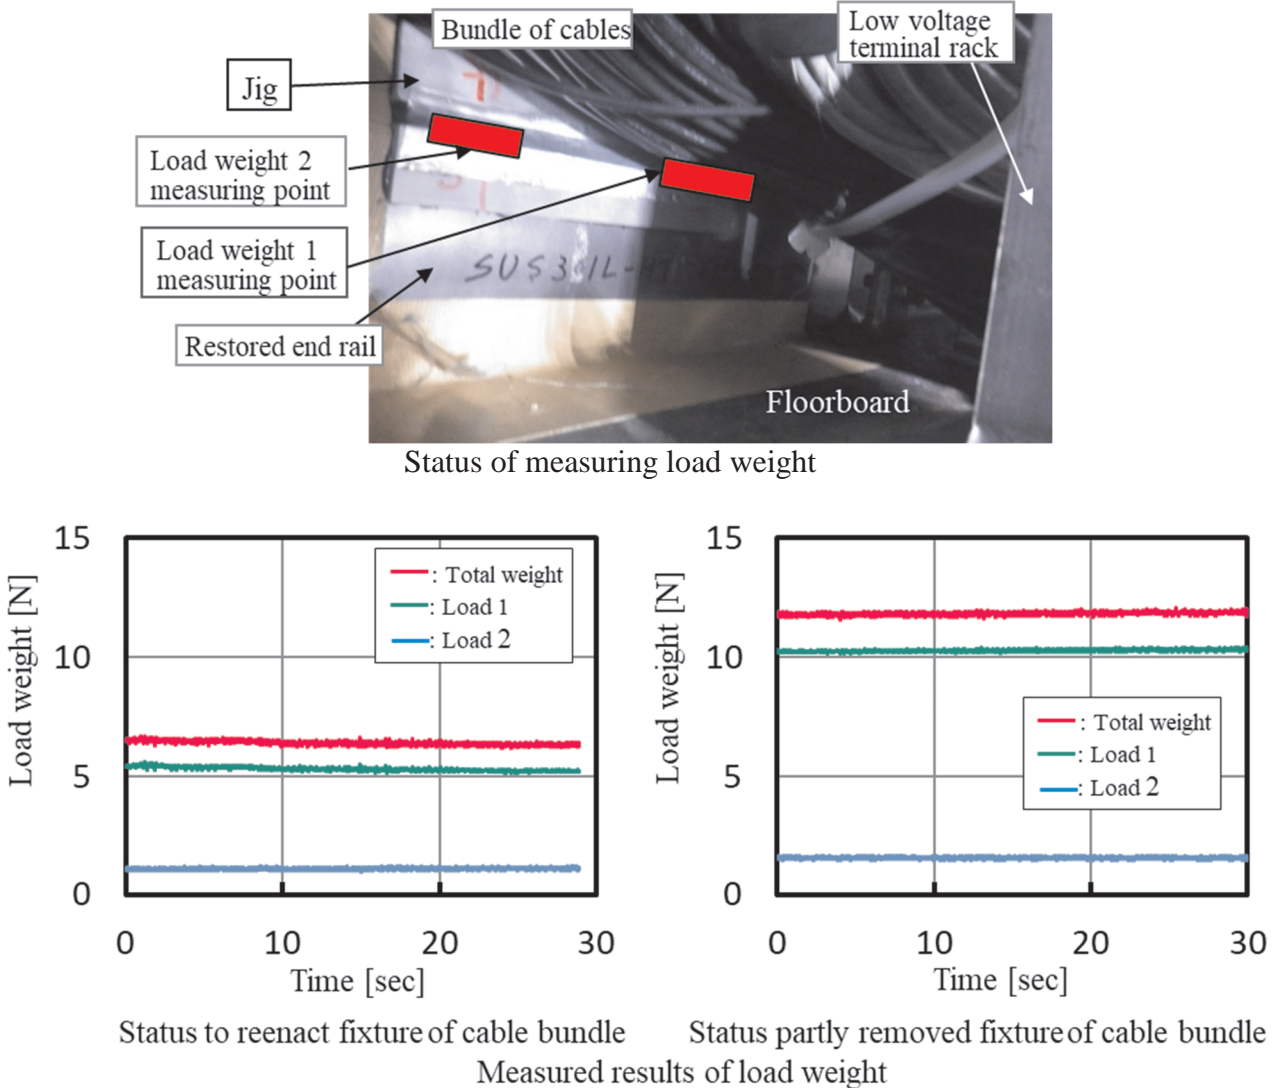
Figure 14. Measurement of load weight of bundle of cables

As the results, the load weight acting on the bundle of cables varies depending on the height or the status of the bundle of cables fixed to the cable support to the low voltage terminal rack, and about 6.4 N in the status reenacted being fixed as possible, and was about 12 N in the status to remove a part of the fixed fastening cable support and laid the bundle of cables on the end rail as possible. Here, the load weight was 0 N when the bundle of cables was fixed in high position.

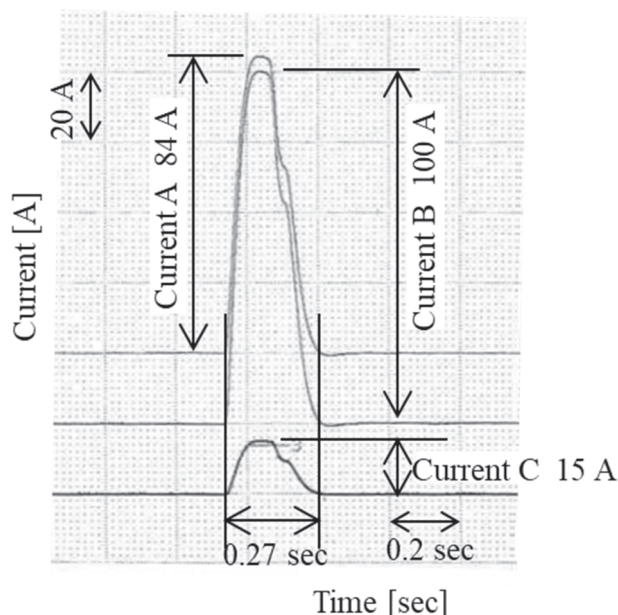
Figure 15. Measured results of the fault grounding current

In the reenacting test of the fault grounding described in 2.11.3, the temporary electric wire covered with the defected insulator was forced to fault grounded. In this case, the temporary circuit breakers in the 1st and the 5th vehicles had been in the "on" status and did not act the breaking operation. The current B flew in the fault grounded place was 100 A in the maximum, the current A and C flew in the temporary circuit breakers in the 1st and the 5th vehicles were 84 A, and 15 A in the maximum, respectively, and the energized time was 0.27 sec in all cases. [Refer to Figure 15]

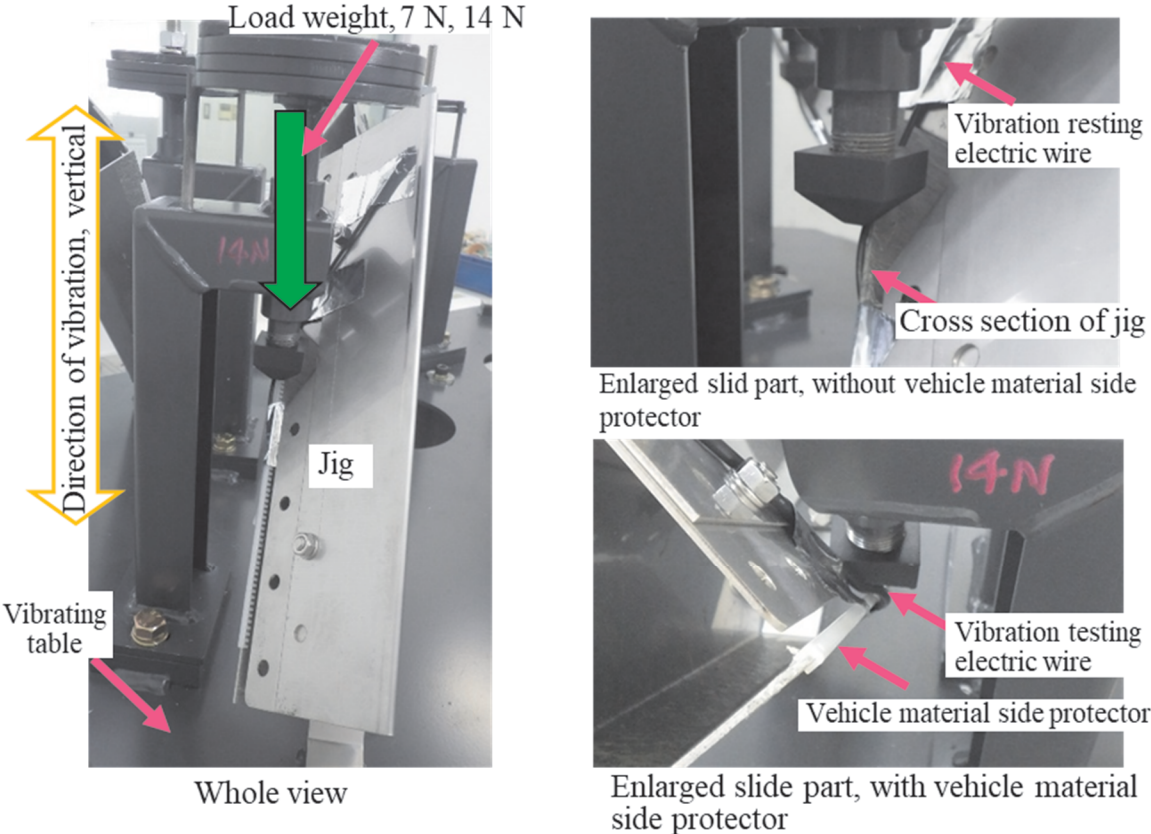
Figure 16. Status of the Vibration Test

As the vibration in three directions, *i.e.*, up and down, left and right, back and forth, are acted to the vibration testing electric wires in the running vehicle, the vibration test was conducted as to act the load weight and the vibration obliquely, by tilted the whole jig by 45 degrees.

The vibrating data used in the vibration test was created using the vibrating acceleration data acted on the floor board near the Device Room, measured by the Company in the test run in the general inspection, and the load weight was set as 7 N and 14 N in the vertical direction, referred to the load weight measured in 2.11.4. [Refer to Figure 16]

After vibrating 5 days or 14 days, the maximum depth of the faults in the insulator of the vibration testing electric wires were measured, individually. As the results, the major results as the followings were obtained in the above test conditions.

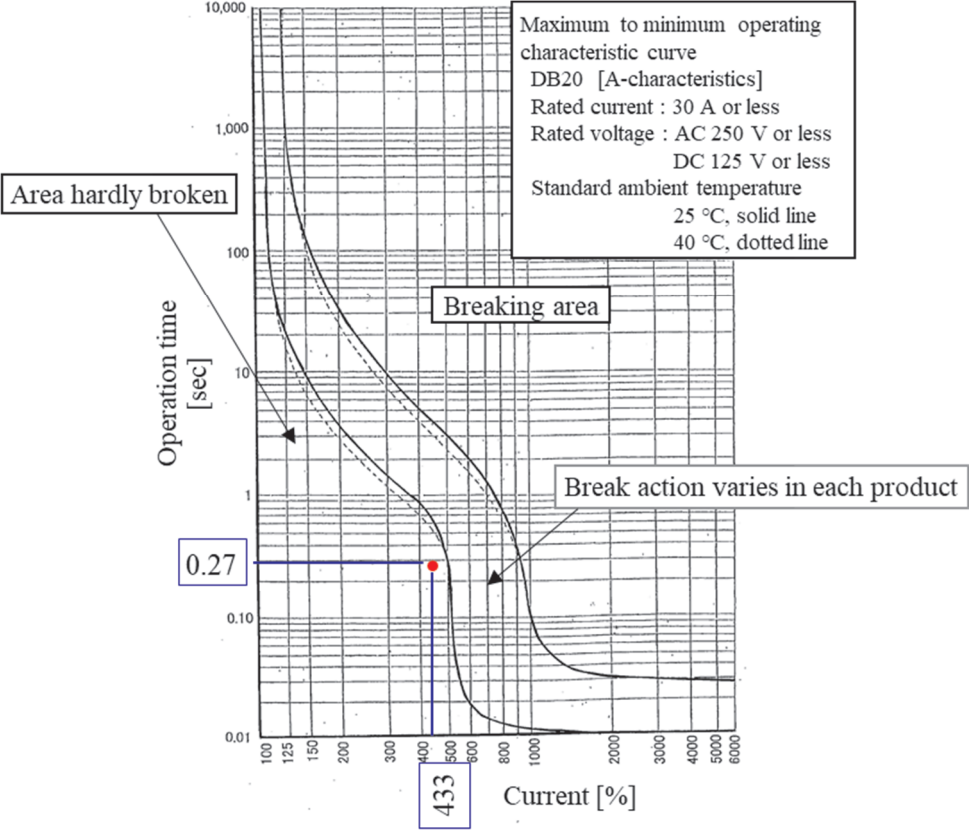
Figure 18. Characteristics of the operation of the control circuit breaker

As described in 2.11.3, based on the reenacting test of the fault grounding, it is highly probable that the ground faulting current in the same level as the current A described in 2.11.5 flew additionally to the steady current for the control power source of the control circuit and the motor control device, in the control circuit breaker of the Vehicle. It is probable that the current flew in the control circuit breaker, 65 A, corresponds to about 433 % of the rated current of the circuit breaker 15 A, because the steady current was about 5.6 A, and the effective value of the current A was about 59.4 A. The energizing time, 0.27 sec, was almost in the area that the circuit breaker did not operate, as shown in Figure 18.

When the control circuit breaker of the rated current 5 A, is connected to only the command cable for the forward and backward switching circuit such as the F cable or the R cable, the current of about 1,300 % of the rated current of the control circuit breaker will flow if one of the F cable

and the R cable was fault grounded, therefore, the control circuit breaker will act to break circuit in high possibility. It is probable that this accident would not occur, if the circuit breaker acts to break electric circuit, because the vehicle becomes impossible to run as the emergency brake will operate. [Refer to Figure 18]

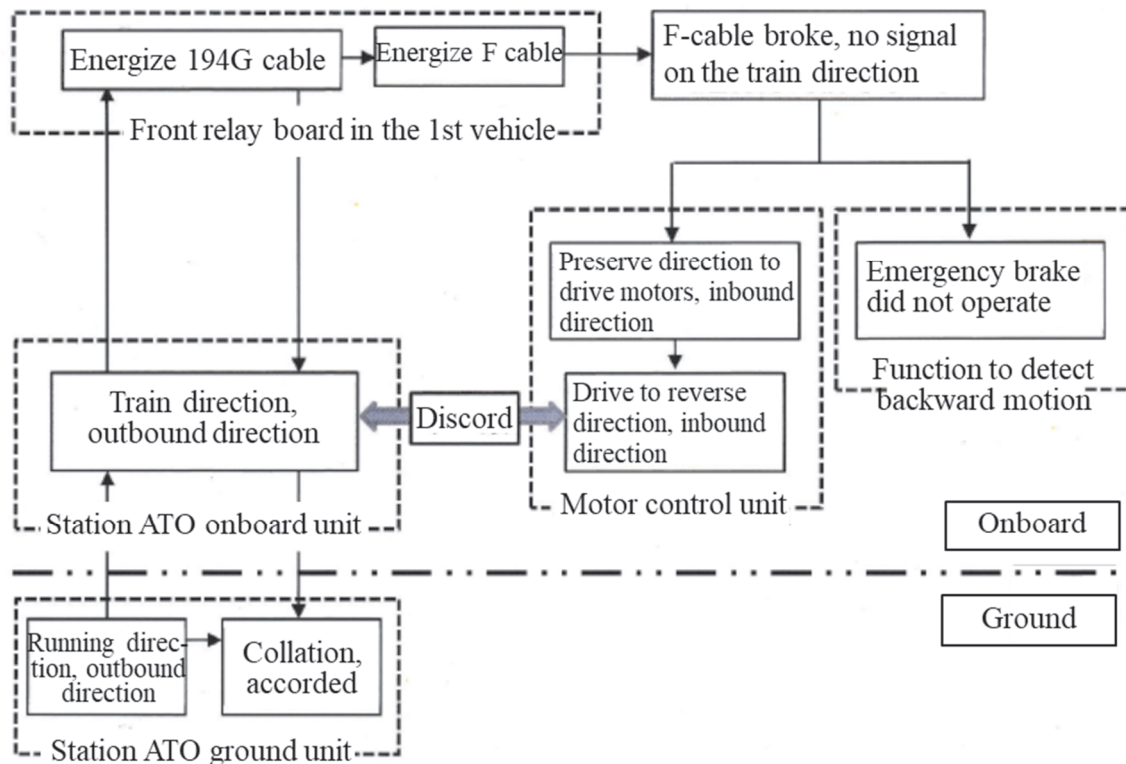
Figure 19. Signal transmission and the recognition in each device in this accident

[3] As the train started in the reverse direction by the process described in [2], the abnormal running was not detected by the function to detect backward running in the ATC onboard unit and the other methods, and the brake did not act until the train collided with the car stop.

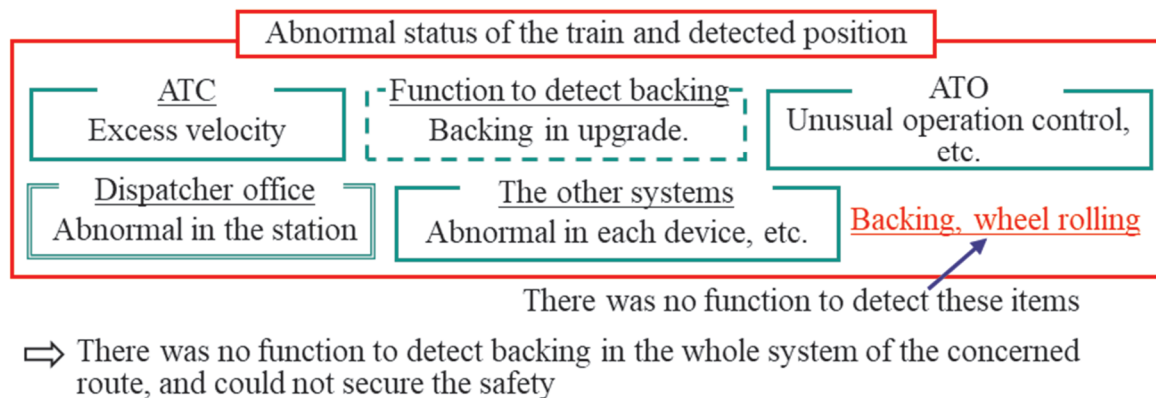
Figure 21. Composition to secure the safety of the 2000 series vehicles

However, the function to detect backward moving of the 2000 series vehicles cannot detect the backward movement when the running direction command has not been inputted as described in 2.8.3, although the 2000 series vehicles are operating by the unmanned operation, and the abnormal status could not be detected in the other system. It is necessary to secure the safety to detect the abnormal status by the function to detect the abnormal status such as the running in wrong direction as in this accident, but it is probable that the function to secure the safety had been insufficient to detect the abnormal status such as the backward running as in this accident. *[Refer to Figure 21]*

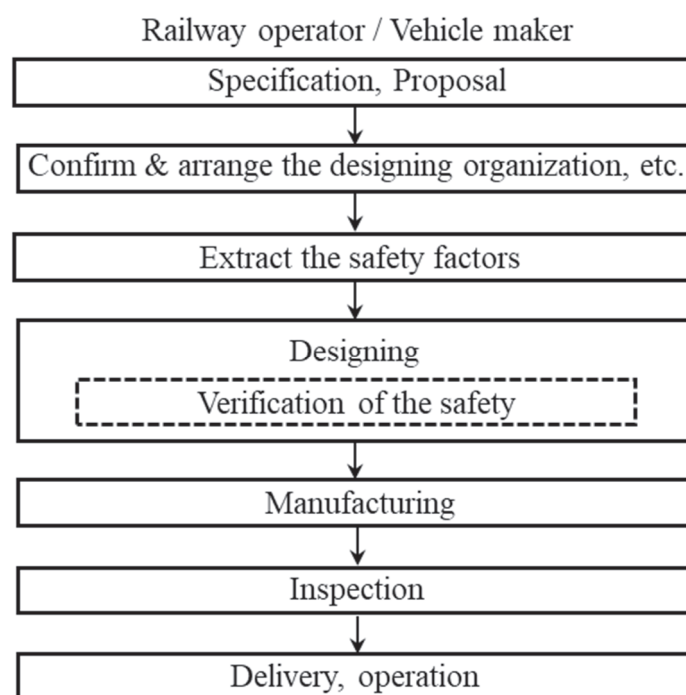
Figure 22. Imaginable design and manufacturing process

Transport and Tourism, 2001, presented in order to realize the safety of the train protection devices, it is considered as necessary to prepare the phases to confirm and coordinate the basic concept and to clarify the sections of responsibility of the related parties, and the phase to adjust the requirements, etc., necessary to secure the safety before implemented the design works, *hereinafter referred to as "the phase to confirm and arrange designing organization", "the phase to extract safety factors", respectively*, and implement the individual phases sufficiently, in the designing and manufacturing processes of the railway and the tramway system. Furthermore, in the final design stage, it is required to prepare the phase to verify the safety of the designed contents, based on the specifications from the customer and the safety factors, etc., coordinated in the phase to extract safety factors, *hereinafter referred to as "the phase to verify safety"*, and implement sufficiently. To summarize the above discussions, a designing and manufacturing process which can be applied to various systems including the vehicles can be imagined, *hereinafter referred to as "the imaginable designing and manufacturing process"*. [Refer to Figure 22]

As confirmed the minute of the meeting for design review for the 2000 series vehicle described in 2.9.3, the manufacturing process, the layout of the onboard devices, the selection of the device manufacturers, etc., were studied in the 1st meeting for design review, and a various matters on the designing and manufacturing of the 2000 series vehicle, such as the body structure, the outfitting, the systems, the layout of the onboard devices, the selection of the device manufacturers, etc., were studied in the following meetings. However, there was no record on the designing organization, such as to clarify the responsible organization to conduct designing between the Company, the vehicle manufacturer and the device manufacturer, and on the confirmation and the coordination of the specification which are considered as the standard, or recognized as general for each device in each company. In addition, in the meetings, etc., held before the design works of the 2000 series vehicles were started, the matters required the attention in the designing and manufacturing works were not adjusted sufficiently. That is, it is probable that the concrete design works had started without confirmation and coordination of the designing organization and sufficient extraction of the safety factors.

the train which the driver did not boarded, it is necessary to prepare the phase to "confirm and coordinate the designing organization, etc.", the phase to "extract safety factors", the phase to "verify the safety", and implement each phase sufficiently, referring the designing and manufacturing process shown in Figure 22.

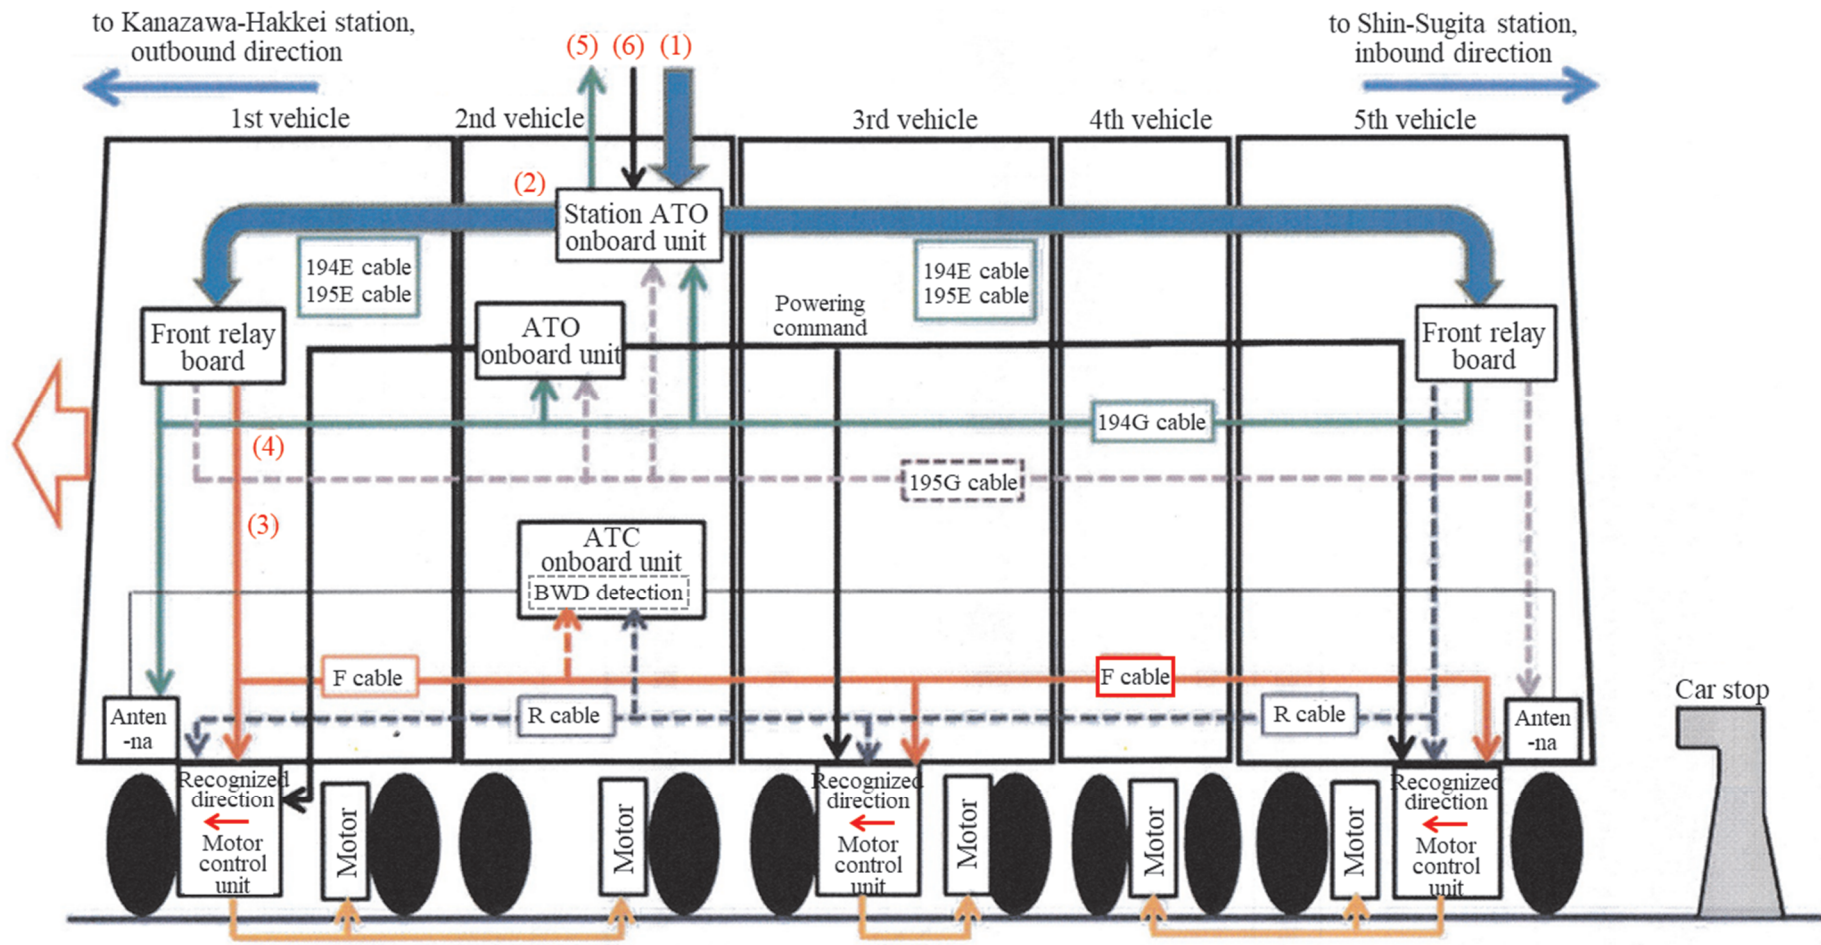
Attached Figure 4. Control Flow of the Onboard System When Changed the Running Direction

Next, the station ATO onboard unit, received the instruction on running direction from the station ATO ground unit, and energize<sup>\*19</sup> the 194E cable or the 195E cable if the running direction is outbound or inbound, respectively, as shown in Attached Figure 4 (2). The front relay board<sup>\*20</sup> mounted on the 1st and the 5th vehicles, set up the 1st vehicle or the 5th vehicle as the front vehicle, when the 194E cable or the 195E cable is energized, respectively, furthermore, energize the 194G cable, which is the command cable to change over the driving desk<sup>\*21</sup> wired through in the trainset, and the F cable, which is the command cable to transmit the running direction of the train to the motor control device and the function to detect backing operation in the ATC onboard unit when the running direction is outbound, or energize the 195G cable and the R cable when the running direction is inbound, as shown in Attached Figure 4 (3) and (4). Here, as described in 2.8.1, the command on the running direction by the F cable and the R cable were the command on the running direction of the vehicle, then there is the case as different from the actual running direction of the train.

station ATO onboard unit switches the energizing statuses of the 194E cable and the 195E cable, as the results, the energized statuses of the F cable and the R cable are reversed. Furthermore, the signal of the onboard antenna for the ATC/TD switches according to the energized status of the 194G cable and the 195G cable, as to activate the 1st vehicle when the running direction of the train is outbound or to activate the 5th vehicle when the running direction of the vehicle is inbound. When the side doors of the vehicles and the platform gates are in the closed status in the scheduled departure time, the station ATO ground unit transmits the departure instruction to the station ATO onboard unit, as shown in Attached Figure 4 (6), then the train start running. [Refer to Attached Figure 3 and 4]
