RA2021-1-II

RAILWAY ACCIDENT INVESTIGATION REPORT

**Train derailment, accompanied to the level crossing accident,
in the premises of Kanagawa-shimmachi station,
Main Line, Keikyu Corporation**

February 18, 2021

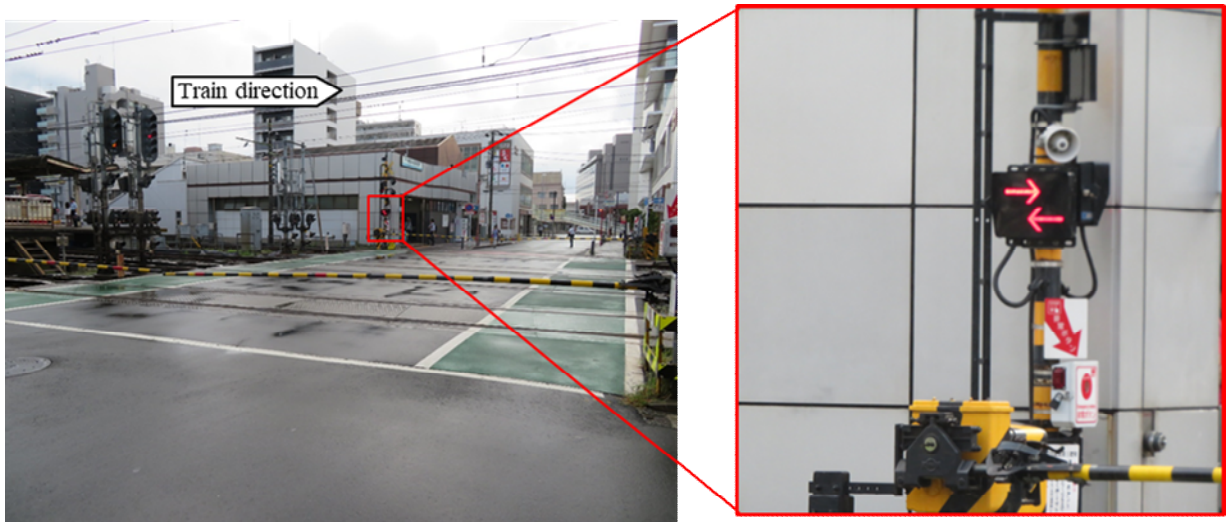
Figure 2. Train direction indicator in the Level crossing

The train direction indicator, shown in Figure 2, was attached to the prop for the road warning device in the Level crossing, and the red arrow lamp to indicate the direction of the approaching train, turns on while the road warning device is in the warning operation.

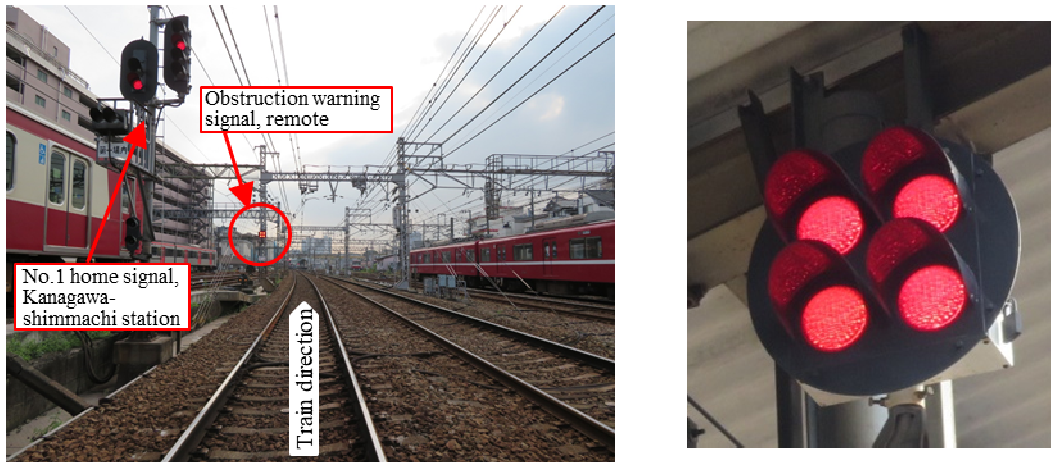
Figure 5. Installed status of the remote OWS, left, and display in the middle OWS, right.

Three OWSs against the outbound train were installed for the Level crossing, and the remote OWS, the middle OWS, and the close OWS were installed in the positions at 19,574 m, 19,837 m, and 19,962 m, respectively. Additionally, the function to back up the driver, such as to cooperate with the safety system of the automatic train stop device, etc., was not added to the OWD in the Level crossing in order to stop or decelerate the train when the stop signal was indicated against the train due to the detection of obstacle by the obstruction detection device for level crossing or the operation of the operating device, *i.e.*, the push button.

According to the record on the changed facilities of signaling system of the Company, the OWSs for the Level crossing were installed on September 1981, and the planted positions were not changed after installed, according to the Company.

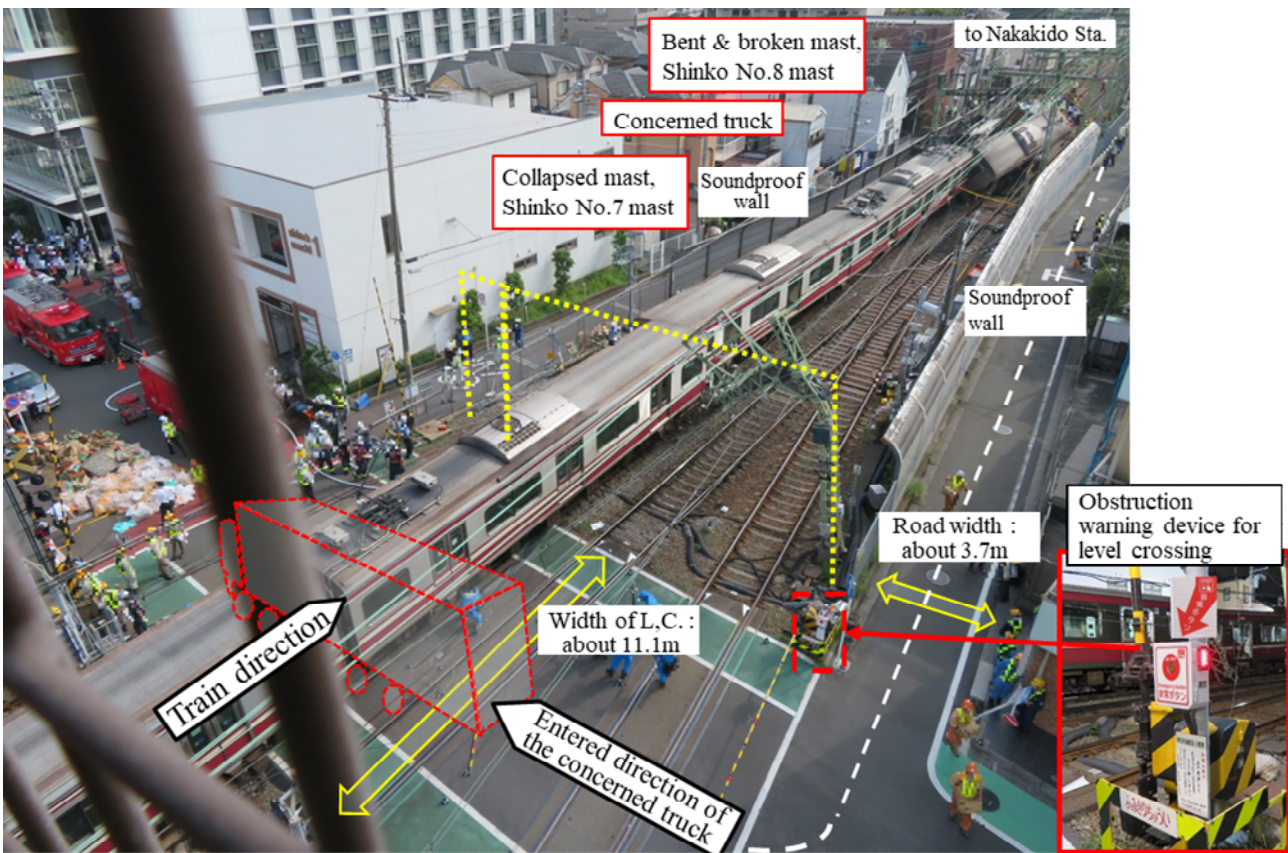
Attached Figure 4. Status of around the accident site

The Shinkou No.1 column, at 19,979 m, supporting the overhead contact lines, etc., planted in the direction to Nakakido station of the Level crossing, had collapsed, and the Shinkou No.8 columns, at 20,023 m, had bent and damaged. The overhead contact line was broken and the support of the contact line was bent by the collapsed mast, etc.

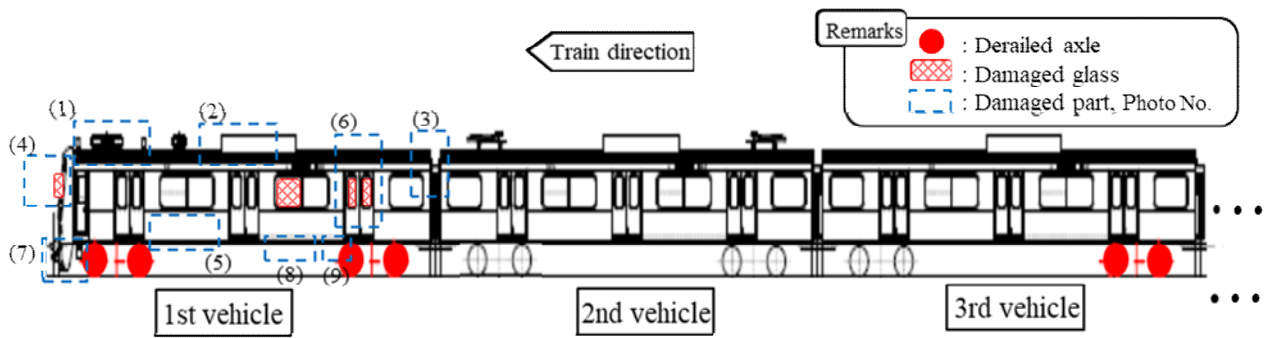
Attached Figure 7. Damaged Status of the Vehicle [1]

The front window glass, the antenna of train radio, the air conditioner, the front skirt, the underfloor equipment, the end part of the vehicle body, etc., were damaged.

Damaged status of the 1st vehicle

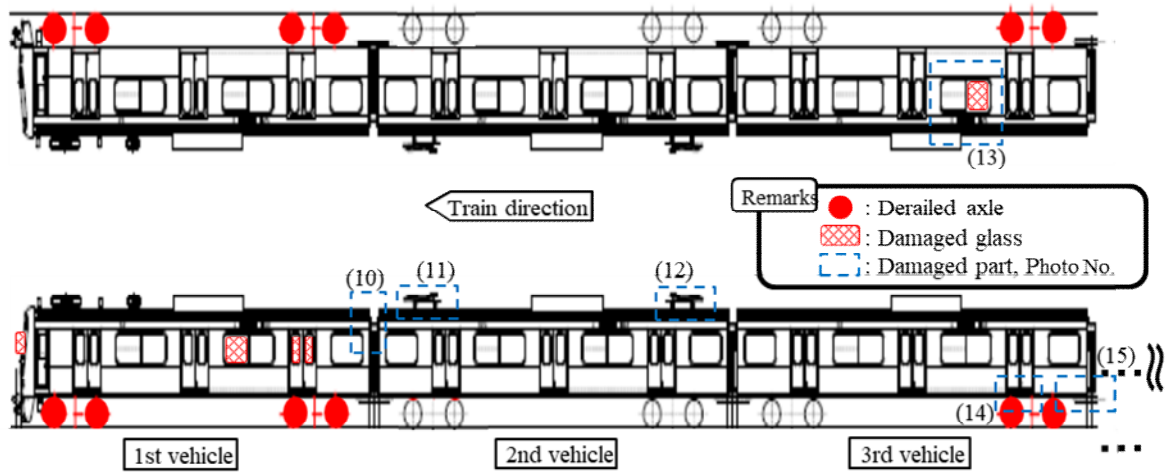
Attached Figure 7. Damaged Status of the Vehicle [2]

The pantograph and the end part of the vehicle body were damaged.

Damaged status of the 2nd vehicle
