RA2022-2-I

# **RAILWAY ACCIDENT INVESTIGATION REPORT**

**Railway accident with train derailment in the premises of Aoto station,  
Main Line, Katsushika City, Tokyo Metropolitan,  
Keisei Electric Railway Co., Ltd.**

Railway operator	Keisei Electric Railway Co., Ltd.
Accident type	Train derailment
Date and time	About 10:16, June 12, 2020
Location	In the premises of Aoto station, Main Line, Katsushika City, Tokyo Metropolitan

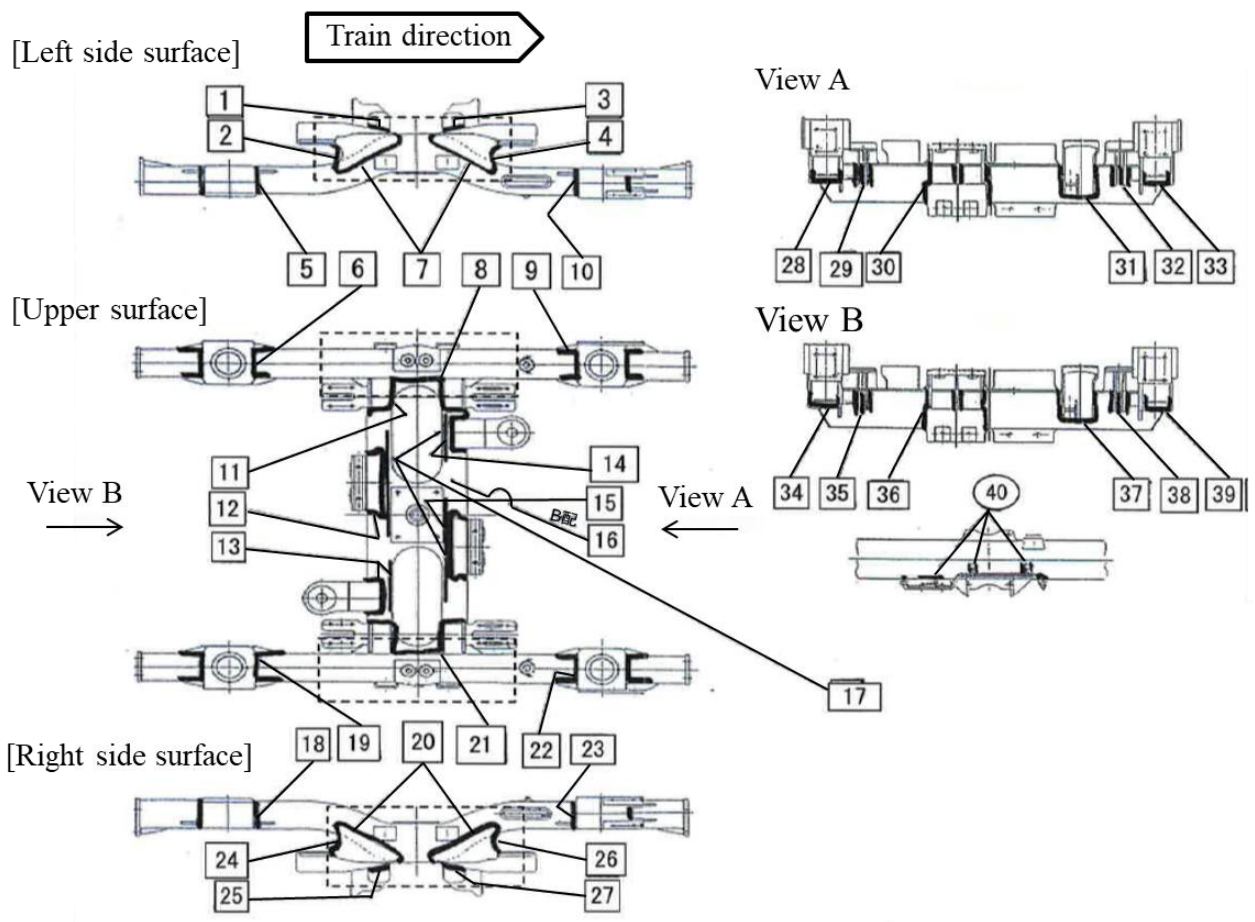
Figure 2. Places for the flaw detecting inspection in the bogie frame

Concerning to the bogie frames, it is prescribed to conduct the visual inspection for the portions indicated by the circled number, and to conduct the magnetic particle inspection<sup>\*12</sup> for the portions indicated by the squared number, shown in Figure 2, after removed from the bogie in the critical parts inspection and the general inspection. The area surrounded by the dotted line in Figure 2, was the place where added to conduct magnetic particle inspection for the entire side beam in addition to the portions indicated by the squared number, referring the past incidents of crack generation in the other company<sup>\*13</sup>. Furthermore, the conducted status of magnetic particle test was checked after the occurrence of this accident, and found that it had been conducted for the circumference of the entire side beam.

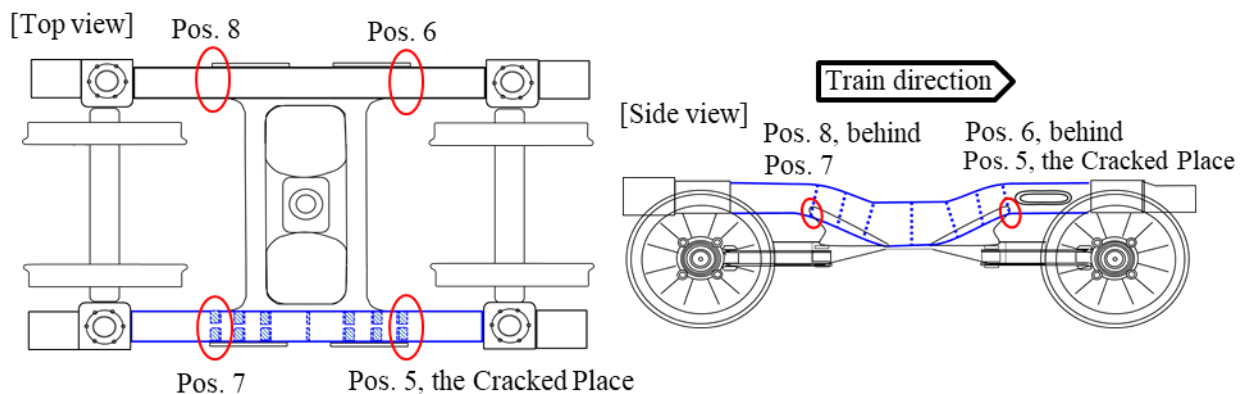
Figure 3. Definition of the positions in the side beam of the Bogie

The positions in the side beam of the Bogie were defined as that, front right is the Pos. 5, front left is the Pos. 6, rear right is the Pos. 7 and rear left is the Pos. 8, as shown in Figure 3.

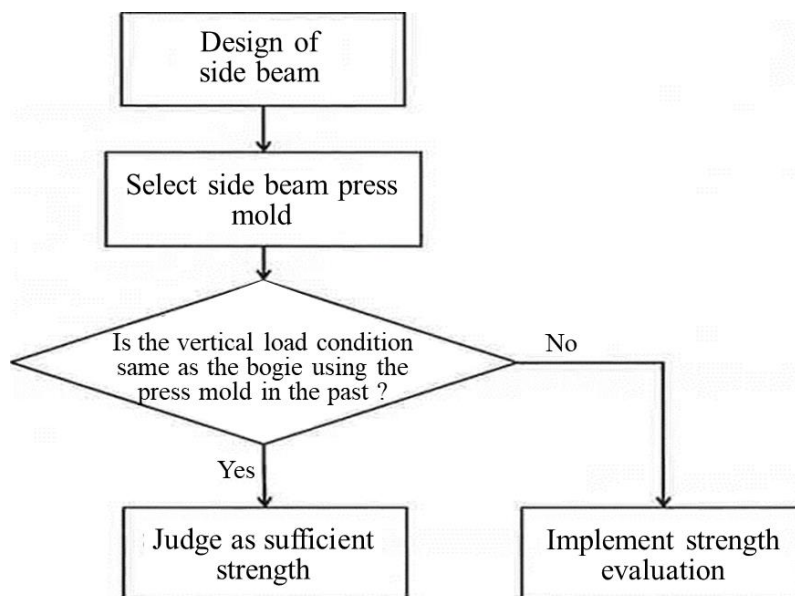
Figure 10. Flow to judge the implementation of strength evaluation of the side beam

implement the strength evaluation had been judged by the size of the vertical load, *i.e.*, whether the vertical load is the same level or not compared with the past bogie types using the press mold to be adopted, as shown in Figure 10.

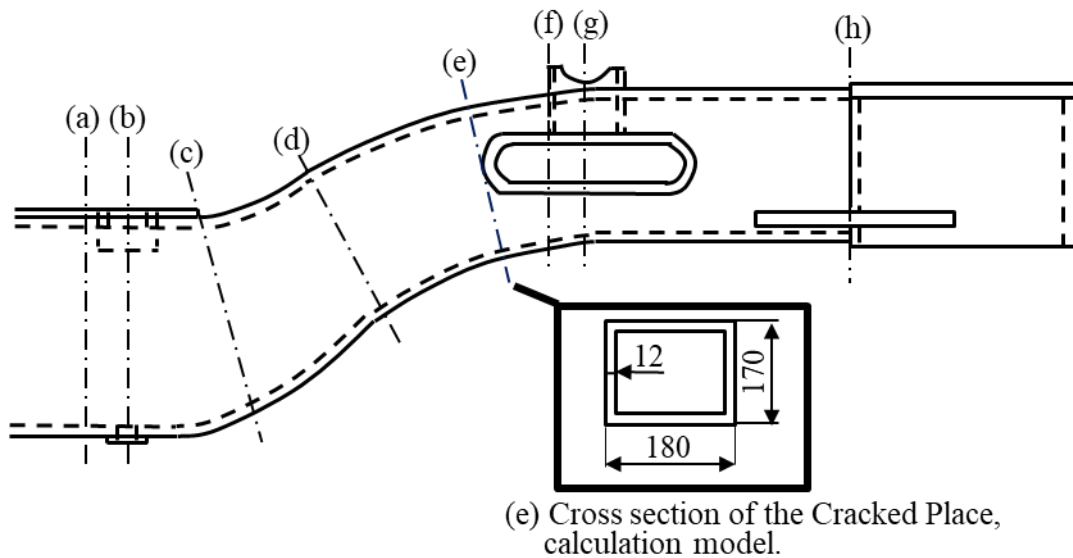
Figure 11. Rough figure of the side beam for the strength calculation, used when designed the Side Beam.

- (3) The adopted side beam press mold was the type used in the bogie type for the other company which had started operation in 1967. The strength estimation was implemented as to calculate the stress for the designed maximum vertical load based on the cross section coefficient for the major cross sections (a) to (h) in the side beam as shown in Figure 11, and obtained the result that the maximum stress was 106.3 MPa in the cross section (d). Then it is judged as no problem considering the total amplitude of fatigue limit 108 MPa for the yield stress 216 MPa of the SS41, which was the material used when designed, as the allowable value. The cross section corresponded to the Crack was the cross section (e), and its calculated results of the stress was 82.4 MPa.

The strength design and the evaluation considering the stress concentration for the weld end edge, etc., was not implemented.

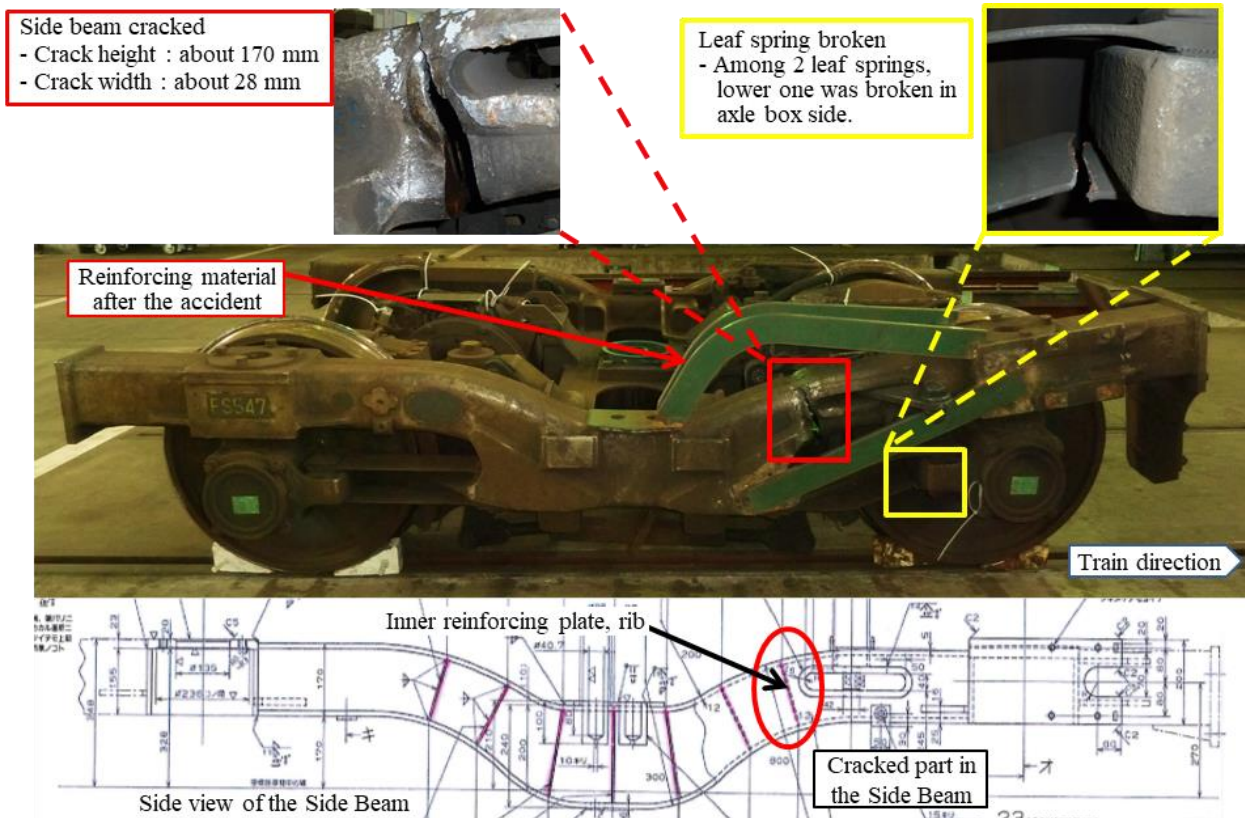
Attached Figure 6. Rough Drawing of the Bogie

In addition, the Bogie was checked after this accident, and found that there was the crack in around the through hole for the brake lever in right side beam of the bogie frame, *hereinafter referred to as "the Crack", and "the Side Beam", respectively*. In addition, the leaf spring in lower part of the Side Beam had been broken, *hereinafter referred to as "the Leaf Spring Breakage"*, other than the Crack but there was no abnormality in the other vehicle body

suspension device such as the axle box suspension device, the air spring height control device, etc. *[Attached Figures 5, 6]*
