**RAILWAY SERIOUS INCIDENT
INVESTIGATION REPORT**

**Vehicle damage of West Japan Railway Company
In the premises of Nagoya station, Tokaido Shinkansen**

March 28, 2019

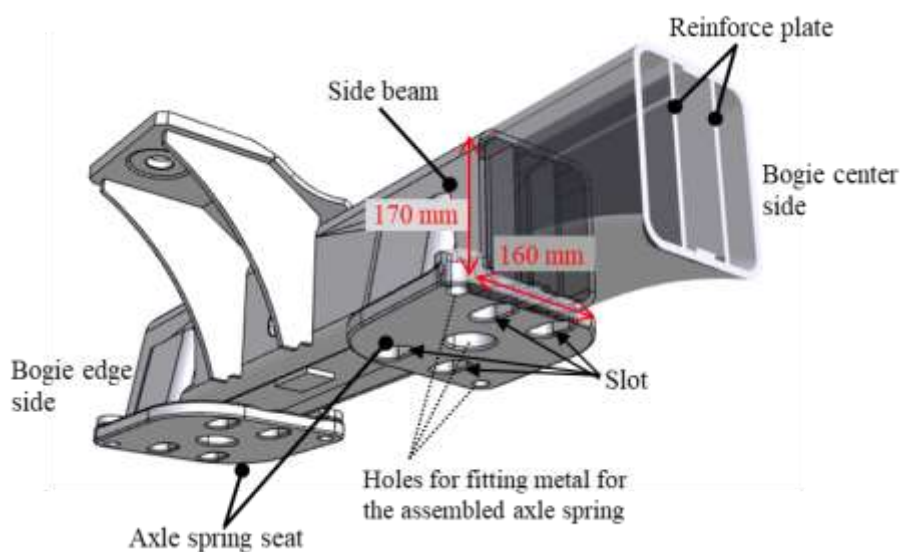
Figure 2. Appearance of a Part of the Side Beam

The structure of the side beam was as follows. The rolled steel for welding structure of 8 mm thick, which is the nominal thickness in the Japanese Industrial Standard, *hereinafter referred as "the JIS standard"*, was bent into U-shape cross section parts by the press machining and being attached the reinforce plate to inside of the U-shape by welding. Then, the two U-shape cross section parts were assembled as to face each other and unified by welding to make the side beam having the rectangular shaped cross section.

The size of the cross section of the side beam was 170 mm in height, *i.e.*, vertical direction, and 160 mm in width, *i.e.*, direction of sleepers, at the place where the crack had generated. The axle spring seats to attach the assembled axle springs were attached in 8 points for each bogie frame, by the fillet welding^{*6} to the bottom surface of the side beam in the circular part of the slotted holes of 55 mm long and 30 mm width, *hereinafter referred to as "the slot"*, in 4 points in each axle spring seat, *Hereinafter the welding method of this type was referred as "the slot welding"*.

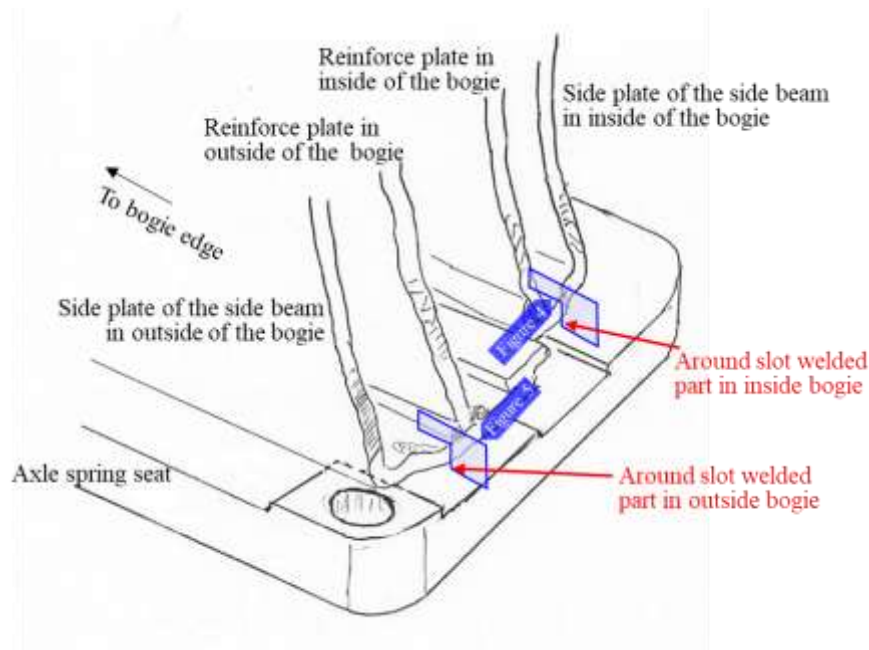
Figure 3. Cutting Positions of the Side Beam and the Axle Spring Seats

The originated point of the concerned crack was estimated as in around the slot welded part where the axle spring seats were attached to the bottom plate of the side beam, as described in 2.4.2.1. Therefore, the composition of the cross section of the concerned crack was observed by cutting the side beam and the axle spring seats at the central positions of the slot welded parts in inside and outside of the bogie in the direction of rail at the position shown in Figure 3

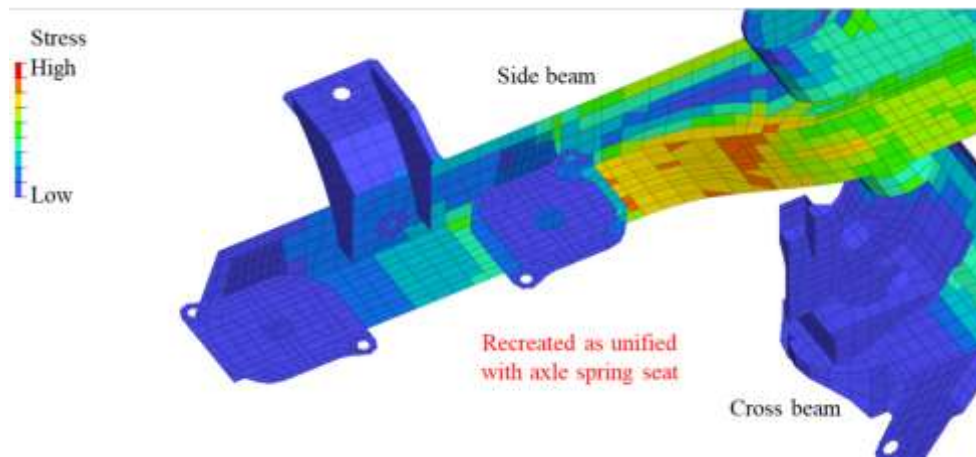
Figure 7. The model of the FEM analysis in the design stage and the results

Status of the strength analysis, when the bogie of the same structure as the concerned bogie was designed, were as follows. The model of the bogie frame used in the FEM analysis in the designing stage of the N700 series vehicle, *hereinafter referred to as "the model when designed"*, and the results of the analysis were shown in Figure 7.

- (1) The model when designed was mainly composed of the plate elements, *i.e.*, the shell elements^{*26}, which is the popular modelling method for the bogie frame also using at present.
- (2) In the model when designed, the area where the axle spring seat was attached to the bottom surface of the side beam, was the single plate of 23 mm thick, which was the total of the designed thickness of the bottom plate of the side beam, *i.e.*, 8 mm, and the designed thickness of the axle spring seat, *i.e.*, 15 mm.
- (3) According to the calculated results of the FEM analysis using the model when designed, the large stress was not generated in the position corresponded to the concerned slot welded part for all loading conditions considering the loads in vertical, lateral, front and rear directions generated during train running.

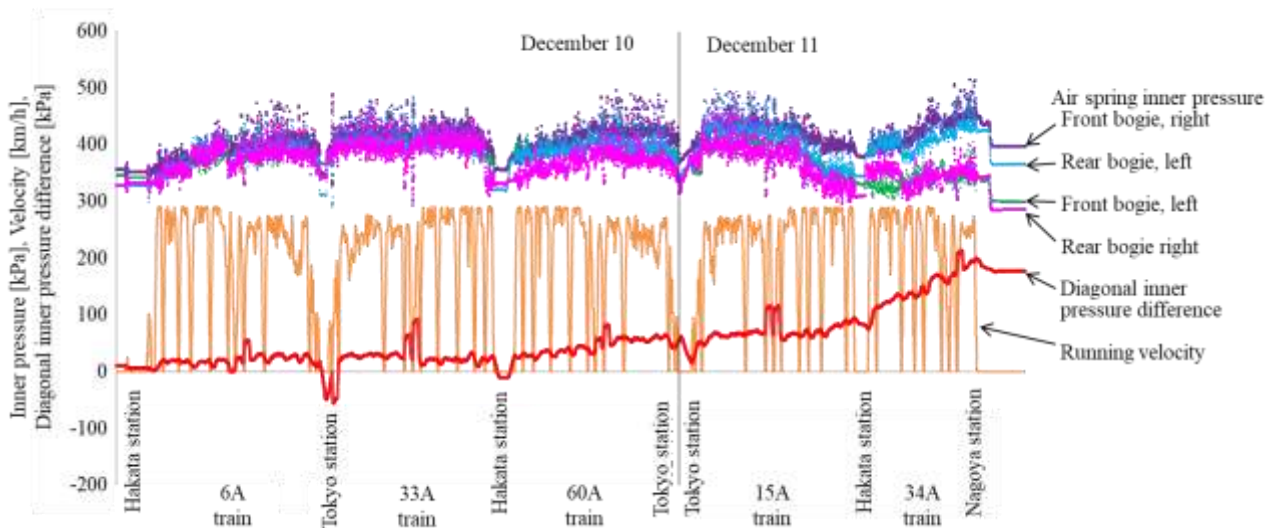
Figure 10. The diagonal inner pressure difference of air springs in the concerned vehicle

force at that place, the inner pressure of the neighboring air spring would decrease. As the vehicle body was suspended by the air springs located in four points, it is supposed that the loads acting on the air spring nearest to the damaged place and the air spring in the diagonal place decreased and cause the decrease of their inner pressures, on the contrary, the load acting two air springs in the inverse side diagonal positions increased and their inner pressures also increased.

In order to confirm the above trends, using the records of inner pressure of the air spring in the data recording device of the concerned vehicle, the summation of the inner pressures of the air springs in left of the front bogie where the concerned crack had generated and in right of the rear bogie, *i.e.*, in diagonal position, was subtracted by the summation of the inner pressures of the air springs in the inversely diagonal positions, *i.e.*, in right of the front bogie and in left of the rear bogie, *hereinafter calculated value was referred to as "the diagonal inner pressure difference"*. The relationships of the operating status of the concerned vehicle and the inner pressures of the air springs, the diagonal inner pressure difference, which was the moving average for 10 minutes, and the running velocity, were shown in Figure 10.

Note : The diagonal inner pressure difference is the moving average for 10 minutes.

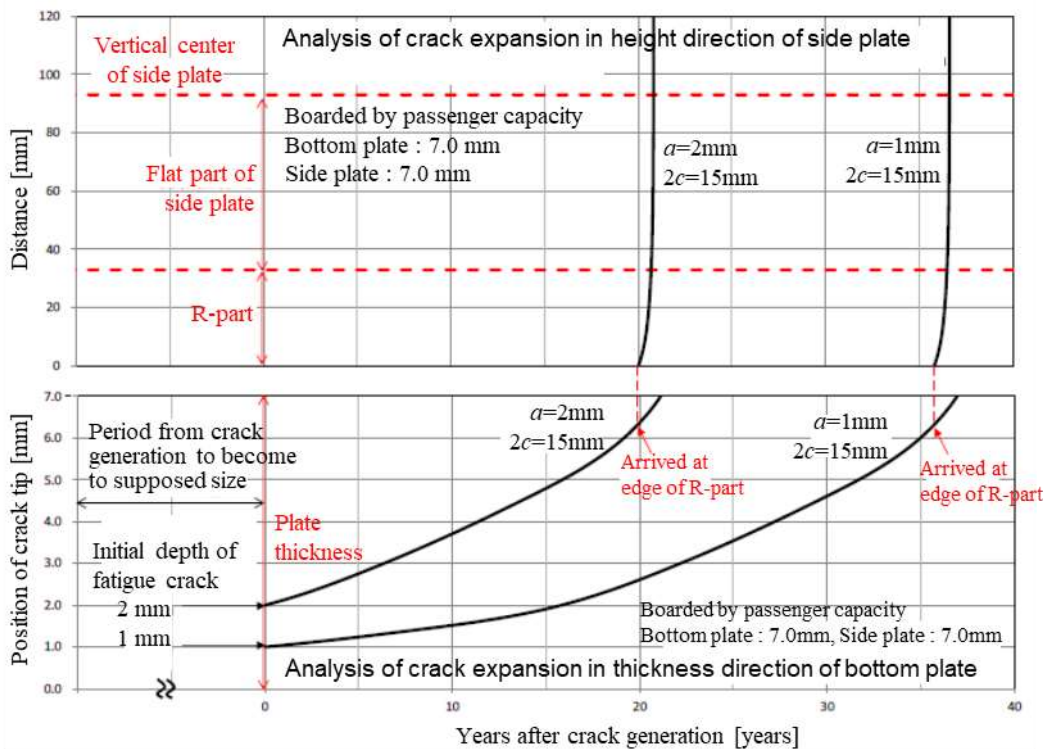
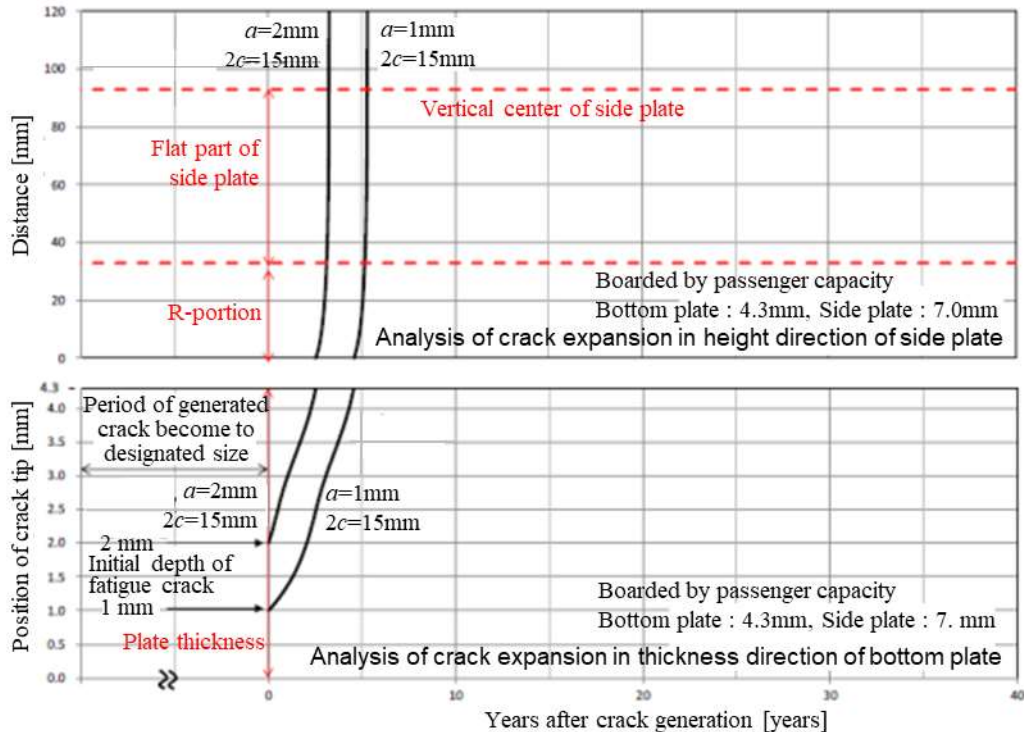
Attached Figure 12. Results of the Simulation Analysis for Expanding Fatigue Crack

* "2c" is the initial width of the fatigue crack, "a" is the initial depth of fatigue crack, in above (a) and (b)

* Years from crack generation was obtained using the stress frequency data measured in the running test using commercial vehicles and converted to the repeated number of loading per year by the average running distance, corresponded to 600,000 km per year.

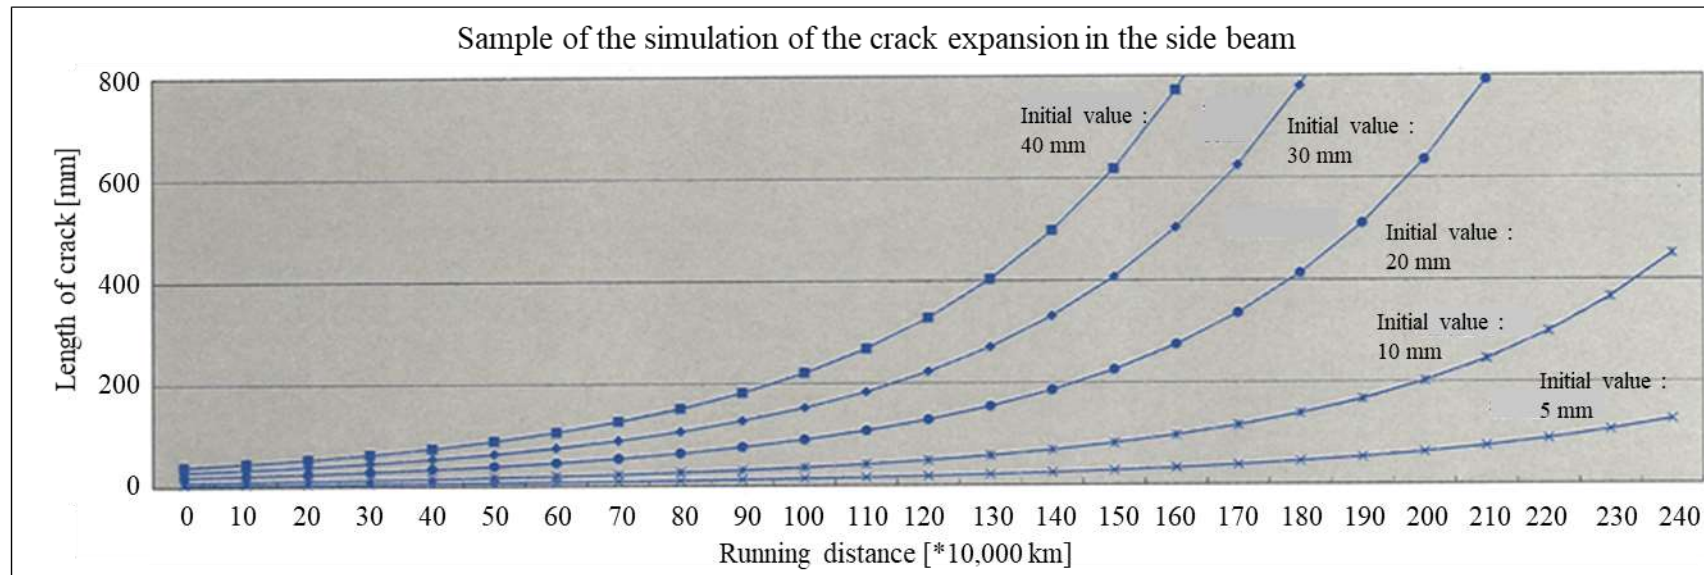
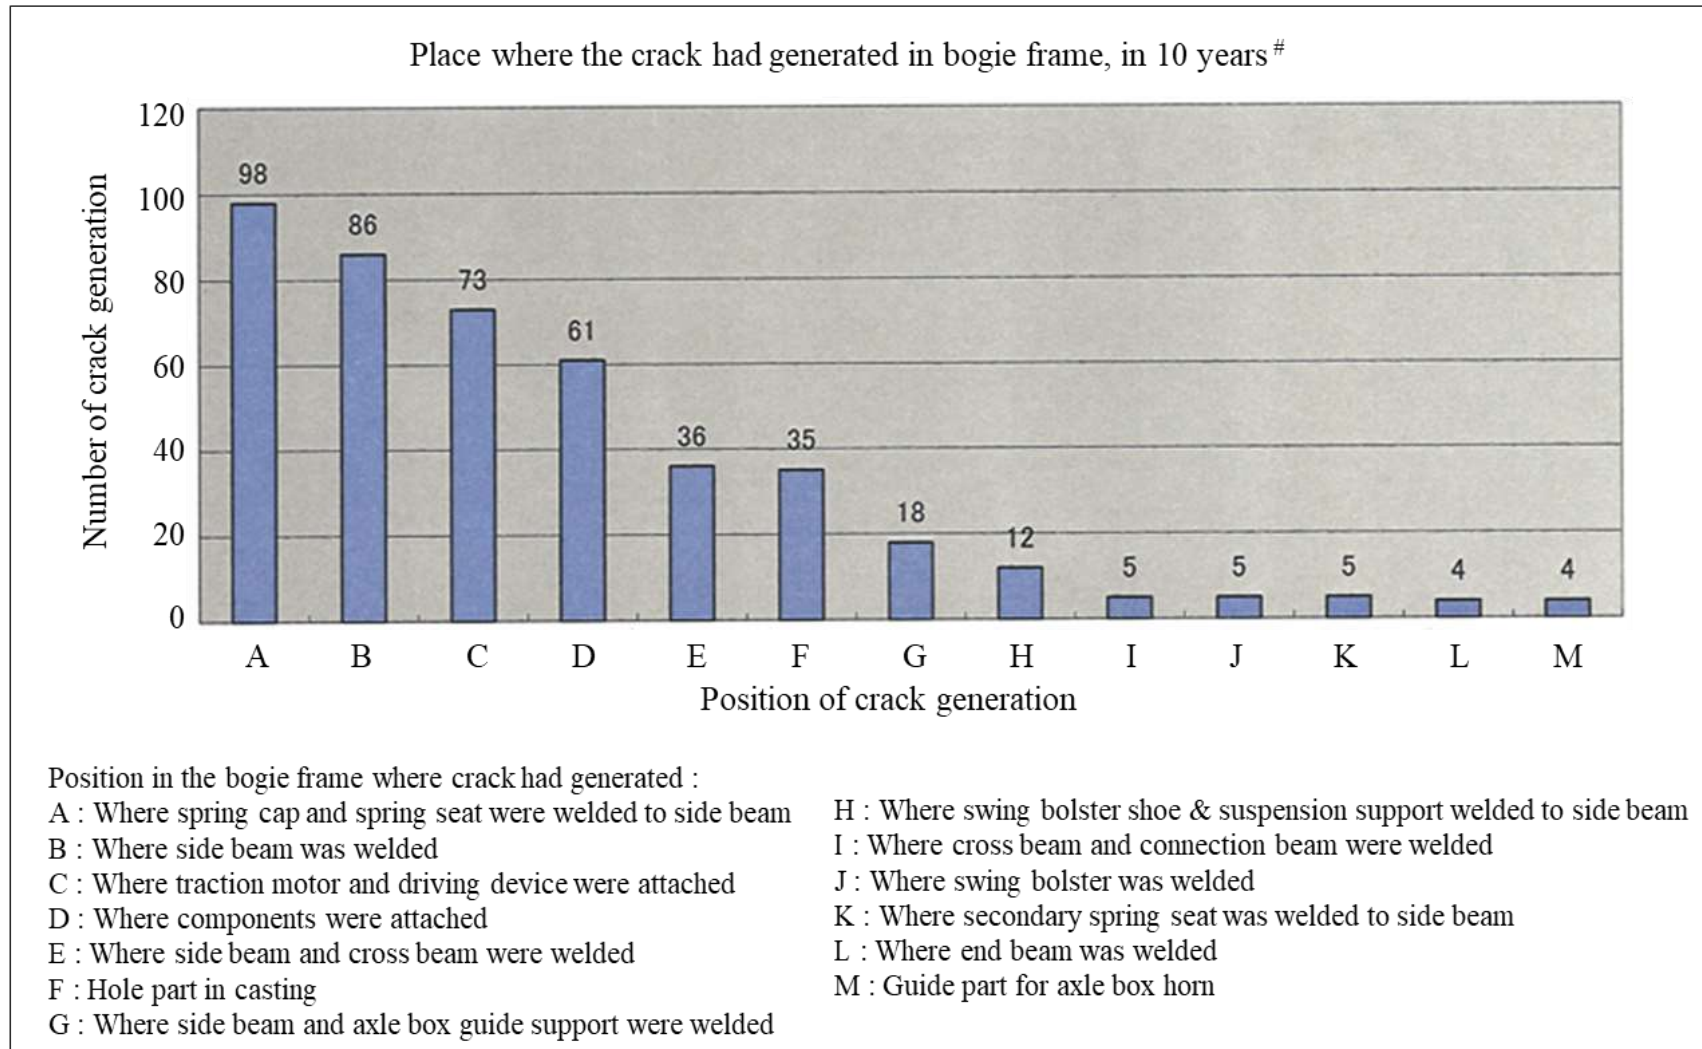
"Length to start plastic deformation" is the length that the fatigue crack expanded to the plastic deformation and corresponded with about 70 % of the circumference of the side beam.

According to the result of the simulation, over 1,500,000 km train running is required for the 40 mm long crack expand to the plastic deformation, about 600 mm. Here, the simulation was based on the results in the time when the inspection manual for the bogie frame was decided.

Calculated based on the data investigated to decide the inspection manual for bogie frame, in April, 2000.
