# FLANGE-CLIMB DERAILMENTS OF FREIGHT TRAINS ON CURVED TRACKS DUE TO ROLLING

Akira MATSUMOTO<sup>1</sup> and Yohei MICHITSUJI<sup>2</sup>

<sup>1</sup> Japan Transport Safety Board (JTSB)  
2-1-2 Kasumigaseki, Chiyoda-ku, Tokyo, 100-8918 JAPAN

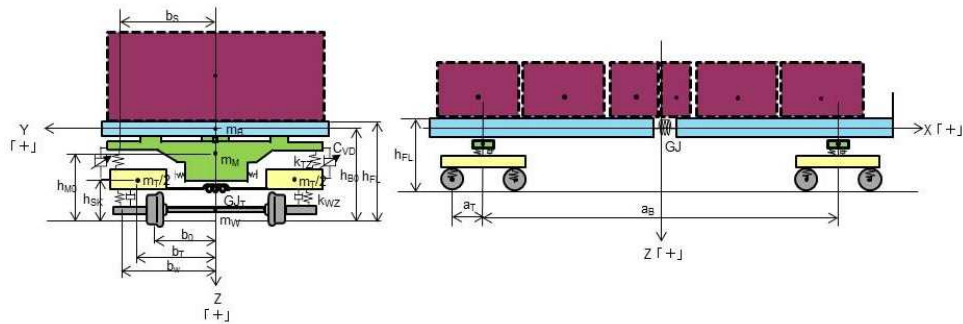
Fig. 1 Simulation model

Multibody simulations by SIMPACK were carried out, considering the conditions of suspension, loading freight, track irregularity, running speed, etc. The simulation model is 46 degree of freedom of the car body of a freight wagon with empty/half-loaded/full -loaded containers, as shown Fig.1. The car body can twist at the center of body frame with actual stiffness. The simulation model have been verified by the comparison between running tests around the accident sites and simulation results.

The characteristics of vertical dampers, which are different between “empty” and “loaded” conditions, is considered in the simulation. The track irregularity is given according to the measured data just before the accidents.
