Chapter 4 Marine accident and incident investigations

1 Marine accidents and incidents to be investigated

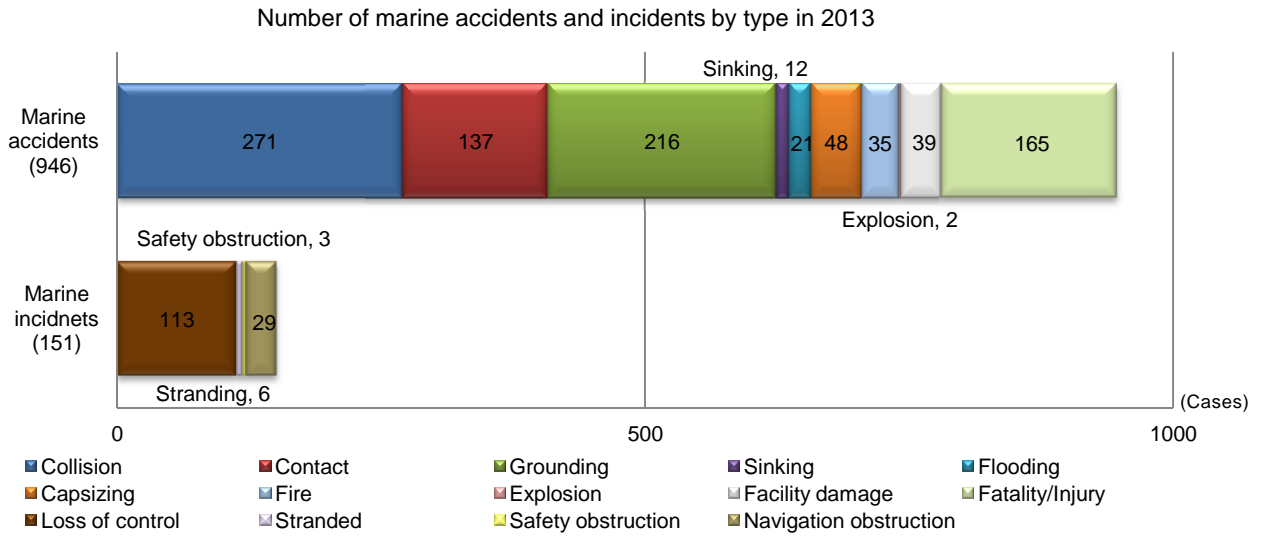
The 1,097 investigations launched in 2013 are classified by types as follows: With regard to marine accidents, there were 271 cases of collision, 216 cases of grounding, 165 cases of fatality/injury, and 137 cases of contact. With regard to marine incidents, there were 113 cases of loss of control (including 69 cases of machinery failure, 6 cases of rope entangling, etc.), 29 cases of navigation obstruction, and 6 cases of stranded. The objects of contact were quays in 39 cases, breakwaters in 25 cases, and light buoys in 14 cases.

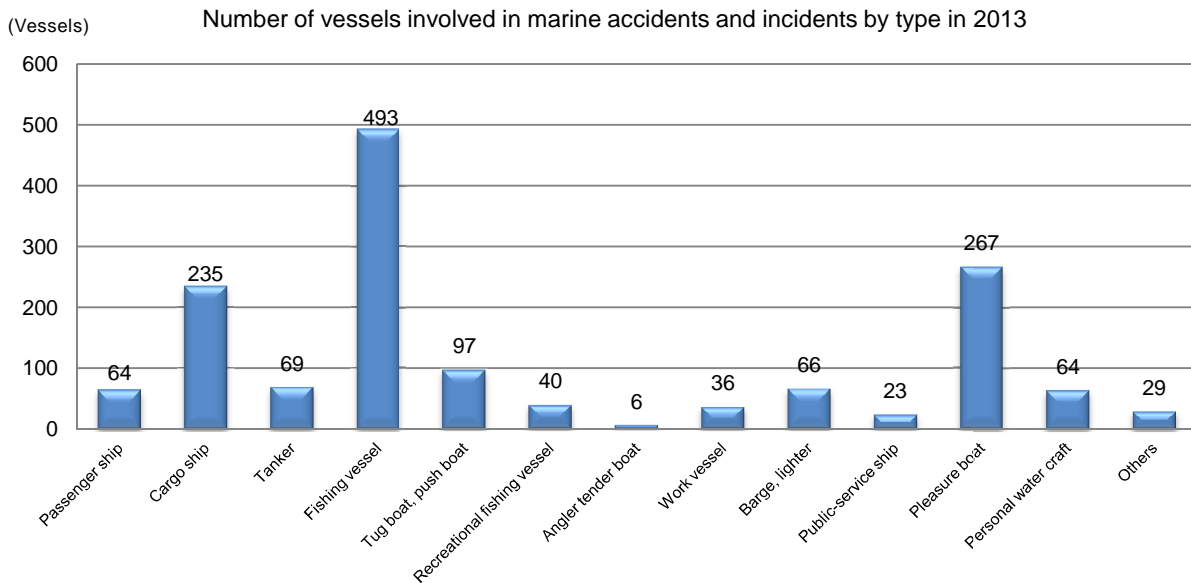
The number of vessels involved in marine accidents and incidents is 1,489. Those vessels are classified by type as follows: 493 fishing vessels, 267 pleasure boats, 235 cargo ships, 97 tug boats and push boats, and 69 tankers. The total of the three categories of fishing vessels, pleasure boats, and cargo

ships is 995, accounting for nearly 70 % of all the accidents and incidents.

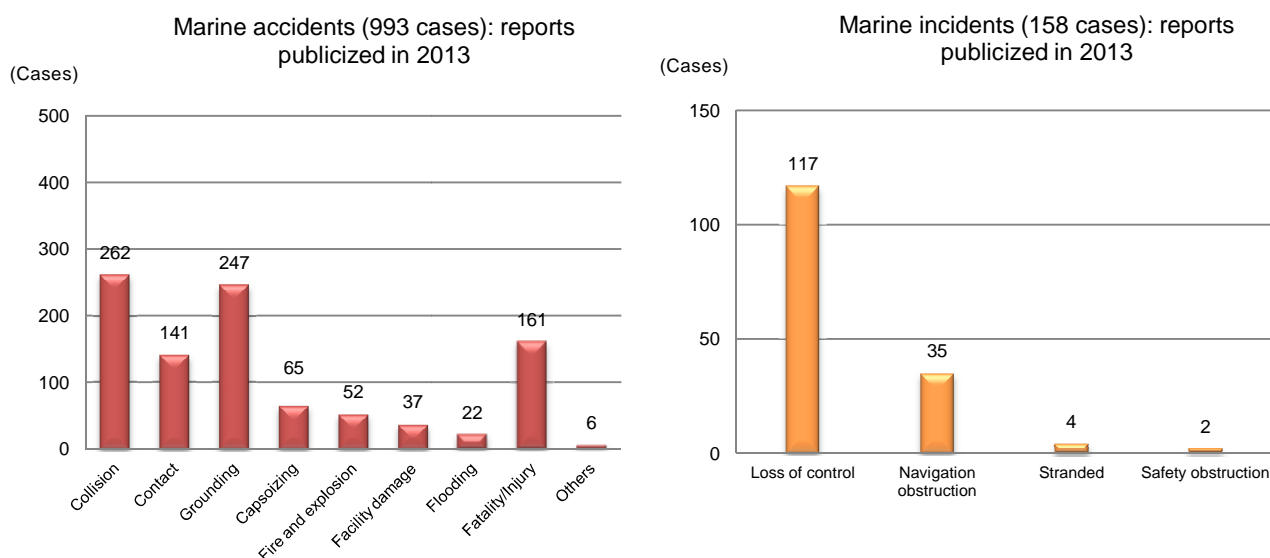
Looking those accidents and incidents by type, there were 262 cases of collision, 247 cases of grounding, 161 cases of fatality/injury, and 141 cases of contact in marine accidents. Whereas in marine incidents, there were 117 cases of losses of control, (including 112 cases of navigational equipment failure and five cases of out-of-fuel), 35 cases of navigation obstruction, and four cases of stranded.

As for the objects of contact, 36 were quays, 21 were breakwaters, and 16 were breakwater blocks.

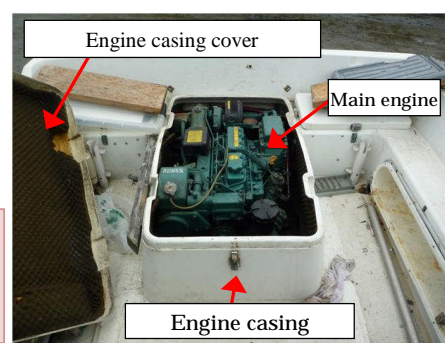
Because the cleaner that was sprayed became vaporized and converted into a flammable gas together with the LPG heavier than the air, it remained inside the engine casing that had no ventilation.

⚠ There was no warning stated on the spray can itself that the gas evaporating from the cleaner is heavier than air and flammable, and that ventilation is necessary as it tends to accumulate in low areas if there is no wind or if used in an enclosed space.

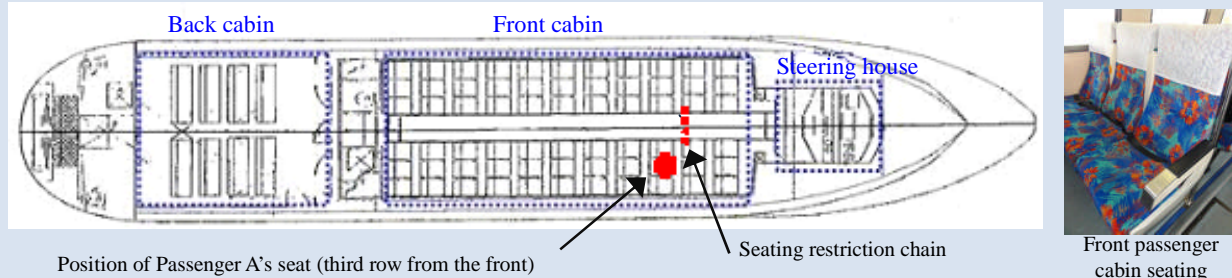
Seating status of Passenger A at the time of the accident

Owner of the ship: Company A, gross tonnage: 19 tons, maximum number of persons: 90 passengers and 2 crew members

- While the master had intended to limit seating by passengers for the front seats of the front passenger cabin where the pitching is likely to be significant, the seating restriction chain was moved from the fifth row to the second row due to the number of passengers.
- The master and deckhand did not guide Passenger A to the back cabin where the pitching is relatively low

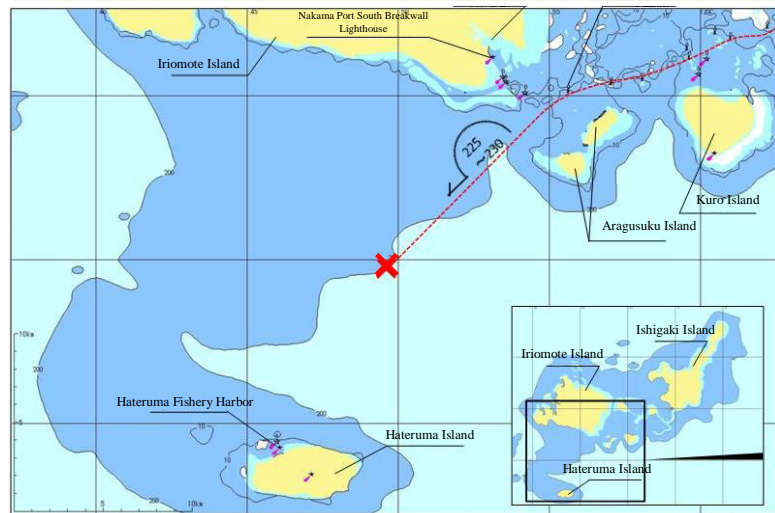
Significant wave height: 1.52m, wave period: 6.5s, wave direction: south-southeast, wind direction: south wind velocity 7m/s

Probable causes: It is probable that this accident was caused by a chain of events in which the ship was sailing south-southwest at a speed of approximately 15 to 20kn in the sea south-southwest of Nakama Port when continuous waves from the south-southeast with a wave height of approximately 1.5m hit the port bow, and because Passenger A was not guided to the back cabin where the pitching is relatively low and Company A did not take measures to ensure that Passenger A properly wore their seat belt, when the vessel's bow rode the high wave crest with a wave height of approximately 2.0m and fell down between the waves, Passenger A's body was lifted up from the seat and the impact on her posterior when falling back on the seat caused a compression fracture in her lumbar spine.
