**Japan Transport Safety Board
Annual Report
2021**

July, 2021

Japan Transport Safety Board

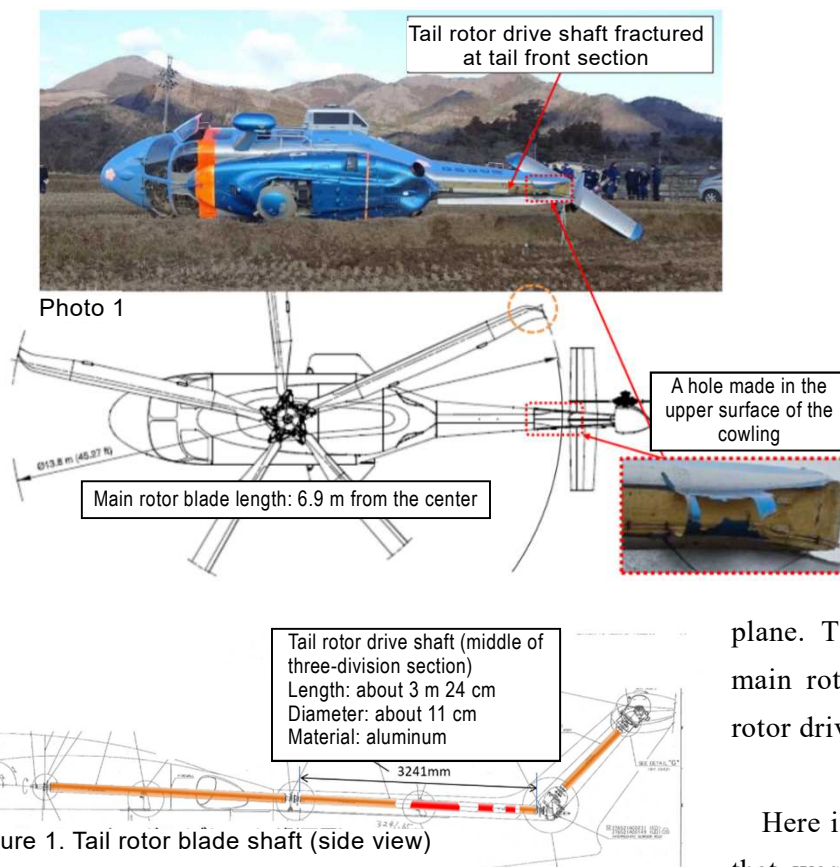
- (1) Regarding the accident investigation of a helicopter that became difficult to control during flight, crash-landed and rolled onto its side in February 2020, the JTSB’s chairperson in a press briefing held in the same month, put forth the possibility that the helicopter’s main rotor blade had impacted the tail rotor drive shaft.

impacted the tail rotor drive shaft. The chairperson explained that helicopter accidents of this kind had also occurred in the past and that they occur due to a combination of the aircraft attitude and a dramatic shift in the angle of the main rotor’s rotational

plane. These factors can cause the main rotor blade to impact the tail rotor drive shaft

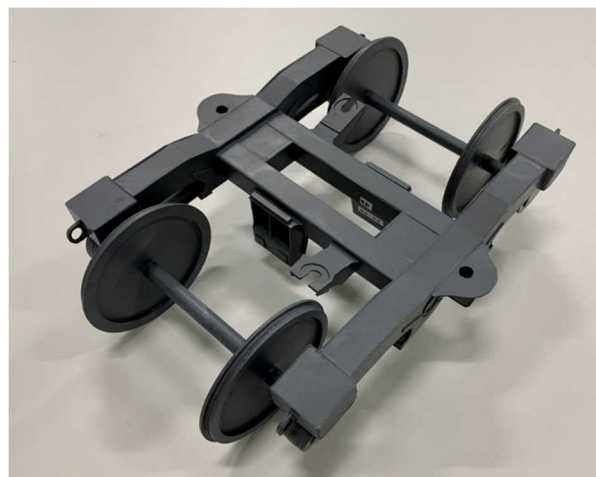
(2) In the serious incident investigation report on a dangerous situation on a railway vehicle (a crack in a bogie) (see page 83, Chapter 4) issued in November 2020, the location where the crack formed was described as “the welded spot connecting the cross beam of a bogie frame with the backside reinforcement rib of a main-motor seat plate.” Because the crack was difficult to identify even using a plan view, railway accident investigators prepared a bogie model, which the chairperson used in a press

Model of bogie

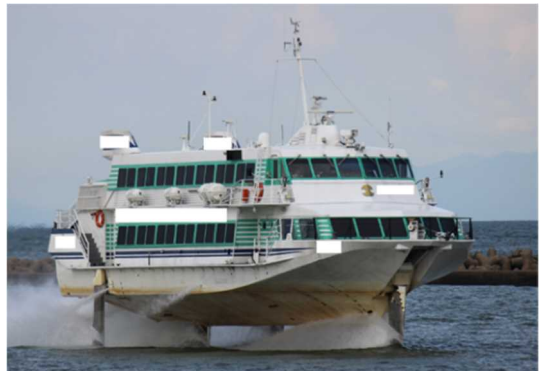
Passenger ship GINGA, with its captain, chief engineer and two crew members as well as 121 passengers, was navigating westward on hydrofoils at about 41.7 knots off the eastern shore of Himesaki, Sado City, Niigata Prefecture on the way to Ryotsu Port also in Sado City, when the ship collided with floating objects at around 12:16, March 9, 2019. This resulted in the injuries of 108 passengers and one crew member.

This accident caused a breach in GINGA's starboard quarter.

It is probable that, after GINGA passed through the deceleration zone located off the eastern coast of Himesaki, it accelerated and headed westward in a foilborne state, when the captain noticed floating objects in the direction of the port bow (front left side) of the ship and attempted to avoid a collision but was not successful. As a result, some objects probably hit the rear hydrofoil wing, resulting in many lumbar fractures among passengers.

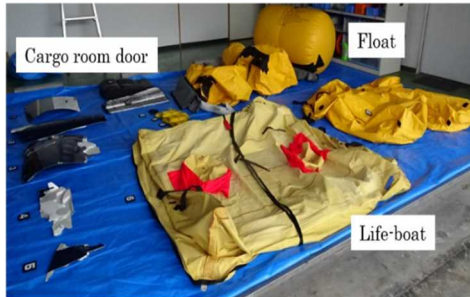
Floating wreckage gathered (Right)

※ “GOV (governor)” denotes a sensing device that senses the rpm of main rotor and engine and automatically controls fuel flow in order to keep main rotor rpm constant

- It is likely that, during the flight, a GOV warning went off, the nose of the helicopter veered rightward, the rpm of the main rotor decreased and the output of the engine dropped.

- The engine’s failure to recover from its low output state was likely due to the manual throttle control (for increasing output) failed, or because adequate fuel flow could not be achieved. In the end, the helicopter subsequently sank into the water and therefore further physical investigations into the causes of the malfunction were not possible.

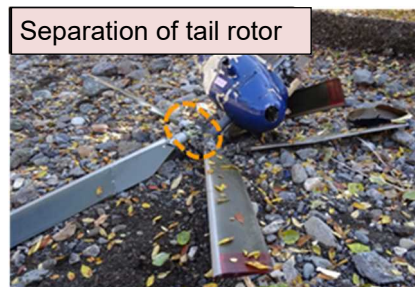
Separation of tail rotor

Fractured spindle bolt

- According to the results of a 10-hour inspection and 50-hour inspection carried out from July to August, 2017, it is likely that the inner rings progressively deteriorated and the flapping hinge of the white blade had frozen.
- It is highly probable that the fracture of the spindle bolt was caused by a frozen component inside the outer ring, which accelerated the cracking of the inner ring and exerted a twisting load to the spindle bolt.
- It is probable that the spindle bolt fracture caused an imbalance of the rotational plane of the tail rotor and its subsequent separation.

It is highly probable that the fractured spindle bolt was caused by damaged and stuck bearings of the flapping hinge. Besides, it is highly probable that this resulted from the fact that the damaged condition of the bearings was not grasped in inspections and maintenance work performed on the Helicopter and the appropriate measures were not taken.

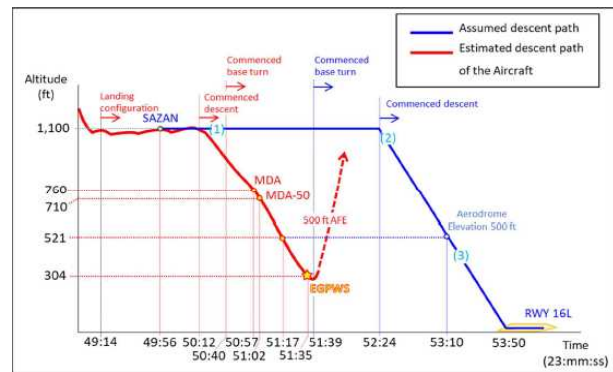
Assumed descent path and estimated descent path of the aircraft

Supplementary note: Landing at 16L via VOR-A approach is very rare—accounting for about 0.04% of the total number of landings in FY2018. Both the PIC and FO never attempted this approach at that time. Neither one had any simulator training for it. An “assumed descent route” means a descending flight route on the assumption of “after flying horizontally along the noise abatement flight course, descending at a normal descent of 3° and then landing on Runway 16L.”

- After passing an altitude of 500 ft, the PIC kept a constant visual confirmation of the runway and continued the approach.
- Tokyo Tower advised the PIC, “Your altitude is too low, confirm that you have 16L insight,” but the PIC could not visually recognize the approach light beacon and also lost sight of 16L.

- When the pilot answered “Negative”, EGPWS warnings “TERRAIN!” went off, so he judged that the aircraft's approach was too low and executed a go-around to avoid collision with the ground.

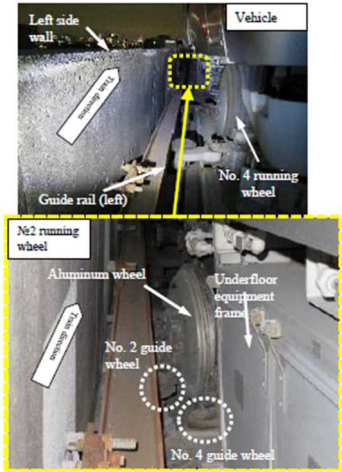
Probable Causes		<p>It is highly probable that the accident have occurred when the air pressure suddenly dropped due to damage to the left tire on the front axle of the vehicle, and the vehicle traveled with the damaged tire, which damaged the Nakago(safety wheel), causing the guide wheels to move off the guide rail downwards and the running wheels to deviate from the track, resulting in derailment.</p> <p>As for the damage to the tire, it is highly probable that the wires of the steel belt broke due to the train running with the inner surface of the tire and the Nakago(safety wheel) in contact due to extreme underinflation of the tire.</p> <p>With regard to the extreme underinflation of the tire, it is probable that the wires of the belt broke because the tire was run with the steel belt exposed due to wear of the tread, and some of the wires reached the inner surface of the tire, causing air leakage.</p> <p>As for the fact that the tires ran with the steel belt exposed due to wear in the tread area, it is probable that the depth of the main grooves was not measured during the temporary inspection, and the tires were not checked for wear during the train inspection, so they continued to be operated without sufficiently checking the situation where the main grooves in the tread area had disappeared due to wear.</p>

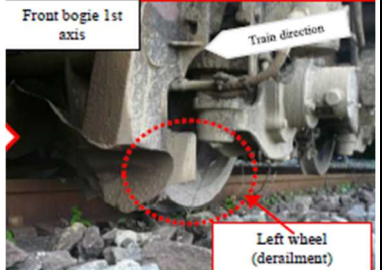
Probable Causes	<p>It is highly probable that the accident caused the train to derail due to the collision of the train with dirt and sand including fallen trees that flowed into the track due to the collapse</p>

<p>of the slope along the railway.</p> <p>Regarding the collapse of the slope, fallen leaves and the like had accumulated in the waterway laid above the collapsed slope, which hindered the water flow function of the waterway, and the water overflowing from this area was discharged to the slope. It is likely that this led to the fact that the surface soil of the slope became unstable due to the increased water content of the soil.</p>		
	Report	<p>https://www.mlit.go.jp/jtsb/eng-rail_report/English/RA2020-3-2e.pdf https://www.mlit.go.jp/jtsb/railway/p-pdf/RA2020-3-2-p.pdf (Explanatory materials (Japanese only))</p>		
	Reference	Case Studies (page 101)		
11	Date of Publication	Date & Accident type	Railway operator	Line section (location)
	October 29, 2020	December 2, 2019 Level crossing accident	Tenryu Hamanako Railroad Co., Ltd.	Tounokisaka level crossing, the class 3 level crossing equipped with road warning device but without automatic barrier machine, in the premises of Nishikajima station, Tenryu Hamanako Line, Shizuoka Prefecture.

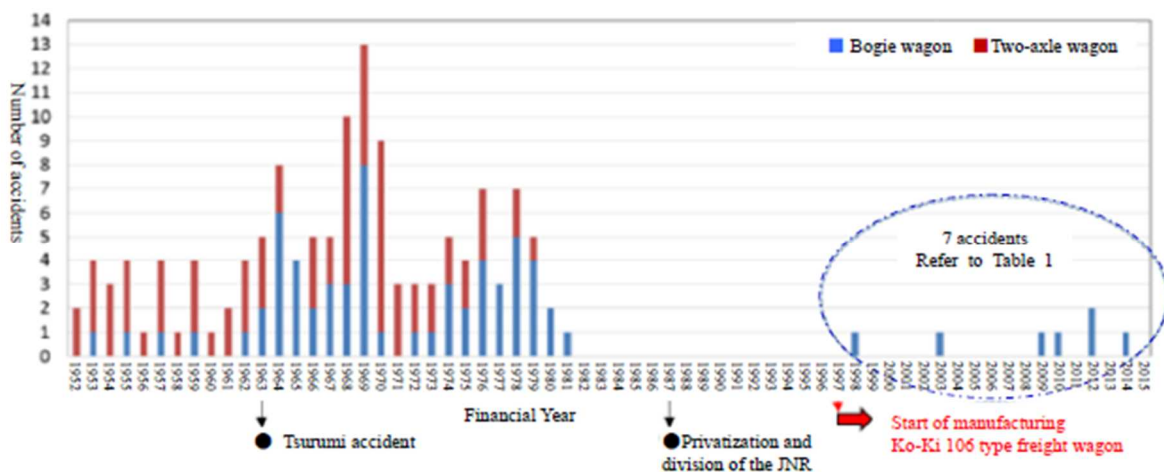
Figure 1 Changes of flange climb derailment and similar derailment accidents of freight wagon

Figure 1 shows the data about flange climb derailment accidents and the similar accidents occurred

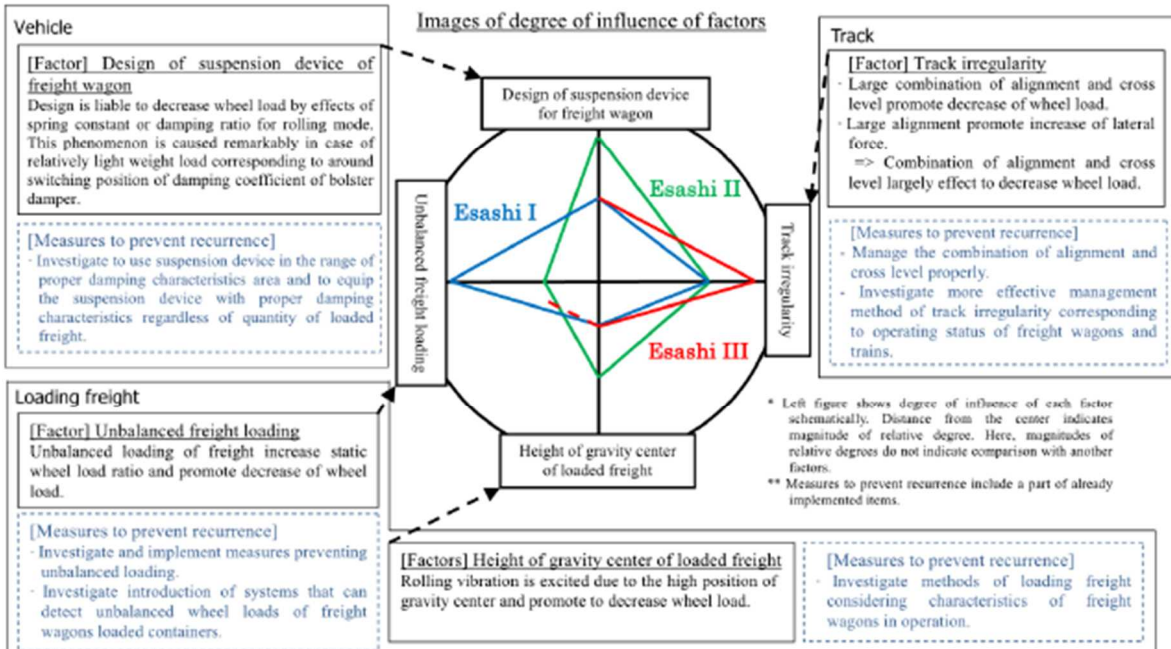
Attached diagram: Factory of the Esashi Line derailment accidents and their degree of influence, etc.

- A series of the derailment accidents of freight trains occurred in Esashi Line have the common situation that the outer rail side wheels of the freight wagon in the freight train running in relatively sharp curve at near the limited speed, derailed by flange climbing.
- It is somewhat likely that these accidents were caused by the combination of the factors such as vehicles, track, and loading freight, etc., in the worse direction, while each factor would not cause the derailment.
- Here, degrees of influence of the factors to a series of derailment accidents differ as shown in the followings.

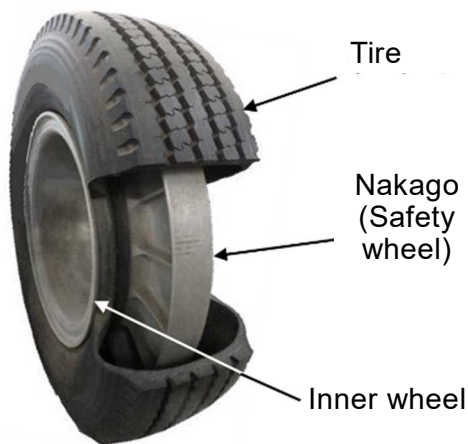
An example of a running wheel being used on the new transportation system

Functions such as operation control and safety devices for new transportation system vehicles we investigated were similar to those of common railway vehicles, but the parts that are most integral to locomotion (wheels) are almost identical to those of automobiles.

Therefore, tires for the new transportation system are hardly different from those of common automobiles and each of them has a “Nakago,” (Safety wheel) made of cast aluminum alloy that makes it possible for the train to continue on a short distance even if puncture—to a rail yard for example.

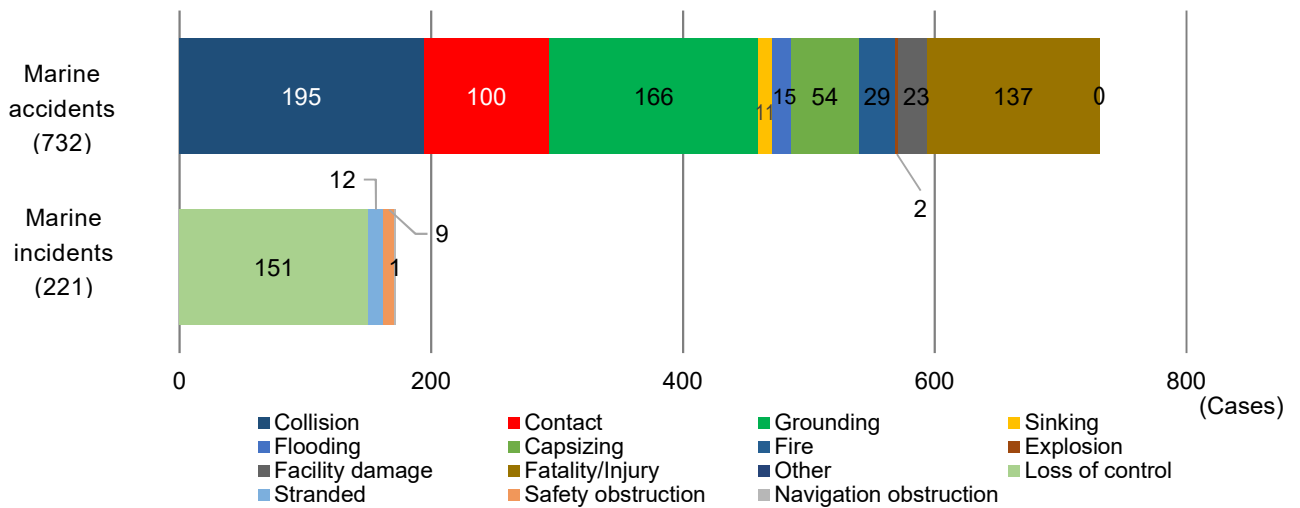
The breakdown of the 905 investigations launched in 2020 by type of accidents and incidents is as follows: The marine accidents included 195 cases of collision, 166 cases of grounding, 137 cases of fatality/injury (not involved in other types of accidents), and 100 cases of contact. The marine incidents included 151 cases of loss of control, 12 cases of stranded, and nine cases of navigation obstructions. Objects that collided with ships included quays in 25 cases, buoys in 20 cases, and breakwaters in 14 cases.

Number of investigated marine accidents and incidents by type in 2020

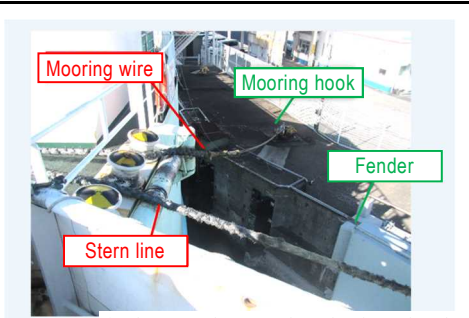
<p>* The vessel moored to the ferry berth</p>

<p>Probable Causes</p>	<p>It is probable that this accident occurred under circumstances in which an onshore worker was not informed in advance of an undocking method test of a newly installed fender on the stern-side ferry berth. During the undocking procedure at the ferry berth, the onshore worker heard the pilot's transceiver conversation, "Release the stern painter." so he mistakenly thought that was an instruction directed at him to release the mooring wire and so he pushed the mooring hook release switch. This action released the taut stern-side spring line, which sprang back and struck second officer who was standing in the snapback zone of the spring line.</p> <p>It is probable that the reason the onshore worker was not informed in advance was that the captain believed that "the worker was listening to cross-talk conversations through a ship's transceiver and therefore he should understand the situation even without being informed directly of the undocking method test using the fender."</p> <p>It is probable that the reason the onshore worker mistook the captain's conversation "Release the stern painter." for an order to him to detach the mooring wire was that he was unfamiliar with the procedure and was only paying attention to transceiver communication so as to prevent a late execution of an order to detach the mooring line.</p> <p>The procedure for undocking work at the ferry birth had been verbally informed to Nankai Ferry Co., Ltd.'s employees through safety guidance but a concrete procedure had not been specified in its safety management manual, and a manual for handling a mooring hook was not available. It is probable that these factors have contributed to this accident.</p>

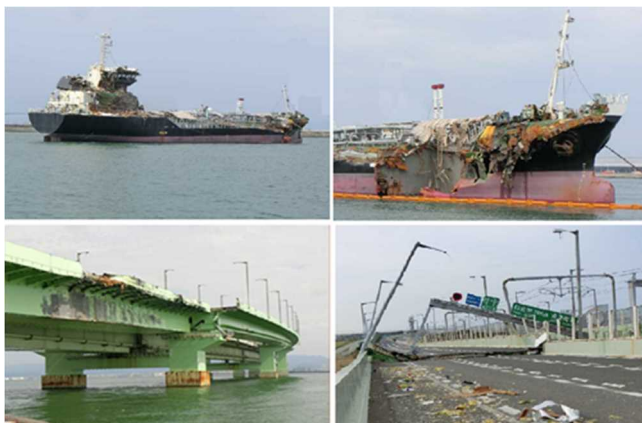
The deck on the starboard bow of the Vessel was crushed, and the road girder of Kansai International Airport Access Bridge was bent, broken, and scratched. The railway girder was collapsed, the rail was warped, and the gas pipe was broken. However, no crew members were injured.

In this accident, the HOUNMARU continued single anchoring at the east side of the Oil Tanker Berth ("the Anchorage") located on the southwest side of the Senshu Port in Osaka Prefecture, where Kansai International Airport Access Bridge is located about one nautical miles north of the southeast of the 'Kansai International Airport First Stage Airport Island' ("the Kanku Island") for the purpose of typhoon

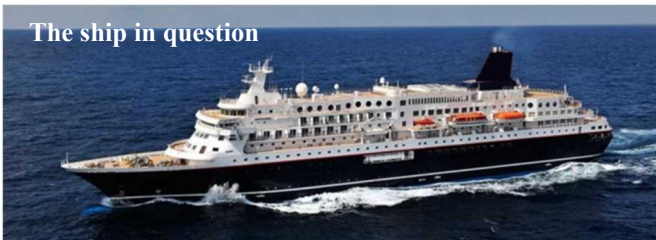
Collision (at around 21:13:27)

(Difference between the captain’s recognition of how he was handling the ship and how he was actually handling the ship)

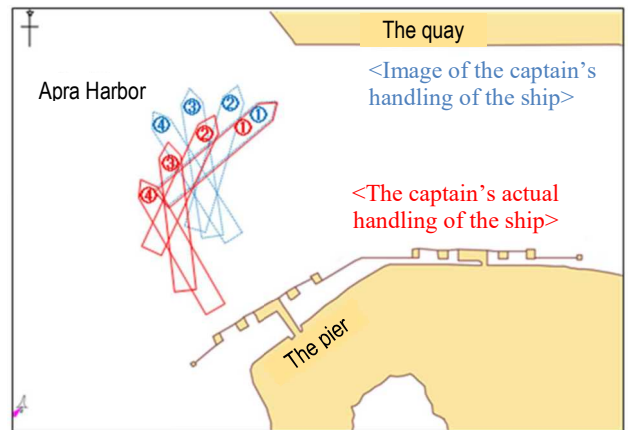
Difference between the captain’s image of his handling and the actual movement of the ship

Probable cause: It is probable that, during the ship’s left turn in an area west of the quay, the captain in an attempt to facilitate the turn tilted the joystick fully sternward although intending to tilt it fully in the starboard direction. He continued tilting the joystick fully sternward unaware of his mistake causing the ship to reverse with its bow rotating leftward when the stern collided with the pile dolphin of the pier.

Probable Causes	<p>It is probable that this accident occurred as follows: When the captain steered the NIPPONMARU leftward in the sea area from quay F-4 of Apra Harbor, Guam, he tilted the joystick fully sternward in his attempt to facilitate the left turn although he should have tilted it fully in the starboard direction. Since he continued his full tilt of the sternward and was unaware of his mistake, the ship went astern while its bow was turning leftward causing the stern to collide with the pile dolphin of pier D located opposite to quay F-4.</p> <p>In fact, the captain intended to tilt the joystick fully in the starboard direction but tilted it fully sternward. It is probable that although he was aware that tilting the joystick fully in the starboard direction requires tilting it fully toward the left side of his body while orienting his body toward the stern, he was in a standing position with his body positioned in a different direction from what he was used to. This resulted in him tilting the joystick fully toward the left side of his body while facing astern, and not sternward.</p> <p>It is probable that the captain was unaware of his misdirection because he performed the operation without watching the way his hands controlled the joystick or the outboard display. He did not think that what was reported to him by the navigation officer in charge of the stern indicated an approach toward pier D, and he understood neither the proposals nor advice by a navigation officer supporting ship's handling nor those of the pilot.</p> <p>It is probable that the captain was unaware of his misdirection because he performed the operation without watching the way his hands controlled the joystick or the outboard display. He did not think that what was reported to him by the navigation officer in charge of the stern indicated an approach toward pier D because the ship was turning leftward by means of a side thruster and a tugboat and because he interpreted what the navigation officer in charge of the stern reported to him as evidence of the ship continuing a left turn. In this way, he selectively collected information corroborating what he was thinking was right and therefore was convinced that his handling of the ship was correct.</p> <p>It is probable that the reason the captain could understand neither the proposals nor advice by the support navigation officer or the pilot was that he ignored any information that might disprove what he was thinking to be right.</p> <p>It is likely that the captain believed that he should always be in charge of the handling, undocking and turning around of the ship and recognized that the navigation officer in charge of steering the ship was a newcomer in training. All these factors led to his prioritizing his own judgements rather than heeding the suggestions and advice of the pilot and the support navigation officer, which likely caused his continued tilting the joystick fully sternward.</p>

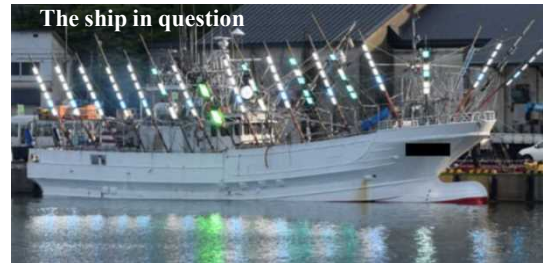
(Conceptual drawing of the impact of wind wave)

Probable cause: Under circumstances in which a high wind maritime alert was issued and a low-pressure system was approaching, the Vessel bound for Hanasaki Port was navigating westward east of Cape Nosappu in the face of winds and ocean waves. It is likely that the lateral waves hitting the port-side oscillated the vessel (causing a maximum expected value of 1/1000), a strong wind blast blew when its port-side (windward side) horizontally oscillated maximally, its tilt moment due to the winds rapidly increased and tilted in the starboard direction in excess of the bulwark submersion angle, causing the starboard bulwark to submerge, thereby capsizing the vessel.
