Chapter 2 Summary of recommendations and opinions

1 Recommendations

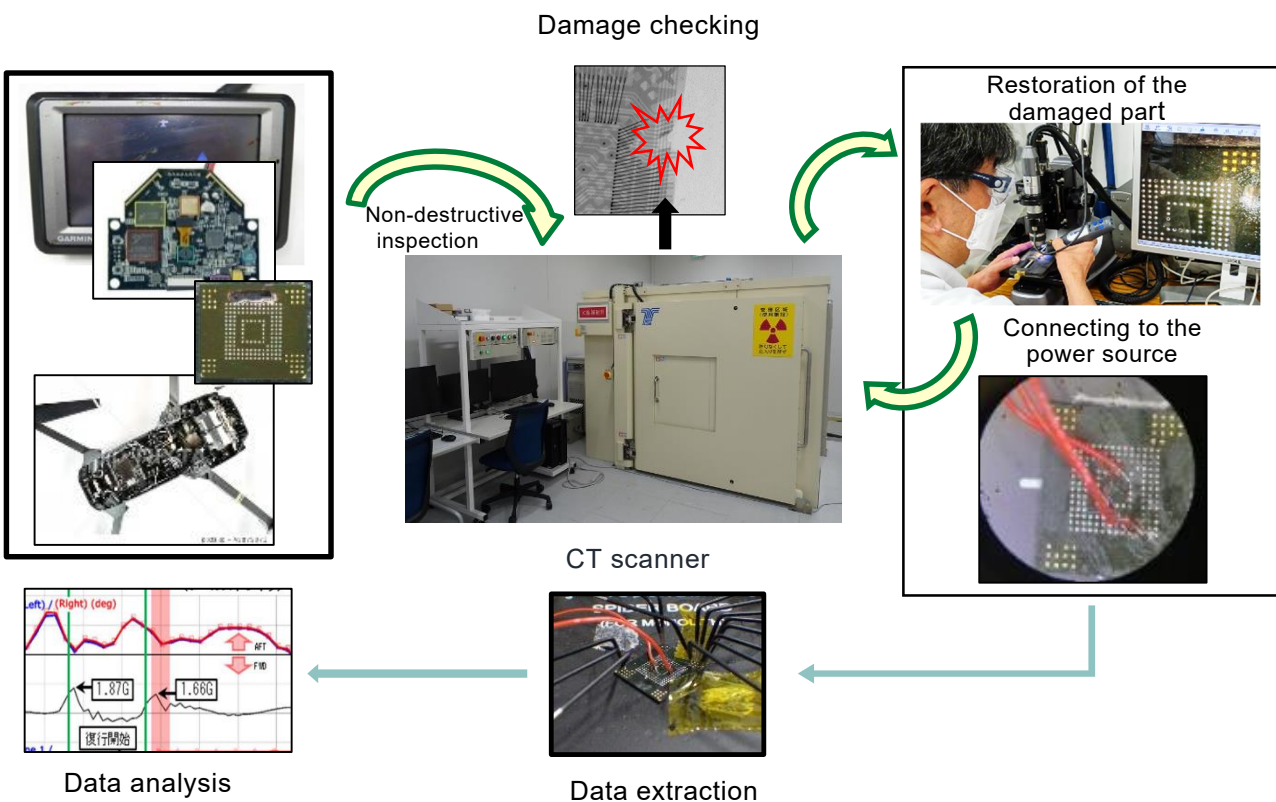
<CT Scanner >

The CT scanner is a very effective device for the JTSB to obtain information from data recorded in electronic devices. For example, when extracting data from electronic devices such as the GPS receiver used in the aircraft related accident, mobile phones and cameras carried by passengers in order to reproduce the estimated route of this aircraft and images taken at the time of the accident, there is likelihood that the data is lost or the data cannot be extracted upon connecting to the power source carelessly in cases in which these electronic devices are wet with water or the internal electronic boards are severely damaged. In these cases, it is necessary to carefully proceed with work such as disassembling, restoring, connecting, etc., for extracting the data. The CT scanner allows the work to be performed speedily and securely. The example below shows a flow to check the damage on the memory chip and perform repair work thereof using a CT scanner in which extremely thin wires are connected to the damage memory chip to supply power and to finally extract the recorded data.

We have just introduced CT scanner which will be used extensively for accident investigations of aircraft, railway and marine in the future.
