アジアナ航空株式会社所属エアバス式 A 3 2 0 - 2 0 0 型 H L 7 7 6 2 の  
航空事故に係る安全勧告に基づき講じた措置について

## アジアナ航空(株)所属エアバス式A320-200型HL7762の航空事故(H27.4.14)に係る安全勧告に基づき講じた措置について

**Safety Action Plan in compliance with  
Safety Recommendations regarding  
HL7762 Accident at Hiroshima Airport**

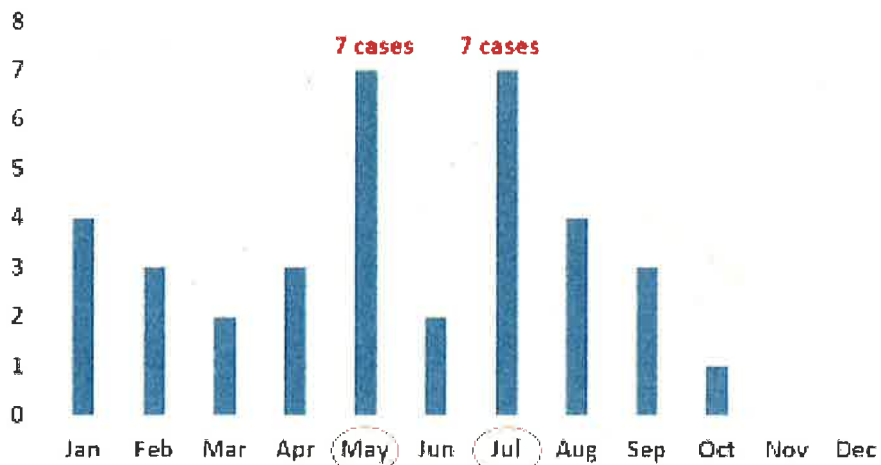
● MONTHLY OCCURRENCE

○ High occurrence on May and July is reckoned due to seasonal threats.(Busy time)

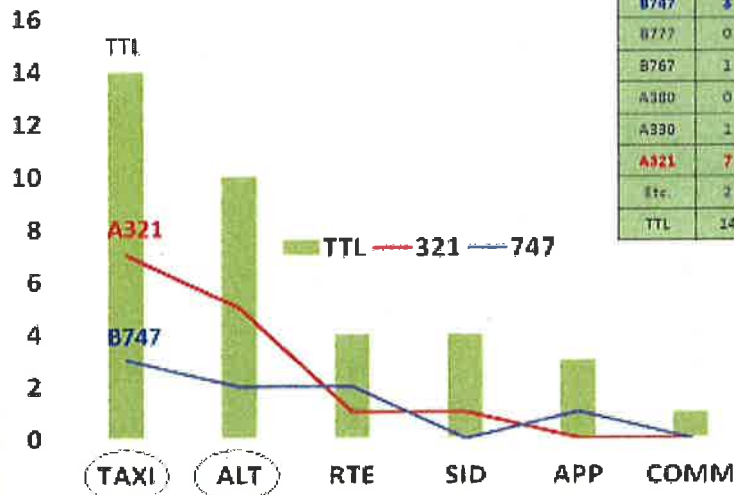
A/C TYPE & VIOLATION TYPE

TAXI	ALT	RTE	SID	APP	COMM
B747	3	2	2	0	1	0
B777	0	0	0	2	0	1
B767	1	0	0	0	0	0
A380	0	0	0	0	0	0
A330	1	1	1	1	1	0
A321	7	5	1	1	0	0
Etc.	2	2	0	0	1	0
TTL	14	10	4	4	3	1

Taxiway incursion and Altitude violation are major, of which counter measures should be planned/do and pursued.

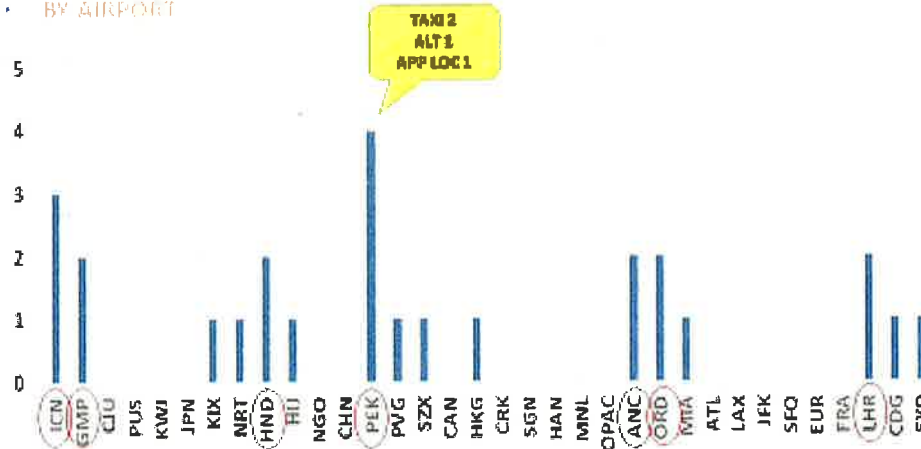
BY AIRPORT

○ ATC violation vulnerable airport (Busy Airport)

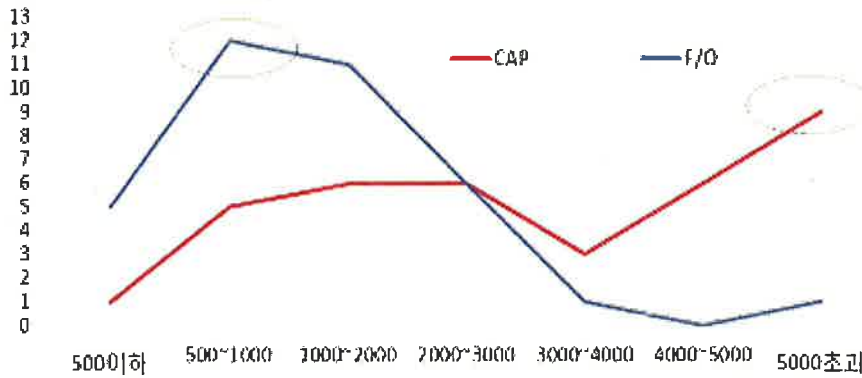
BY CREW FLYING TIME

○ CAP: high frequent over 5000 hours  
 ○ F/O: high frequent between 500~1000 hours

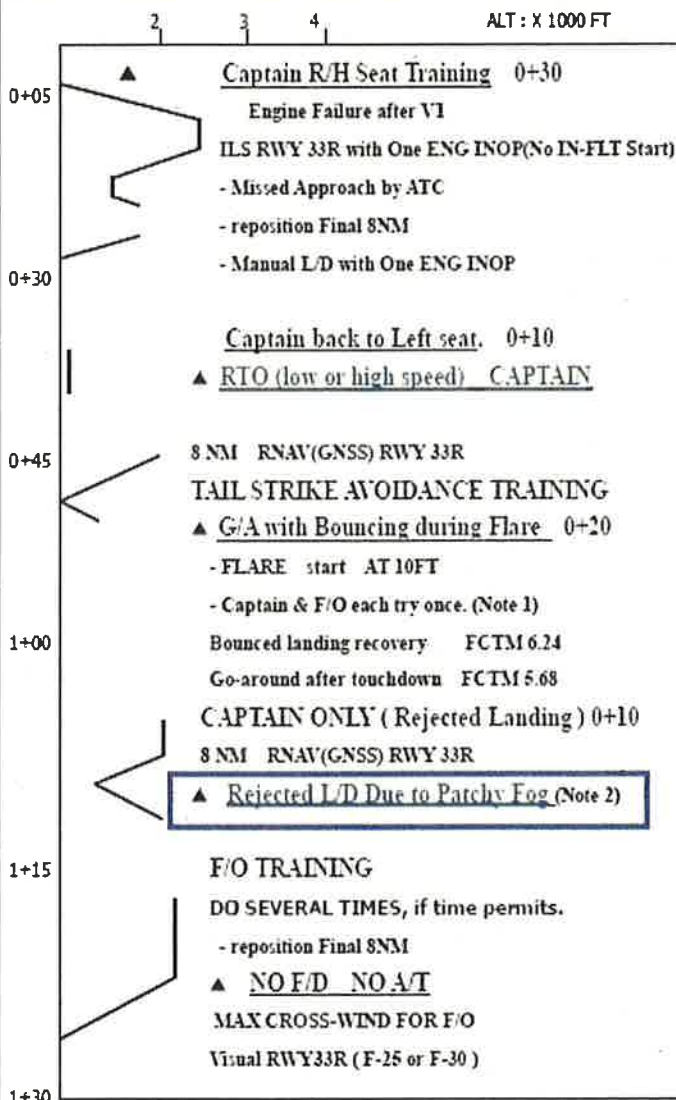
CTG VIS	WIND	G/W CG x 1000	BRAKE ACT	OZ 112 CLEARED TO KIX AIRPORT EGOPA 1L DEP CLIMB MAINTAIN 4000'DEP FREQ 125.15 SQ 4001	RKSI	T/O PSN
					QNH 1013	OAT: -10C
CAVOK	24010	440.0 24%	RKSI 33L DRY

CAVOK	24010	440.0 24%	33R			
CAVOK	calm	440.0 24%	RKSI 33R DRY			
1000 FT 4800M	24010	440.0 24%	RKSI 33R DRY			
CAVOK	240/20 or 060/20	440.0 24%	RKSI 33R DRY			
REMARK	<p>☞ BRAKING ACTION IS GOOD</p> <p>▲ TRAINING ITEMS</p> <p>Note1 : If F/O bounces, then Captain takes over controls.</p> <p>Note2 : Sudden W/X changes to CAT III B at 100FT</p>

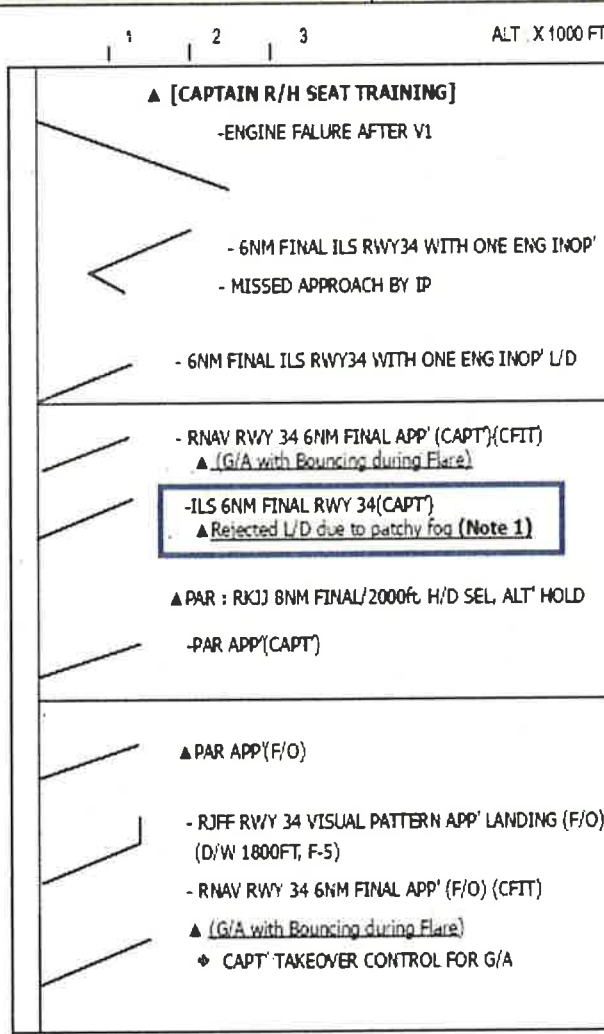
CIG VIS RVR	CROSS WIND	GW CG (ZFW)	RWY COND. B/A	OZ 135 CLIMB RWY HEADING MAINTAIN 3,000FT CLEARED FOR T/O RWY 34	RJFF	GATE: RWY
					QNH 29.92	OAT: -10°C / -20°C
CAT- I	10KTS	280 24%	RJFF 34 WET GOOD

<p>1   2   3</p> <p>ALT X 1000 FT</p> <p>▲ [CAPTAIN R/H SEAT TRAINING]</p> <p>-ENGINE FAILURE AFTER V1</p> <p>- 6NM FINAL ILS RWY34 WITH ONE ENG INOP'</p> <p>- MISSED APPROACH BY IP</p> <p>- 6NM FINAL ILS RWY34 WITH ONE ENG INOP' L/D</p> <p>- RNAV RWY 34 6NM FINAL APP' (CAPT')(CFIT)</p> <p>▲ (G/A with Bouncing during Flare)</p> <p>- ILS 6NM FINAL RWY 34(CAPT)</p> <p>▲ Rejected L/D due to patchy fog (Note 1)</p> <p>▲ PAR : RKJJ 8NM FINAL/2000ft. H/D SEL. ALT' HOLD</p> <p>-PAR APP'(CAPT)</p> <p>▲ PAR APP'(F/O)</p> <p>- RJFF RWY 34 VISUAL PATTERN APP' LANDING (F/O) (D/W 1800FT, F-5)</p> <p>- RNAV RWY 34 6NM FINAL APP' (F/O) (CFIT)</p> <p>▲ (G/A with Bouncing during Flare)</p> <p>◆ CAPT' TAKEOVER CONTROL FOR G/A</p>	0+05
